## Awning Fabric Weld Repair Instructions

<b>Bulletin Type:</b>	Recall	<b>Publication Date:</b>	August 2022
<b>Bulletin #(s):</b>	22V-571 US 2022-424 Canada	<b>Make(s):</b>	Jayco
<b>Job Code(s):</b>	9901578	<b>Model(s):</b>	Eagle, Jay Flight, North Point, Pinnacle, Seismic
<b>Flat Rate(s):</b>	9901578A - 0.20 Inspection 9901578B - 0.50 Inspection and Repair 9901578C - 1.7 Inspection and Replace	<b>Model Year(s):</b>	2022-2023

<b>Incident:</b>	Insufficient Fabric Awning Weld
<b>Affected Units:</b>	2022-2023 Jayco Eagle, Jay Flight, North Point, Pinnacle, Seismic
<b>Parts Kit: 22V-571</b>	Parts Kit #: 22V-571
	Part Kit Contents: Adhesive, RPR Seam Awning (Jayco Part #2040196)
<b>Misc. Tools &amp; Supplies: N/A</b>	<b>Parts Return Information: N/A</b>

## INSUFFICIENT AWNING WELD(S) INSPECTION

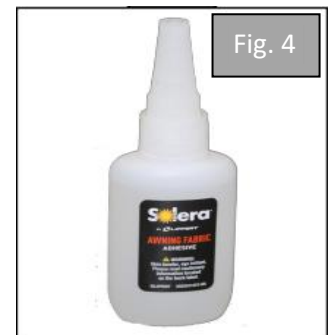
- **Seam Separation Repair Procedure is below**
- **Note: The repair procedure is optimal for seam separation less than 6".**
- Resources Required: Awning Seam Repair Adhesive Parts Kit #: 22V-571 (Figure 4)
  1. Begin by extending the awning:
    - a. For a seam fix at the awning rail, extend the awning a few feet.
  2. Tie both awning arms slightly back to gain some slack at the fabric.
  3. Clean the area to be repaired with mild soap and water. Allow to dry completely.
  4. Spread open the seam area needing repair (Figure 5) and apply a continuous bead of Awning Seam Repair Adhesive. (Figure 6)

- a. Note: Figure 5 shows fabric off awning for clarity and upside down. The repair can be completed with the awning fabric installed.
5. Use Awning Seam Repair Adhesive Parts Kit #: 22V-571 (Figure 4) along the entire separation (Figure 6).
6. Press down firmly and hold for several minutes.
7. Allow to dry for at least four hours.

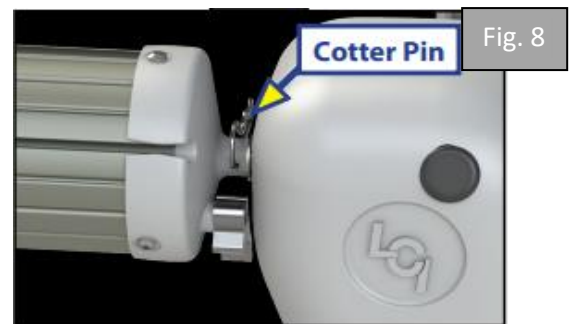
1. Order the Awning Fabric using the Compliance Order Form. You must include with order form:
  - a. Clear photo of the awning tag.
  - b. Photos documenting any weld separation concerns with tape measure.
2. Remove the drip cap (if equipped) from the end of the awning from which the fabric will be removed.
3. Extend the awning out approximately 12" and insert cotter pins through both end caps into the shafts on the head assemblies. (Figure 8)
  - a. Note: If the awning is 6' in length it will only need one cotter pin for the drive side end cap.

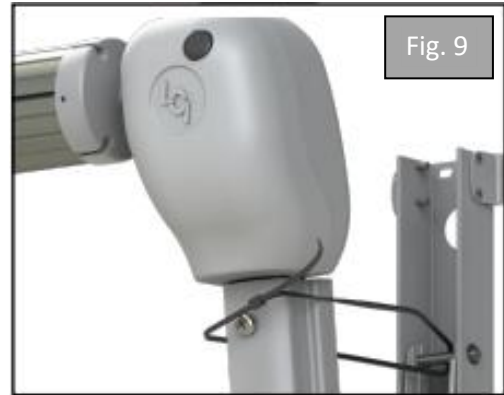
4. Secure both support arm assemblies by running a zip tie around the outer arm and around the pin on the top of the mount arm where the mount arm and inner arm connect. (Figure 9)

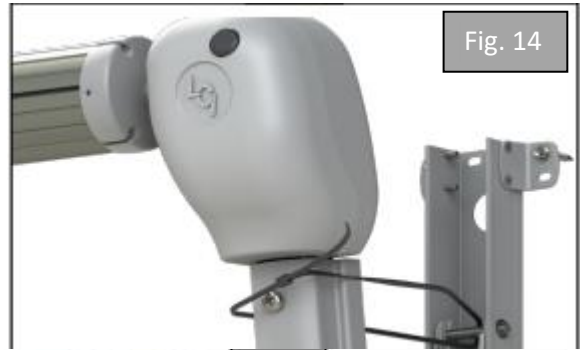
Fig. 14

4. Retract the awning until approximately 12" remain visible.
5. Secure both support arm assemblies by running a zip tie around the outer arm and around the pin on the top of the mount arm where the mount arm and inner arm connect. (Figure 14)

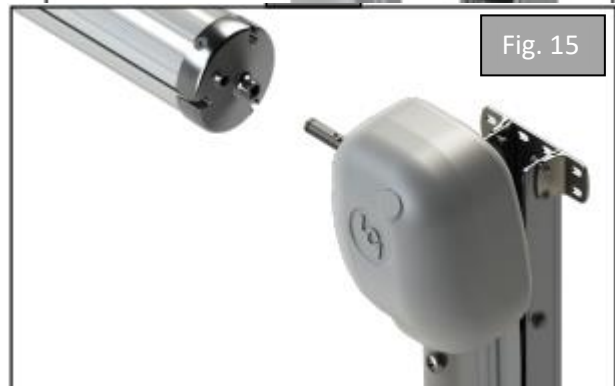
Fig. 15

6. Remove the screws holding the poly cord in place on the awning rail.
7. Remove the wax screws holding the end caps onto the drive and idler head shafts (Figure 15).
