<b>HYUNDAI</b> <b>Technical Service Bulletin</b>	GROUP <b>RECALL</b>	NUMBER <b>22-01-079H-1</b>
	DATE <b>OCTOBER, 2022</b>	MODEL(S) <b>ELANTRA N-LINE (CN7) ELANTRA N (CN7N)</b>
<b>SUBJECT:</b> DRIVER AIRBAG (DAB) REPLACEMENT (RECALL 234)

**Description:** On certain 2022-2023MY Elantra N-Line (CN7) and 2022MY Elantra N (CN7N) vehicles, the emblem on the driver's airbag may not have been installed correctly. The emblem could detach during frontal airbag deployment, increasing the risk of injury during a crash.

This bulletin provides the procedure to replace the driver airbag to correct this condition.

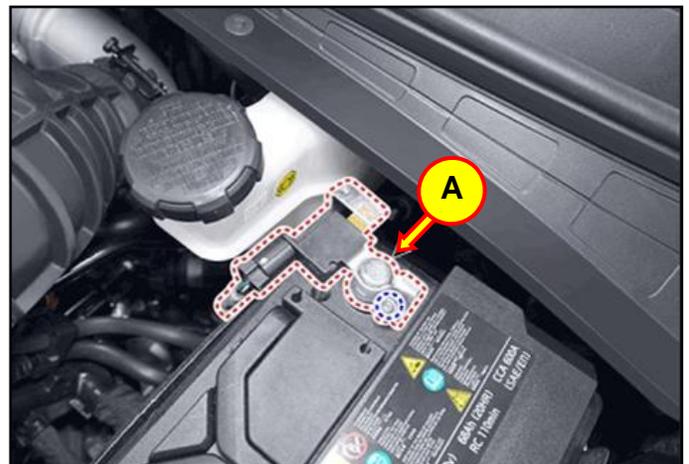
1. Turn vehicle ignition ON and record the customer's radio presets, if applicable.
2. Turn vehicle ignition OFF and disconnect the 12V battery negative (-) terminal.

After disconnecting the battery negative (-) terminal, wait at least three minutes before beginning work.

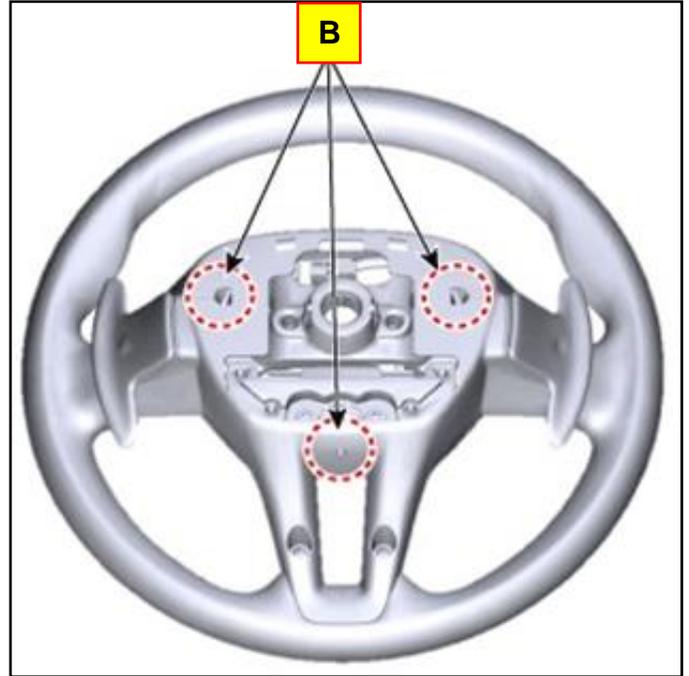
The driver airbag is fixed to the steering wheel by three fastening pins (B).

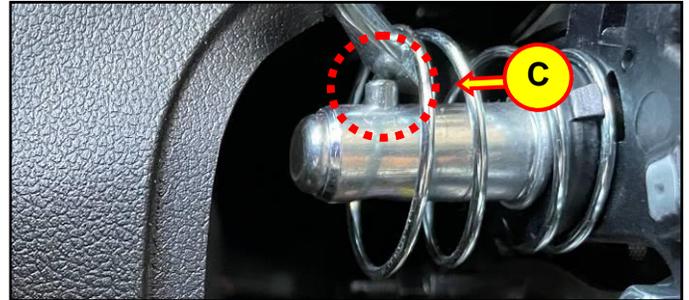
Remove the driver airbag by depressing the three locking pins (C).

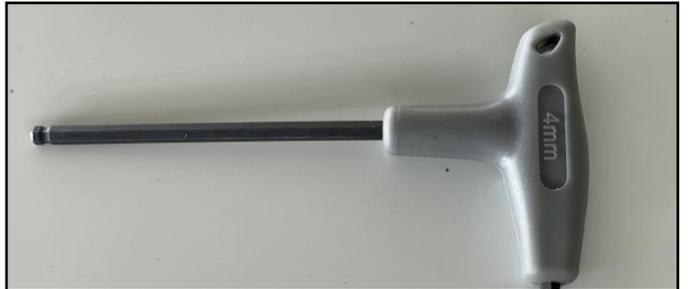
Use an H4/H5 Allen wrench/screwdriver to depress the airbag fastening pins.

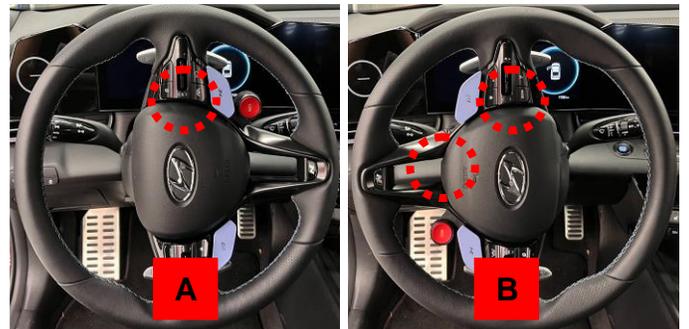
4. Turn the steering wheel as shown to the right to gain access to the guide holes.

Start with the steering wheel in the (A) position. This will position it for the picture requirement when rotated to position (B) to access the second and third access points.

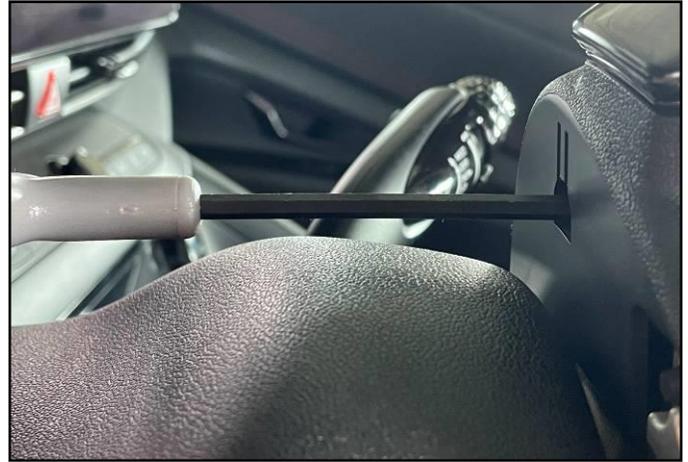
- 5A. To release the left and right fastening pins, insert the Allen wrench/screwdriver H4/5 in a straight parallel position as shown in the picture to the right.

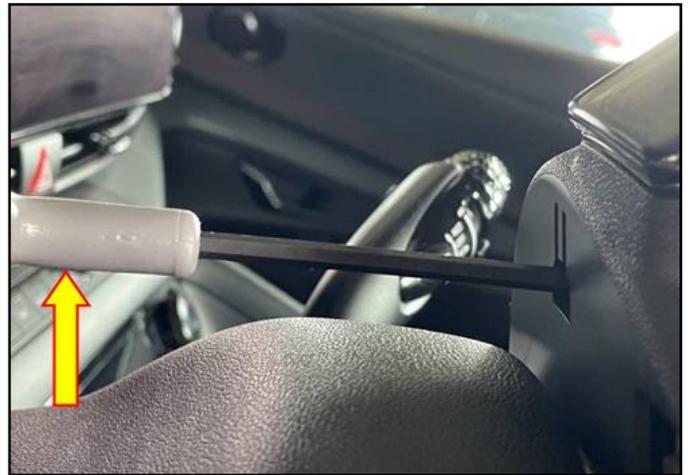
Insert the Allen wrench/screwdriver until it cannot go in any further. Gently press the end of the Allen wrench/screwdriver upward to depress the pin.

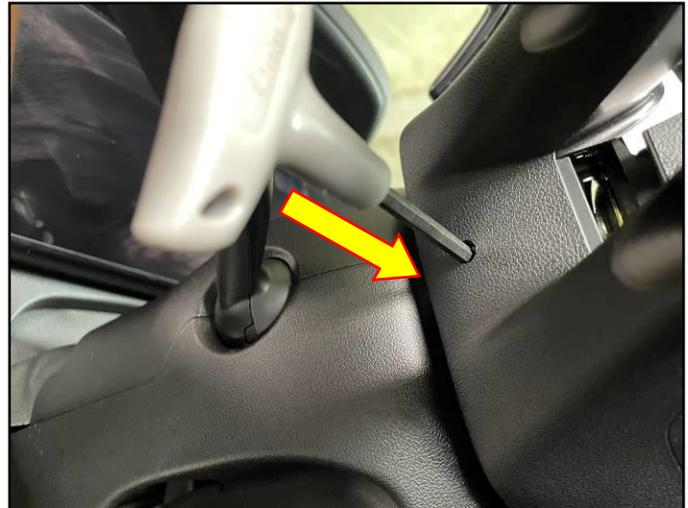
- 5B. To release the bottom fastening pin, insert the Allen wrench/screwdriver and push inward to depress the pin.

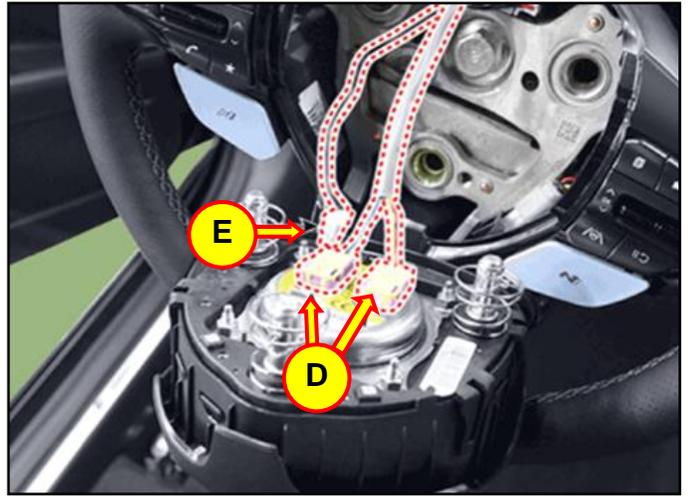
6. Disconnect the airbag module connectors (D) and the horn connector (E).

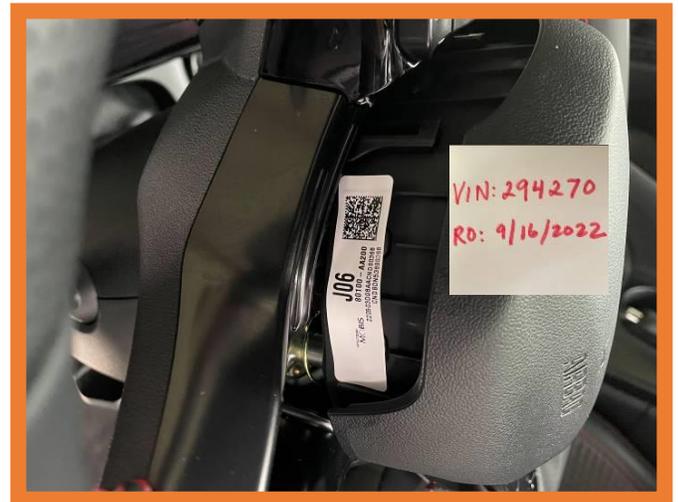
7. Remove and replace the driver airbag with a new one.
8. Before fully inserting the new driver airbag into the steering wheel, write the last six digits of the VIN and date of repair onto a piece of paper and place it near the driver airbag label and take a picture.

Using STUI, take a photo of the driver airbag label with the last 6 digits of the VIN and the date of repair on a piece of paper.

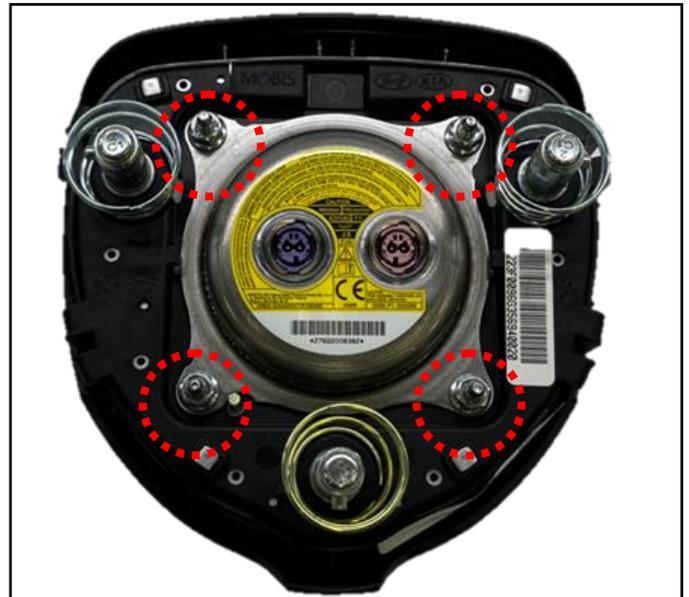
2. Remove the four (4) mounting nuts.

Do not use a power tool to remove the mounting nuts.

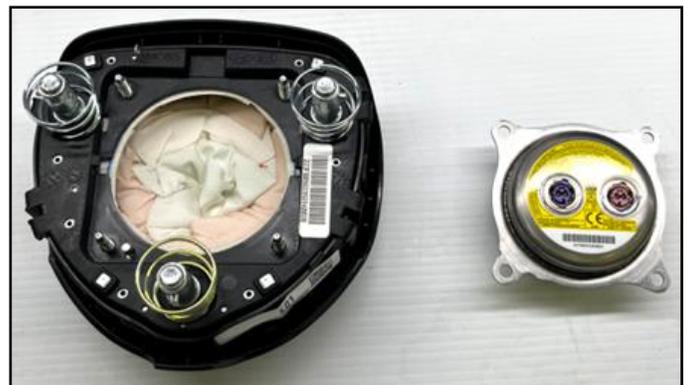
3. Separate the driver airbag cover from the airbag inflator module.
