INSTRUCTION TO SERVICE

| ITS: 60505 | | August 24, 2022 |
| SUBJECT: | NHTSA Equipment Recall 22E-047 – RH Sheppard Steering Systems | |
| ISSUE: | The steering gears may have been assembled incorrectly, which can cause the gear to fracture. | |

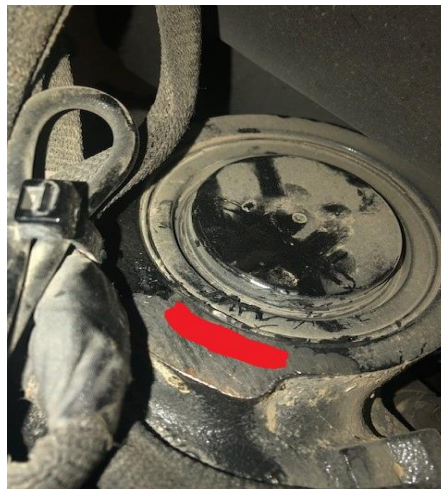
Figure 1: Serial Number and Part Number Location (Red Field is Example of Location)

1. Set park brake and chock wheels.
2. Turn the main battery disconnect switch to the “OFF” position.
3. Locate the steering gear and steering gear serial number and part number located on the lip of the steering gear. See Figure 1. Use Steps 1 to 9 in the Identification Guideline for Sheppard Steering Gears in Appendix A to identify the serial number and part number on the steering gear. It will look something like 21D12345 or 22D12345 depending on what year the steering gear was manufactured and may have a -C at the end.

6. If the steering gear serial number shows “Suspect” in the Sheppard Steering Gear Classification Tool, this steering gear will need to be replaced with a new steering gear (NF PN 497510) before the bus can be safely returned back to revenue service.

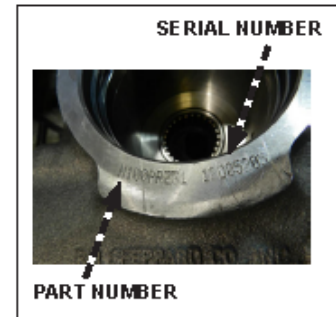
Figure 1 – Style 1

Style 1: This style will have the serial number and part number engraved on one line with a space between the part number and serial number. The entire engraving should be centered on the machined surface as shown in *Figure 1*.

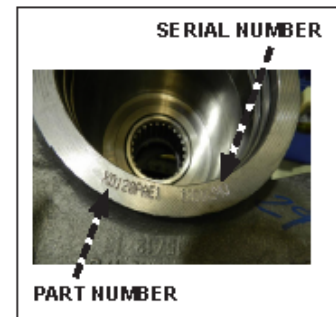
Figure 2 – Style 2

Style 2: This style will also have the serial number and part number engraved on one line with a space between the part number and serial number. The only difference is the amount of machined surface given for the engraving. The numbers should be engraved on more of a curve due to the lack of space provided. See *Figure 2*.

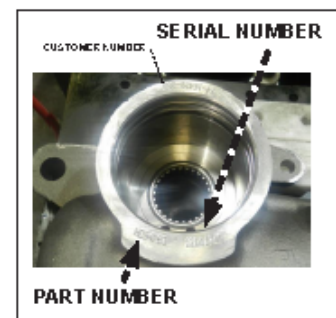
Figure 3 – Style 3

Style 3: The serial number and part number should be displayed on one line with a space between the part number and serial number. This style will also have a customer number printed on the housing opposite of the part number and serial number. See *Figure 3*.

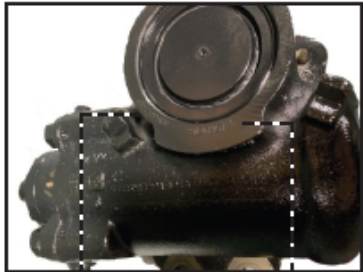
Figure 4 – Serial Number and Part Number Interpretation

A serial number and part number are engraved into the steering gear housing. See Figure 4 for further information on interpreting the serial number and part number.

21 E 07957 -C

21 represents the year the steering gear was built.

E indicates the month the steering gear was built (A - January, B - February, C - March, D - April, E - May, etc.).

-C indicates the steering gear has a snap ring style sector cover with a retainer clip.

07957 is the sequential serial number for gears built that month.

SD 110 PAU 3

SD stands for "severe duty." The first character of the part number represents the steering gear family.

110 indicates the diameter of the piston in mm.

3 indicates the steering gear has automatic relief springs. Other designators are "1" for manual relief springs and "2" for special applications. An additional number after "3" indicates there is a pitman arm installed on the steering gear.

PAU: The first letter in this sequence will indicate "P" to indicate "Power" or "S" to indicate "Slave." "AU" represents the specific model for the M110 steering gear.

- **Slave Gears:** Slave gears will not have an input shaft or a connection to a steering column. Note that slave gears are typically located on the passenger side of the vehicle. See Figure 4. A "P" in the part number represents a power steering gear. An "S" in the part number represents a slave gear. If the part number includes an "S," this indicates the steering gear is a slave gear. This type of gear does not fall within the recall parameters. See Figure 7 for an example of a slave gear part number and a side-by-side comparison of a power gear and a slave gear.

- **Steering Gears Outside the Date Range:** See Figure 4. If a steering gear serial number begins with 21 E (May 2021) or earlier (i.e. 21 D [April 2021], 21 C [March 2021], 21 B [February 2021], 21 A [January 2021], 20 L [December 2020], 20 K [November 2020], etc.), it does not fall within the recall parameters. If a steering gear serial number begins with 22 C (March 2022) or later (i.e. 22 D [April 2022], 22 E [May 2022], 22 F [June 2022], 22 G [July 2022], 22 H [August 2022], etc.), it does not fall within the recall parameters.
