# VOLUNTARY RECALL CAMPAIGN

Classification: FE22-004	Reference: NTB22-077	Date: August 31, 2022
-----------------------------	-------------------------	--------------------------

## VOLUNTARY SAFETY & EMISSIONS RECALL CAMPAIGN 2022 ROGUE; FUEL TANK INSPECTION

**CAMPAIGN ID #:** PC912  
**APPLIED VEHICLES:** 2022 Rogue (T33)

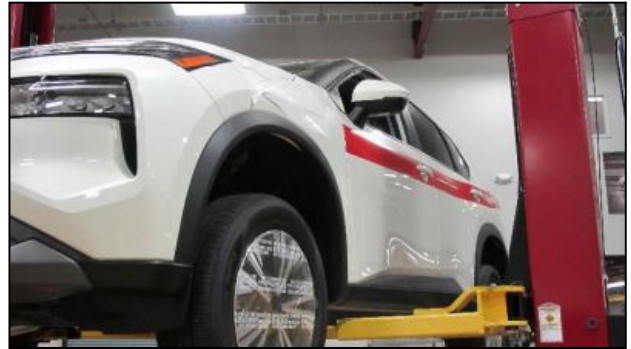
Figure 3

1. Place the vehicle on a suitable lift and raise it up.

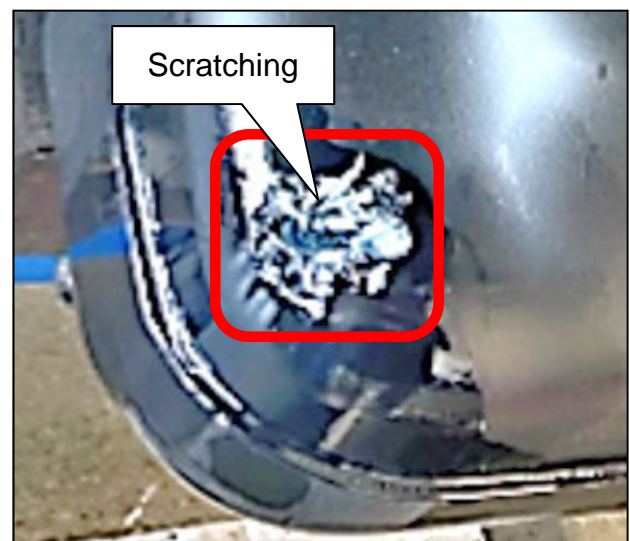
Figure 8

- Inspect the top left front corner of the fuel tank for a hole or any drill bit scratches/scuffing (Figure 7 and Figure 8).

- Use your hand to feel for scratching and/or scuffing on the fuel tank.
- The fuel tank should be smooth to the touch in the inspection area.

5. Did the fuel tank inspection in step 4 on page 6 reveal a hole or any scratching/scuffing on the top left front corner of the fuel tank?
  - **GOOD - NO HOLES OR SCRATCHING/SCUFFING**
    - No repair is needed. Lower the vehicle and remove it from the lift. Refer to **CLAIMS INFORMATION** to submit a claim for Op Code PC9120.
  - **NO GOOD - HOLES OR SCRATCHING/SCUFFING FOUND**
    - Continue to step 6 to replace the fuel tank.

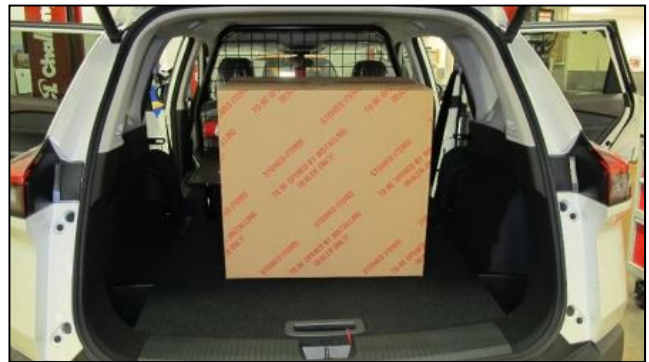
Figure 9

6. Open both rear doors and the back door.

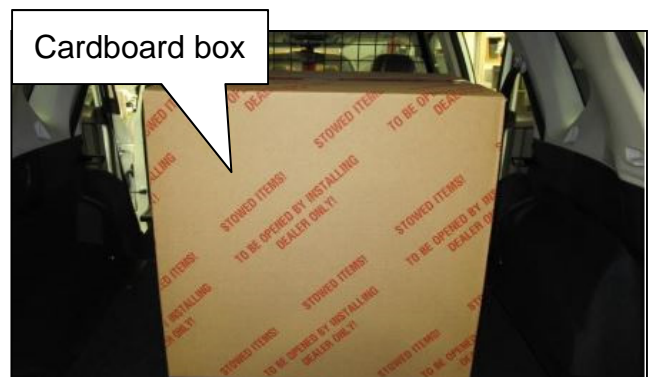
Figure 10

7. If present, remove the cardboard box labeled “STOWED ITEMS” (Figure 10).

**IMPORTANT:** Do not open the cardboard box, it has a tamper proof seal.

- Secure the cardboard box in a safe place, it will be placed back in the vehicle.

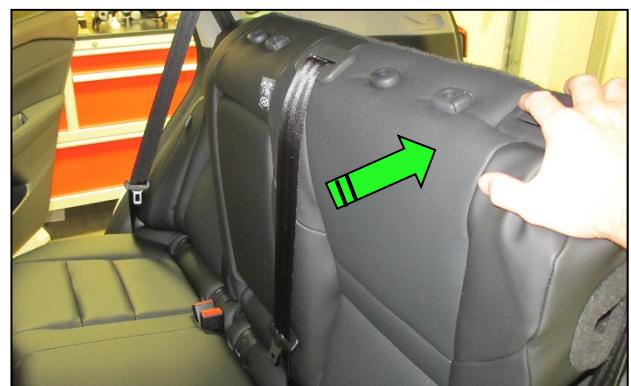
Figure 16

12. Move both second row seat backs to the full upright position.

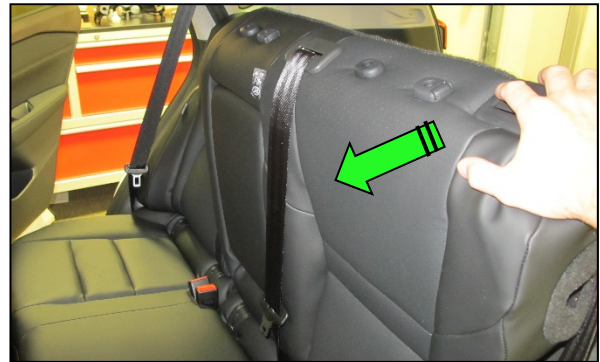
Figure 19

14. Fold both second row seat backs to the fully down position.

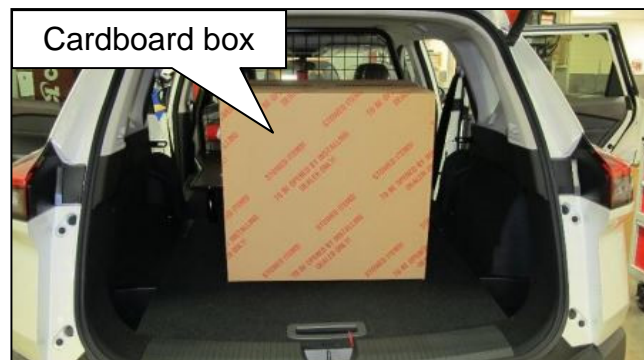
Figure 25

19. If applicable, place the cardboard box labeled "STOWED ITEMS" into the rear cargo area.

**IMPORTANT:** Do not open the cardboard box, it has a tamper proof seal.

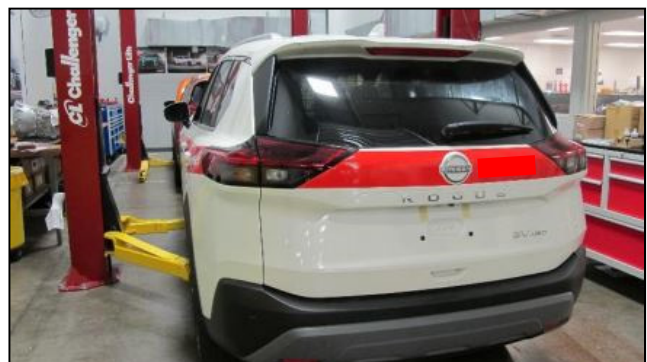
Figure 26

20. Close both rear doors and the back door.
21. Remove the vehicle from the lift.
