Keystone RV Company

SAFETY ADVISORY # 22-435

Dutchmen Stabilizer Jack Switch

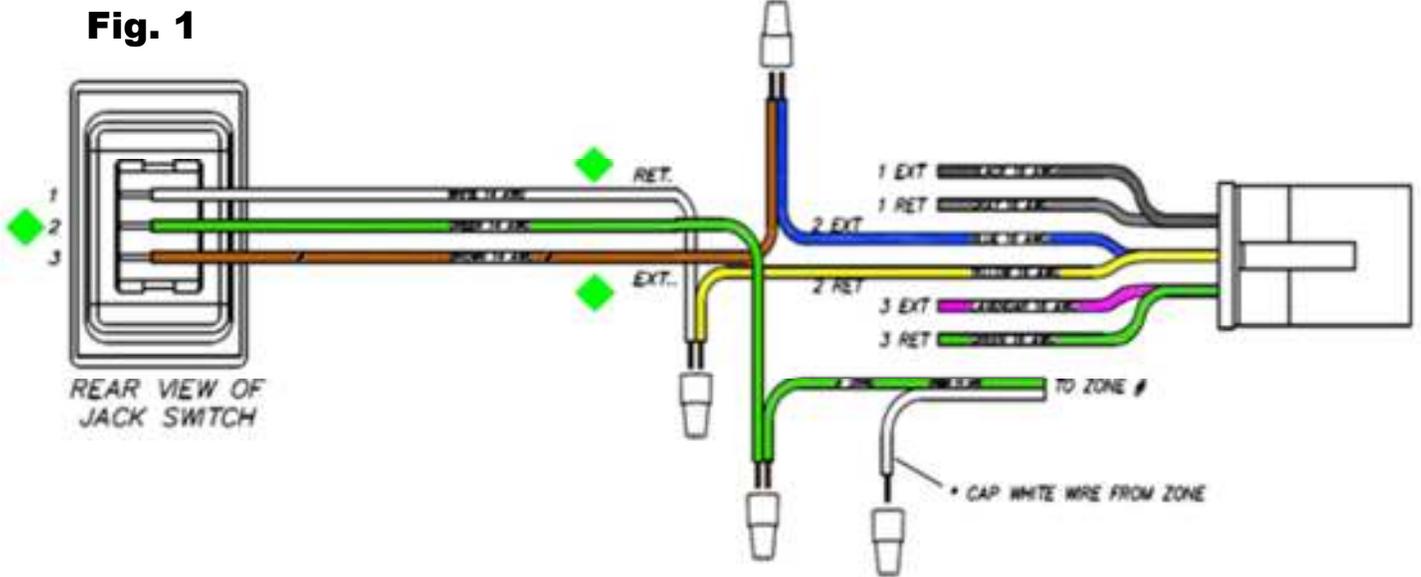
Keystone is conducting a voluntary RECALL notification campaign in accordance with the National Highway Transportation and Safety Act. It has been decided that the vehicles in the recall population have an electric stabilizer jack switch that is not waterproof from the back side of the switch. Under certain conditions during travel, the back side of the extend/retract switch for the electric stabilizer jacks can short out causing the jacks to extend during travel, leading to an increased risk of personal injury, and or vehicle crash.

Using the replacement stabilizer jack switches, KRV # 700834 - Switch - 12V - Mom On/Off/Mom On - SPDT - 260F - IP66 - Gasket - w/Extended Retract Print - w/Wire Harness – Black, match the wire colors using the diagram in Figure 1. Stabilizer Jack wiring to unit harness wiring - White to Yellow, Green to Green, and Brown to Blue. Any remaining harness wires should be capped off and not used.

The remedy is to replace the existing stabilizer jack switches with the waterproof switches, 2 – KRV # 700834 - Switch - 12V - Mom On/Off/Mom On - SPDT - 260F - IP66 - Gasket - w/Extended Retract Print - w/Wire Harness – Black.

Remove the existing switches on each of the two stabilizer jacks that do not have waterproof tape wrapped around the back of the stabilizer jack switch connection.
