Safety Recall

Code: 47T2

Subject	Brake Lines																									
Release Date	November 22, 2022																									
Affected Vehicles

Repair Overview

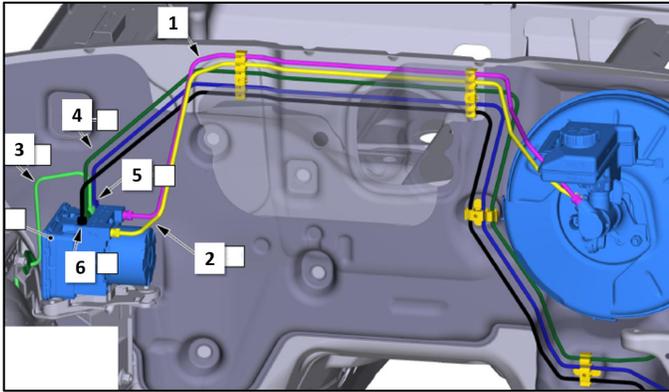
- Replace all brake lines connected to the ABS hydraulic unit.

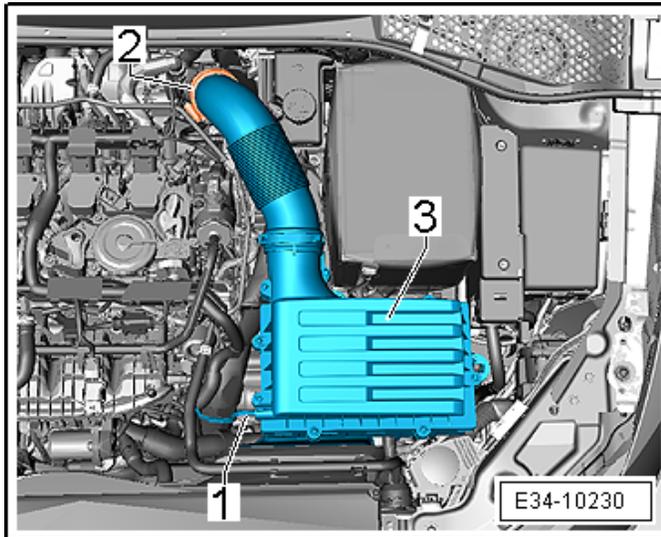
Remove air duct and air filter housing

- See ELSA Repair Manual: *Repair manual > Engine > 24 Multipoint Fuel Injection > Air Filter > Air Filter Housing, Removing and Installing*

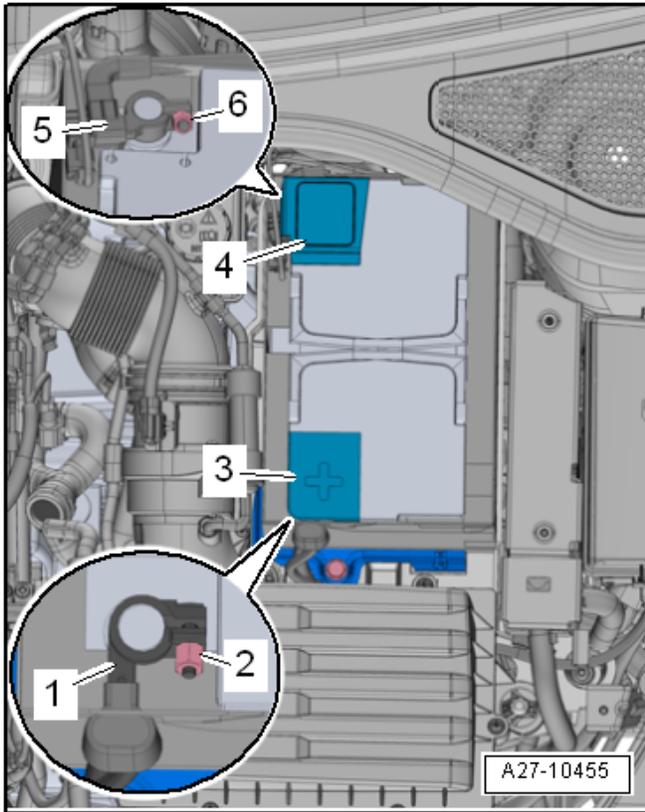
Remove 12V battery:

- See ELSA Repair Manual: *Repair manual > Electrical Equipment > 27 Battery, Starter, Generator, Cruise Control > Battery > Battery, Removing and Installing*

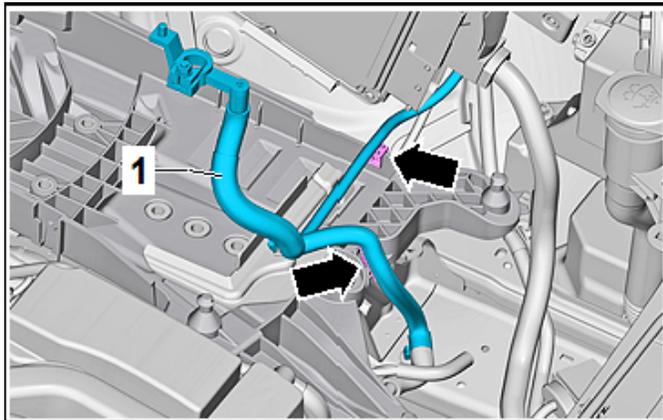
Remove battery tray:

- Remove the bracket <arrows> on the wiring harness <1> from the battery tray.

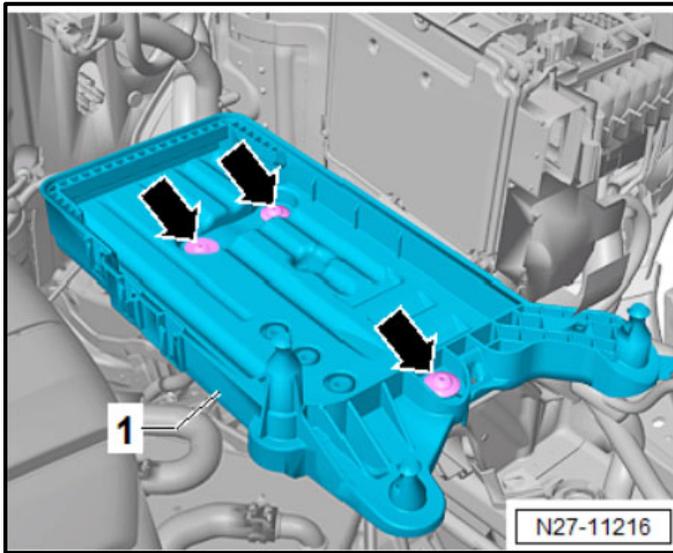
- Remove the bolts <arrows>.
- Remove the battery tray <1>.

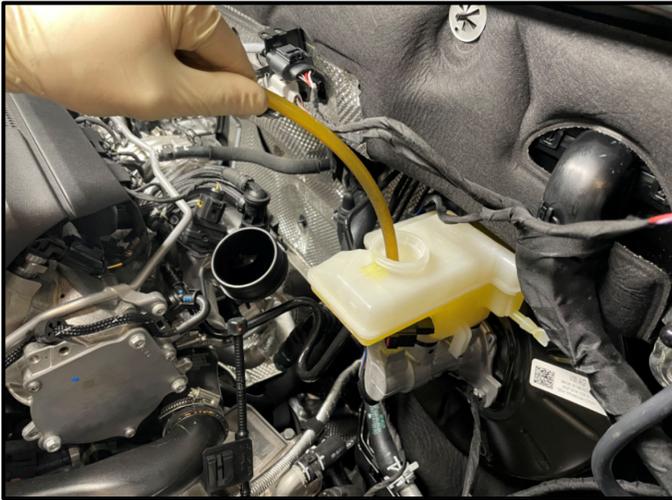
Remove brake fluid from reservoir:

- Suck out the brake fluid from the brake fluid reservoir.

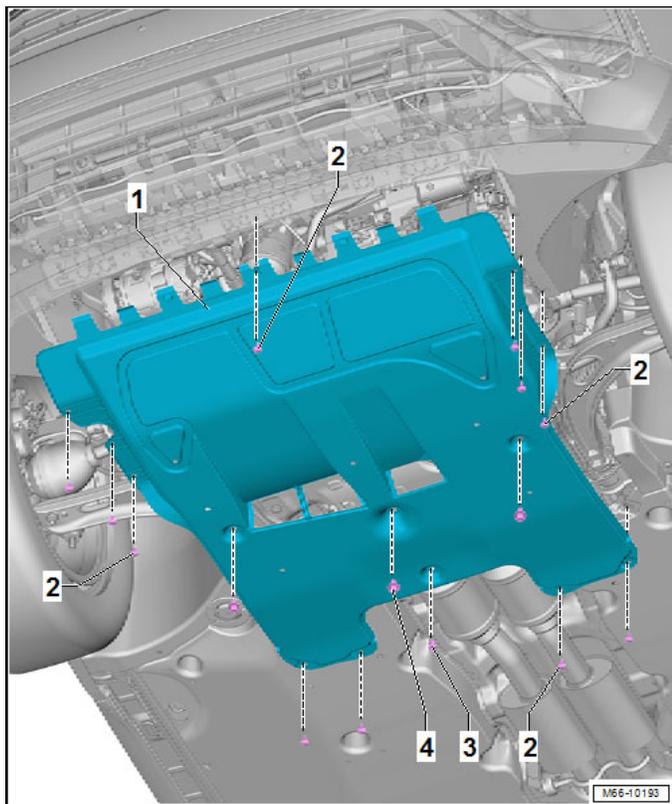
Remove noise insulation:

- See ELSA Repair Manual: *Repair manual > Body > Body Exterior > 66 Exterior Equipment > Noise Insulation*

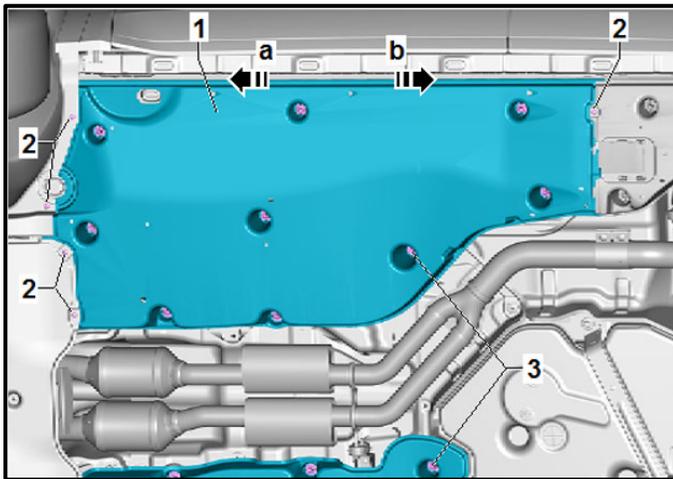
Remove driver side under body shield:

- Remove the nuts <3> and bolts <2>.
- Pull the underbody trim panel <1> forward in direction of <arrow a> out of the rear underbody trim panel.
- Pull the underbody trim panel <1> toward the rear in direction of <arrow b> out of the noise insulation.

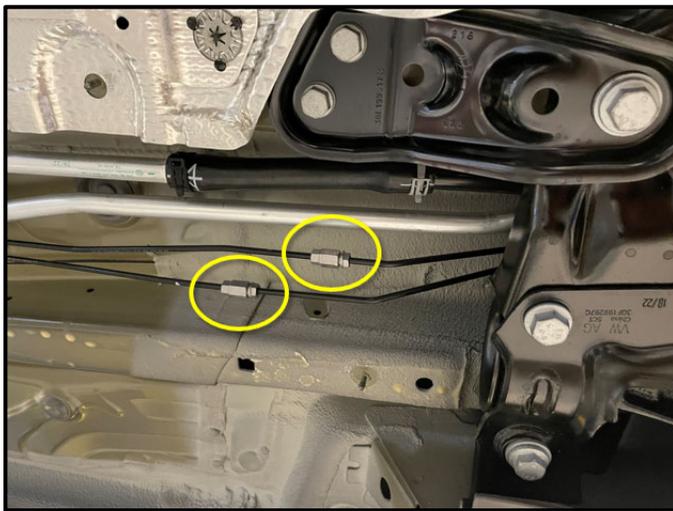
Disconnect underbody brake lines:

- Place a drip tray underneath the vehicle.
- Counterhold the union nuts and loosen the underbody brake line fittings <circles>.

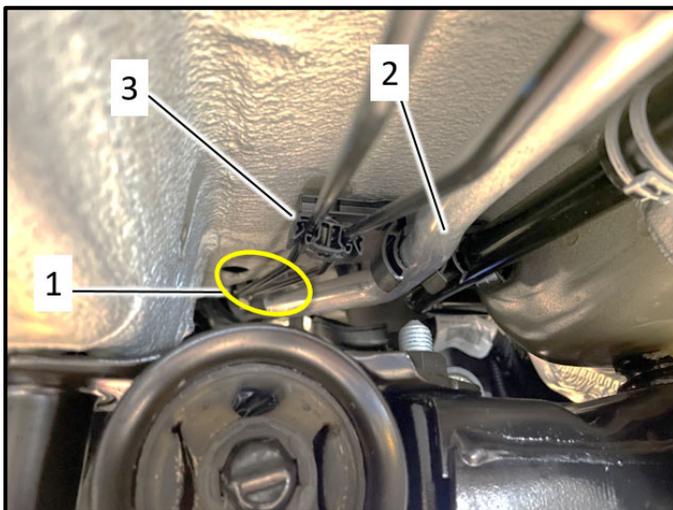
Remove brake line/heater hose bracket:

- Remove brake lines <1> and coolant pipe <2> from bracket <3>.
- Remove bracket <3> from the body.

The bracket <3> holding the brake lines and coolant pipe is located above the subframe.

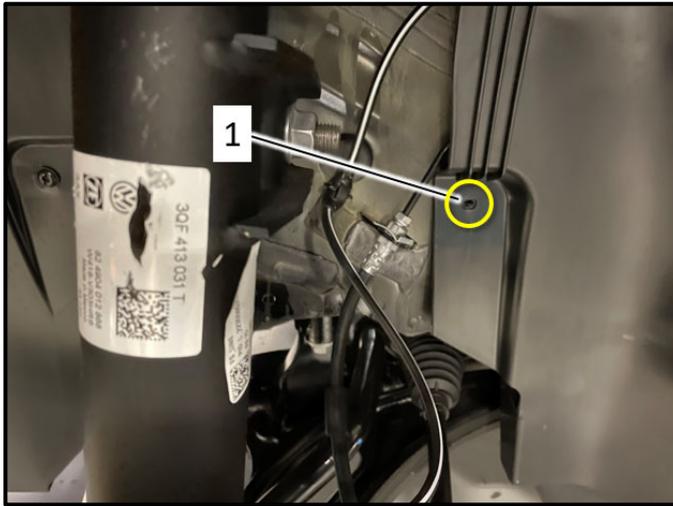
Remove front wheels and screws from front fender liners:

- Remove both front wheels.
- Remove the screw <1>, closest to the brake line, from the fender liner on both front fender liners.

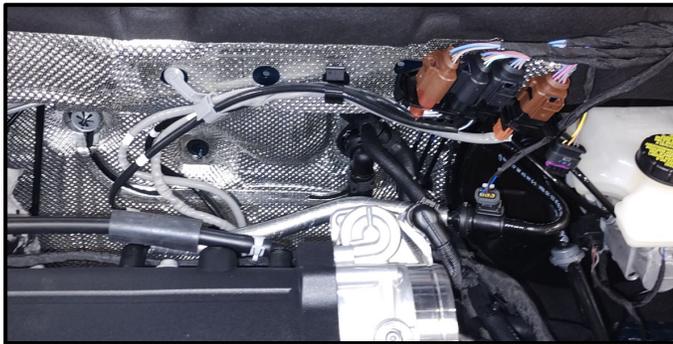
Free up wiring harness:

- Free up sensor wiring, vacuum line and ABS wiring from the firewall.
- Secure out of the way as needed.

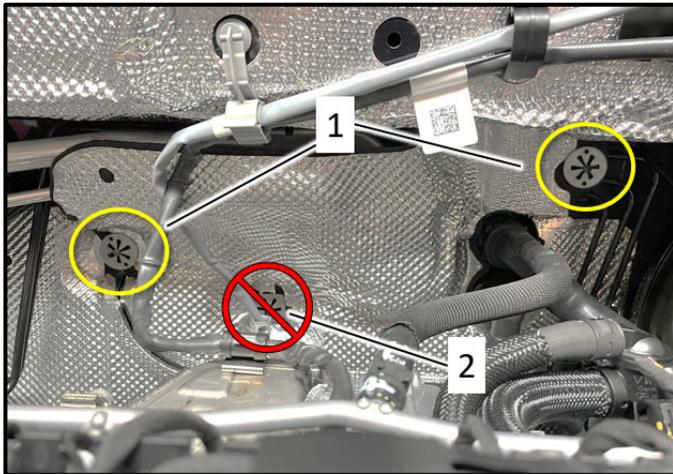
Remove firewall insulation clips:

- Remove clips <1> by unscrewing them.

Clip <2> does not require removal.

- Fold firewall insulation down to expose the brake lines.

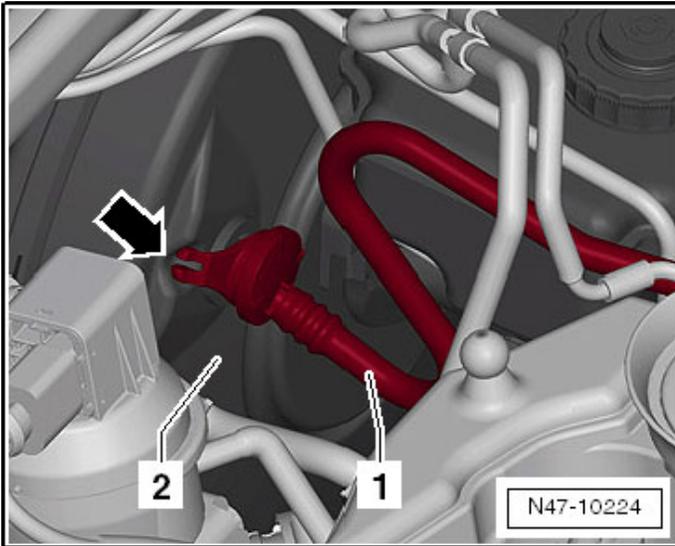
Remove vacuum hose from brake booster:

- Pull the vacuum hose <1> from the brake booster <2>.

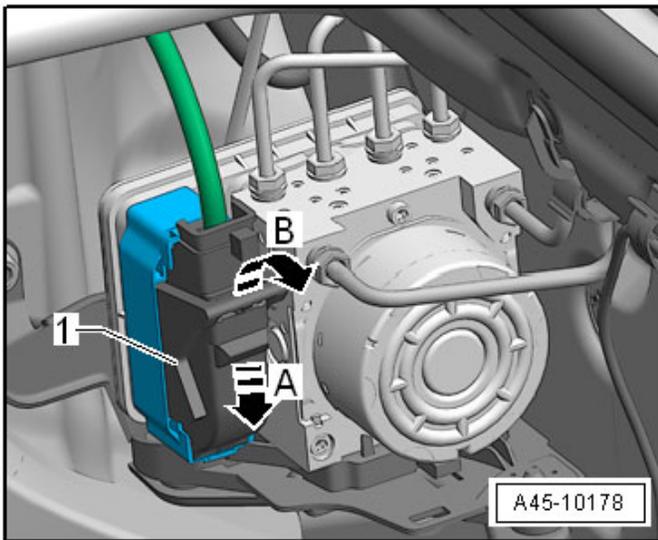
Disconnect ABS control module:

- Press the locking mechanism downward in direction of <arrow A>.
- Release the connector in direction of <arrow B>.
- Remove the connector <1>.

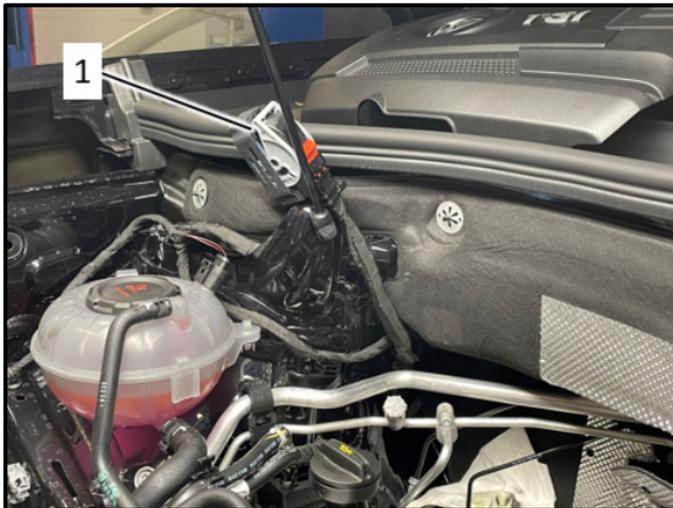
- Secure the ABS control module connector <1> out of the way.

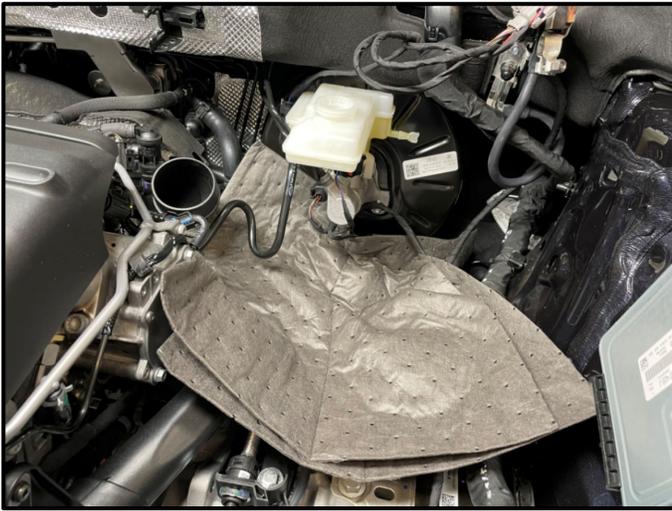
Prepare for brake line removal:

- Place absorbent cloths under the master cylinder AND the ABS control module to catch any escaping brake fluid.
- Clean brake fluid off painted surfaces immediately.

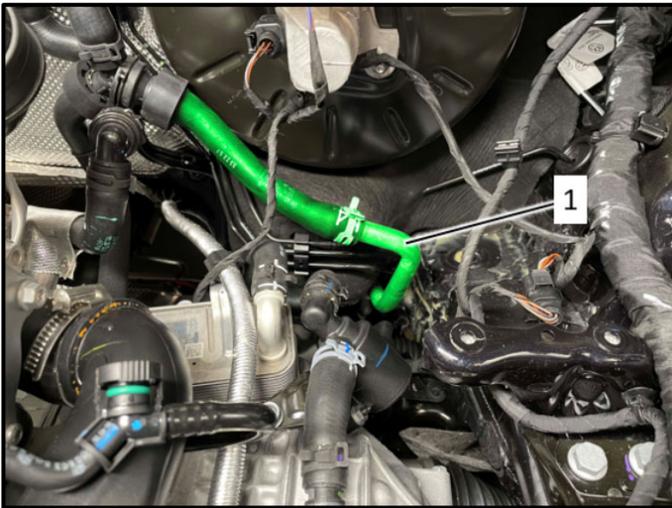
- Heater hose <1> must be freed from its brackets to allow brake lines to be removed.
- The hose DOES NOT have to be disconnected.
- Unplug electrical connectors as needed to allow removal of the brake lines.

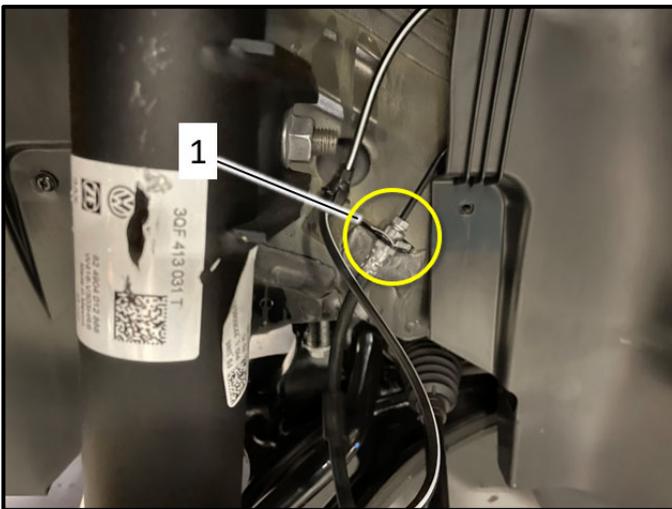
- Loosen the left front and right front brake line to brake hose fittings <1>.

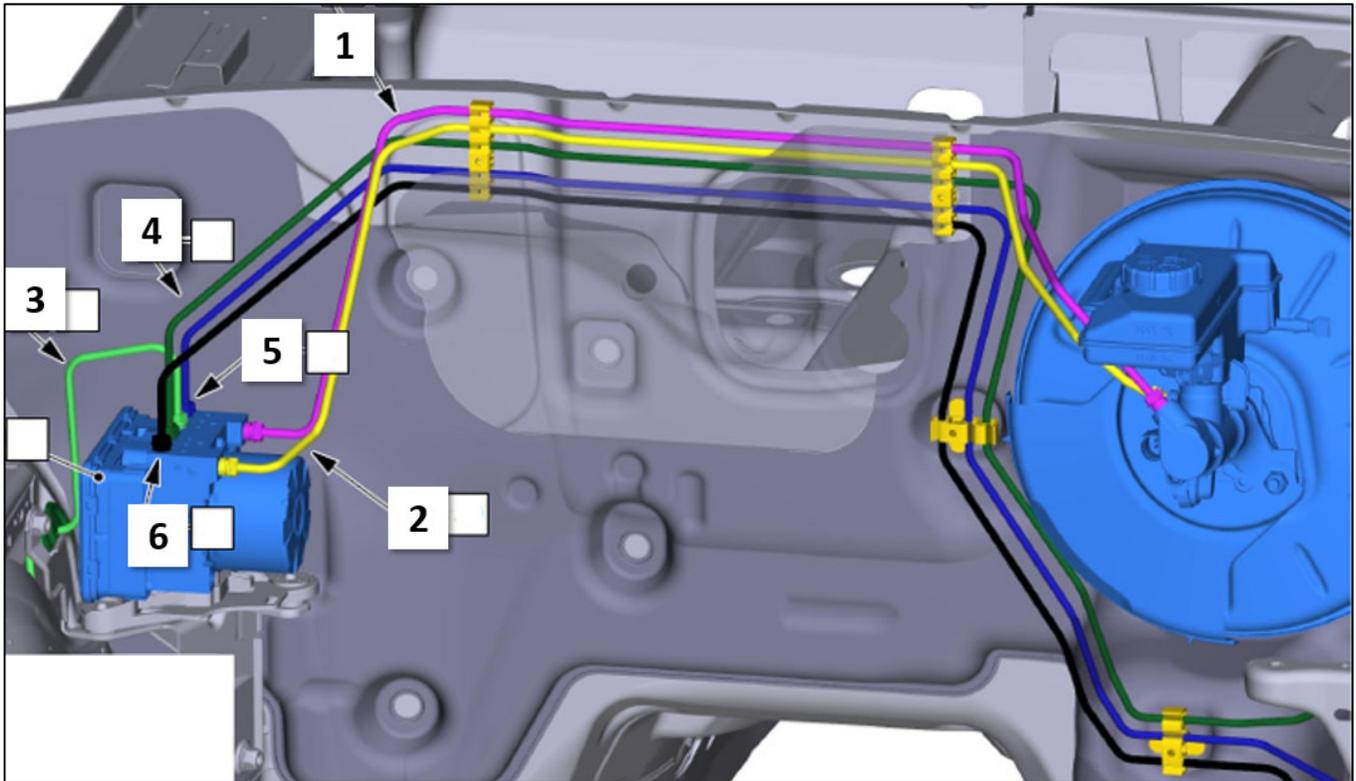
Removing brake lines:

Order	Color (on diagram)	Part Number	Brake Line Designation
1	Pink	3QF-614-740-A	Master Cylinder (secondary)
2	Yellow	3QF-614-739-A	Master Cylinder (primary)
3	Light Green	3QF-614-724-A	Passenger Front
4	Dark Green	3QF-614-723-A	Driver Front
5	Blue	3QF-614-725-A	Driver Rear
6	Black	3QF-614-726-A	Passenger Rear

- Remove brake lines one at a time in the order suggested above.
- Carefully loosen the brake line fittings for each brake line before removing it.
- Then carefully remove the brake line from the securing clips.
- Each brake line will have to be manipulated differently in order to remove it.
- Each brake line (except #3) will have to be moved slightly toward the passenger side of the vehicle and then over the A/C line in order to remove it.
- All brake lines can be removed without removing the A/C lines.

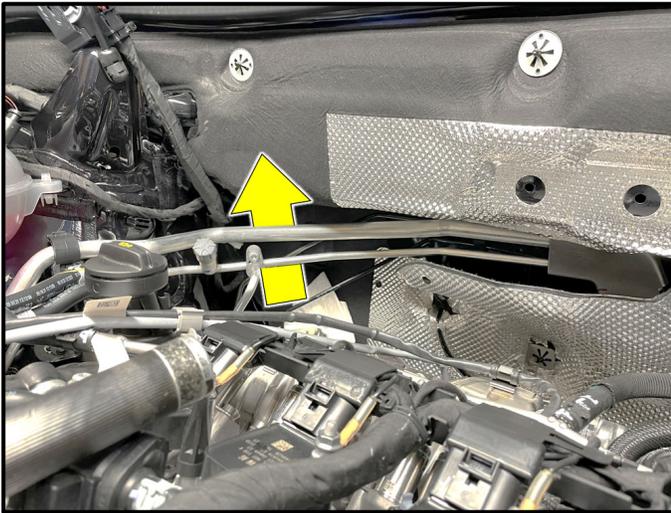
Brake lines can be removed by working them out behind the A/C lines.

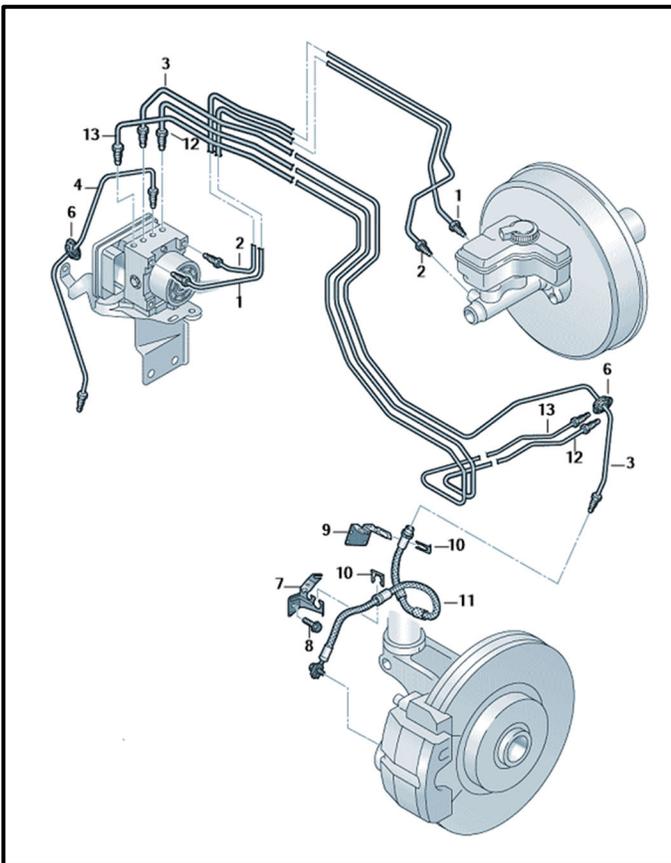
Installing brake lines:

Use extreme care when tightening the brake line fittings.

Start the brake line fittings before securing brake lines in their holders.

Thread the fittings all the way in by hand before torquing them.

- The new brake lines are installed in the reverse order of removal.
- When installing the brake line fittings, they **MUST** be started by hand and extreme care must be used when threading the fittings into the ABS control module and master cylinder.
- Torque all brake line connections to 14 Nm.

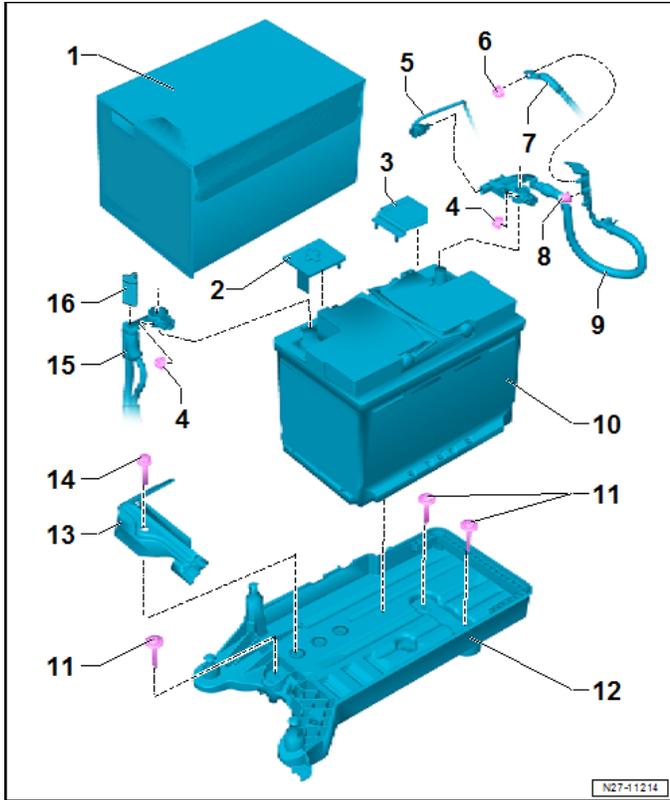
Reinstall battery tray and 12V battery:

- Installation is the reverse order of removal.
- Torque battery tray bolts <11> to 9 Nm.
- Torque hold down bolt <14> to 20 Nm.
- Torque battery terminals to 6 Nm.

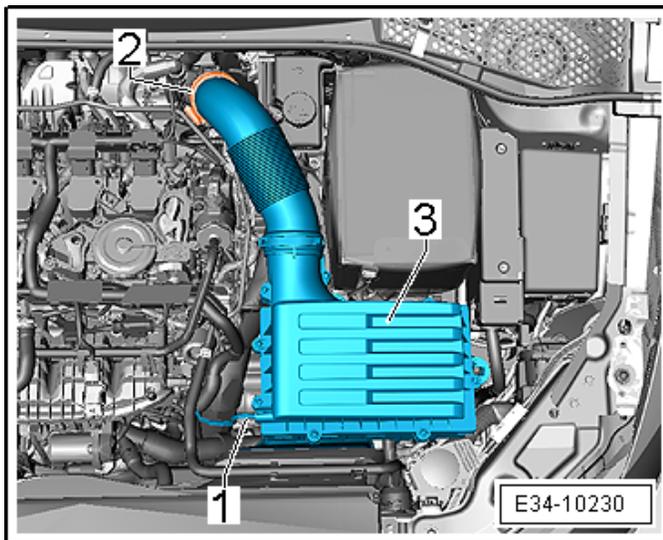
Reinstall air cleaner:

- Installation is the reverse order of removal.

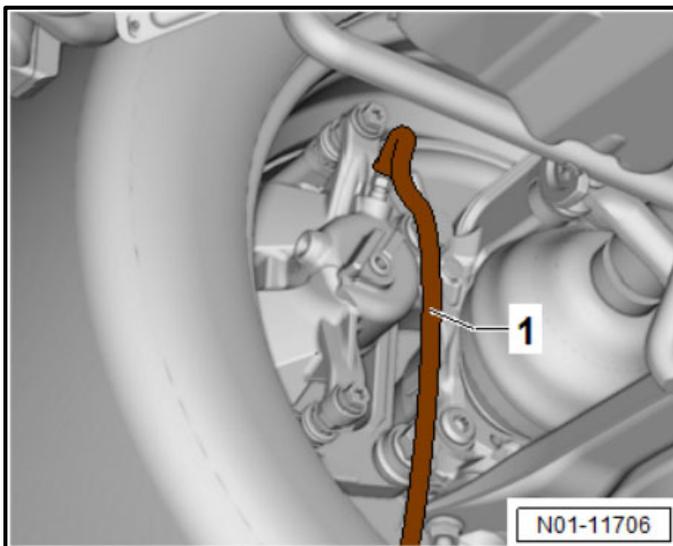
Bleed brakes:

- See ELSA Repair Manual: *Repair manual > Chassis > Brake System > 47 Hydraulic Components > Hydraulic System > Hydraulic System, Standard Bleeding*
