Keystone RV Company

SAFETY ADVISORY # 22-437

Equalizer Jack Pads

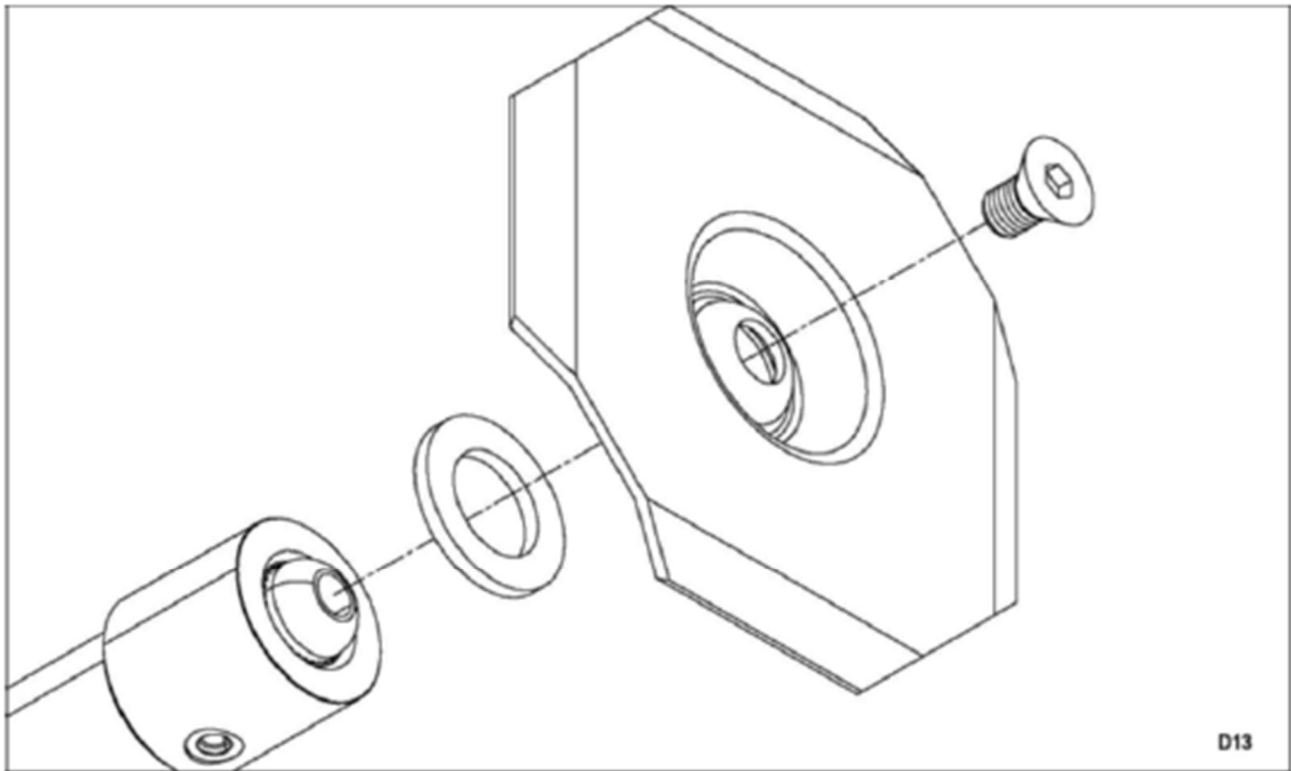
Once completed the foot is not intended to be tight. It is designed to pivot slightly and will be free to rotate when the cylinder is slightly extended.

- There may be a "foam" cushion or damping ring that is attached to the bottom of the cylinder body with adhesive. Its only purpose is to keep the foot from rattling when fully retracted. If it comes loose/falls it may be glued back up to the bottom of the cylinder or it may even be removed. Replacement part number for this ring on SL 15 is part # 1800.
- Some cylinder rods may have a rubber ring around them that may stick to the rod as it is extended. This is a protection ring that is used in production to keep paint from the rod and lower seal area. It may be ignored or removed; it has no other use. Its presence, or lack of, is not a defective component.
