Dealer Service Instructions for:

## **Safety Recall Z71 / NHTSA 22V-768**

### **High Voltage Battery Fuse**

**2022-2023 (JL) Jeep® Wrangler 4XE PHEV**

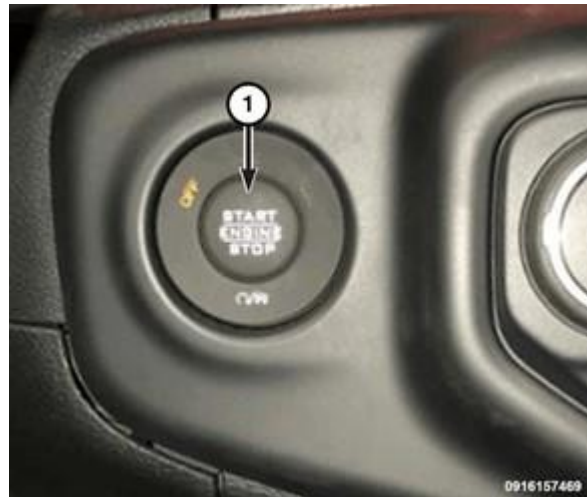
**Figure 1 – Keyless Go Button**

5. Turn the ignition to Off by pressing the keyless go button (1) and move keys away from the car a minimum of 20 feet (Figure 1).

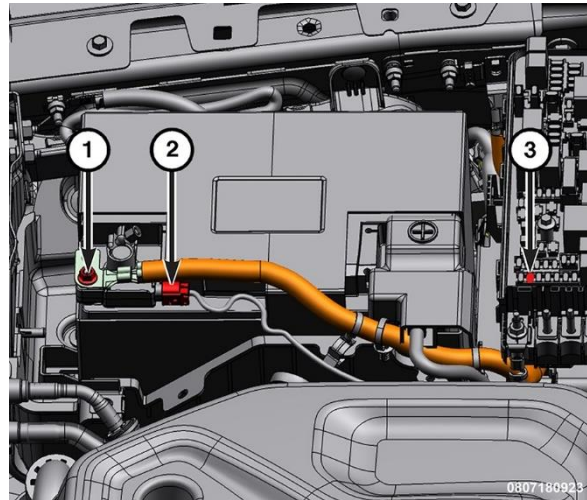
**Figure 2 – 12-Volt Battery**

7. Disconnect the IBS wire harness connector (2). Remove and isolate the battery negative cable (1) using Covers, HEV Battery Terminal 2035100082 (Figure 2).
8. Remove the F09 (5 amp) fuse (3) from the Power Distribution Center (PDC) (Figure 2).

- 1 - Battery Negative Cable Nut
- 2 - IBS Wire Harness Connector
- 3 - F09 (5 amp) fuse

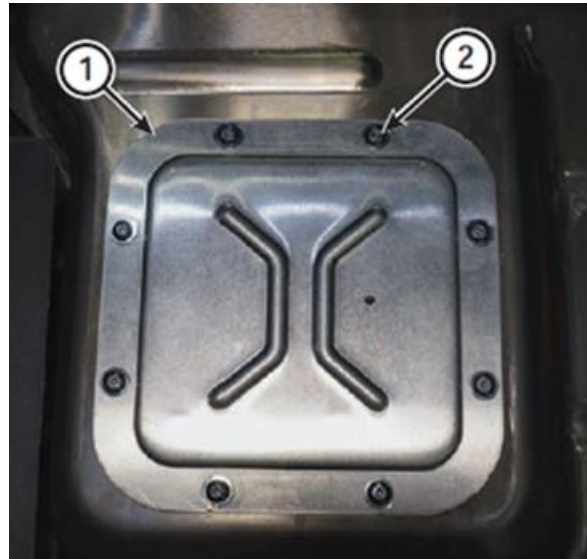
**Figure 3 – High Voltage Test Point Access Cover**

11. The high voltage service test points access cover (1) is located on the battery pack, under driver side rear seat cushion (Figure 3).
12. Remove the M6 Torx screws (2) from the high voltage service test points access cover (1) (Figure 3).
13. Carefully remove the test points access cover (1) and set in a protected location such that the cover plate alignment and HVIL pins are not damaged (Figure 3).

- 1 - High Voltage Test Point Access Cover
- 2 - M6 Torx Screws

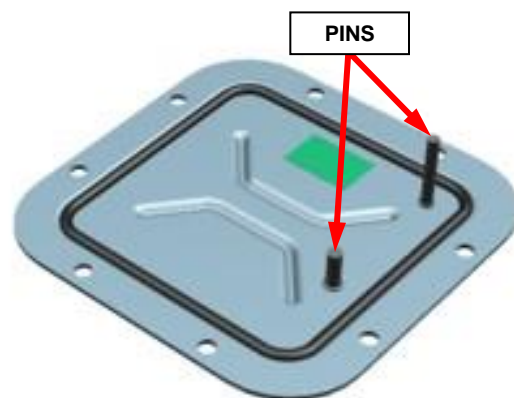
**Figure 4 – Access Cover Pins**

**NOTE:** Lift the cover straight up to avoid bending or damaging the pin on the cover that is used to engage the HVIL switch (Figure 4).

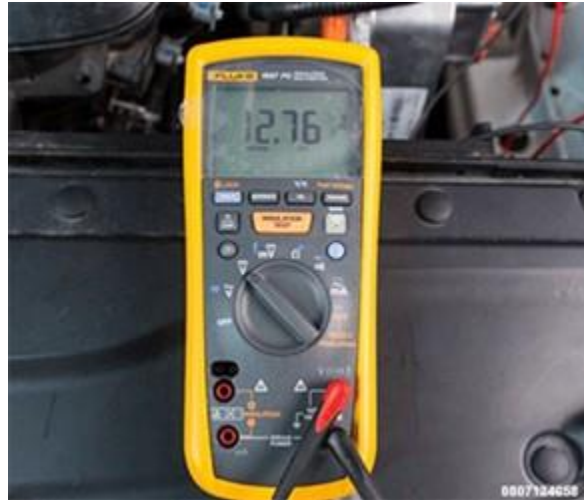
**Figure 5 – Fluke Meter, Multi 126-1587**

14. Use of an insulation tester such as the Fluke Meter, Multi 126-1587 is recommended for PHEV circuit testing. Perform the multi-meter functionality tests per the manufacturer's directions. Verify the multi-meter is operating correctly by measuring voltage from a known good power source, such as the vehicle's 12-volt battery. If at any point during the procedure, the multi-meter settings are changed, or the probes are repositioned in the meter, verification with a known good power source must be repeated (Figure 5).

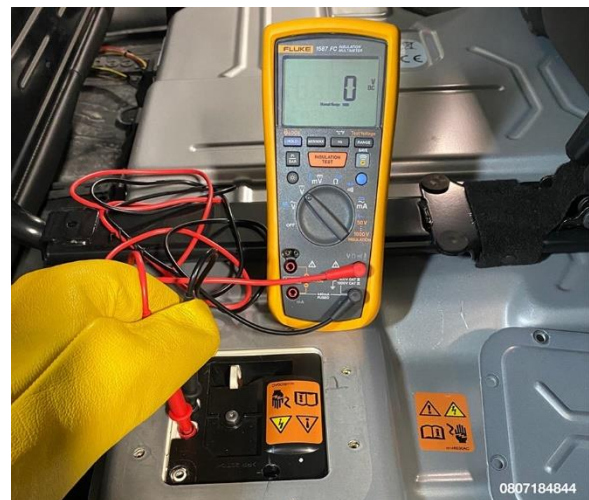
**Figure 6 – Measuring at High Voltage Test Points**

15. Using the Fluke multi-meter, measure the voltage at the high voltage positive and high voltage negative test points (Figure 6):
- Measure for voltage between the positive and negative high voltage test points.
  - Measure for voltage between positive test point and chassis ground.
  - Measure for voltage between negative test point and chassis ground.

- If the voltage is greater than 60 volts, an internal condition exists within the high voltage battery such as stuck contactors, that are preventing it from being powered down. This should be accompanied by contactor stuck DTCs. Do not attempt to carry out testing on any of the vehicle's high-voltage components or wiring. The HV Battery Pack requires replacement. Reference the HV BATTERY SERVICING WITH WELDED CONTACTOR(S) procedure at the top of the HV PHEV BATTERY REMOVAL AND INSTALLATION procedure for safely removing a high voltage battery that will not power down (Refer to 08 - Electrical/Battery System/BATTERY/Removal and Installation).

- If the voltage is between 2.0 volts and 60 volts, the HV system is safe to work on, however there is a problem that should be diagnosed. Disconnect each of the following HV modules one at a time and check the voltage at the test points. If the voltage drops to 2.0 volts or less, the faulted module has been found. Reconnect each module before continuing to the next.

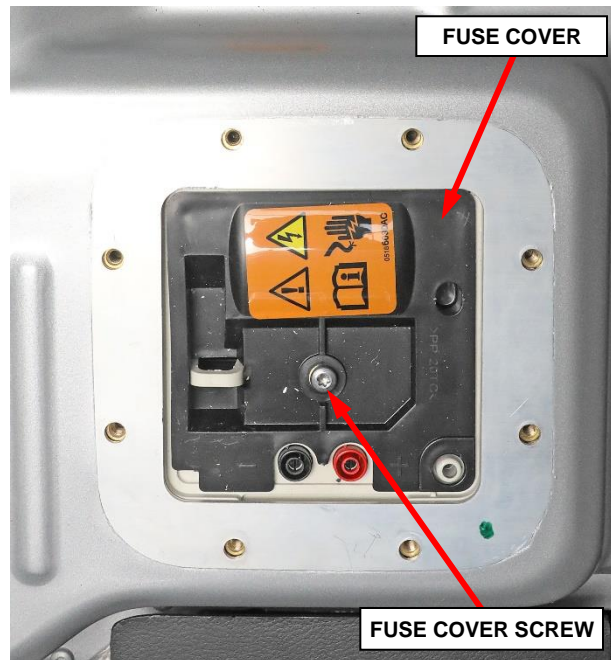
1. Remove the fuse cover screw then remove the fuse cover (Figure 7).

7. Were the bus bar contacts clean or carbon marked as shown in (Figure 10)?
  - **Clean, no Carbon Marks:** Replace the 200A fuse and fasteners. Continue with **Step 9**.
  - **Visible Carbon Marks:** Battery will require replacement Proceed to **Section C**.
8. Order and obtain the 200A fuse kit with proper screws. The photographs taken previously will be required to place the parts order.
9. Replace the 200A fuse and fasteners from the kit then tighten the screws to 5.7 N·m (50 in. lbs.) (Figure 8)
10. Install the fuse cover then tighten the cover screw to 6 N·m (53 in. lbs.) (Figure 7).
11. Power up the HV battery system.

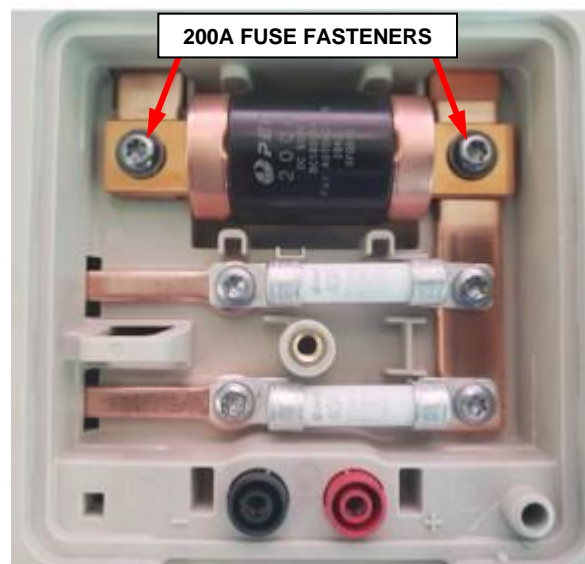
**Figure 8 – 200A Fuse Fasteners**

2. Inspect the 200A fuse fasteners in the fuse tray under the fuse cover (Figure 8).

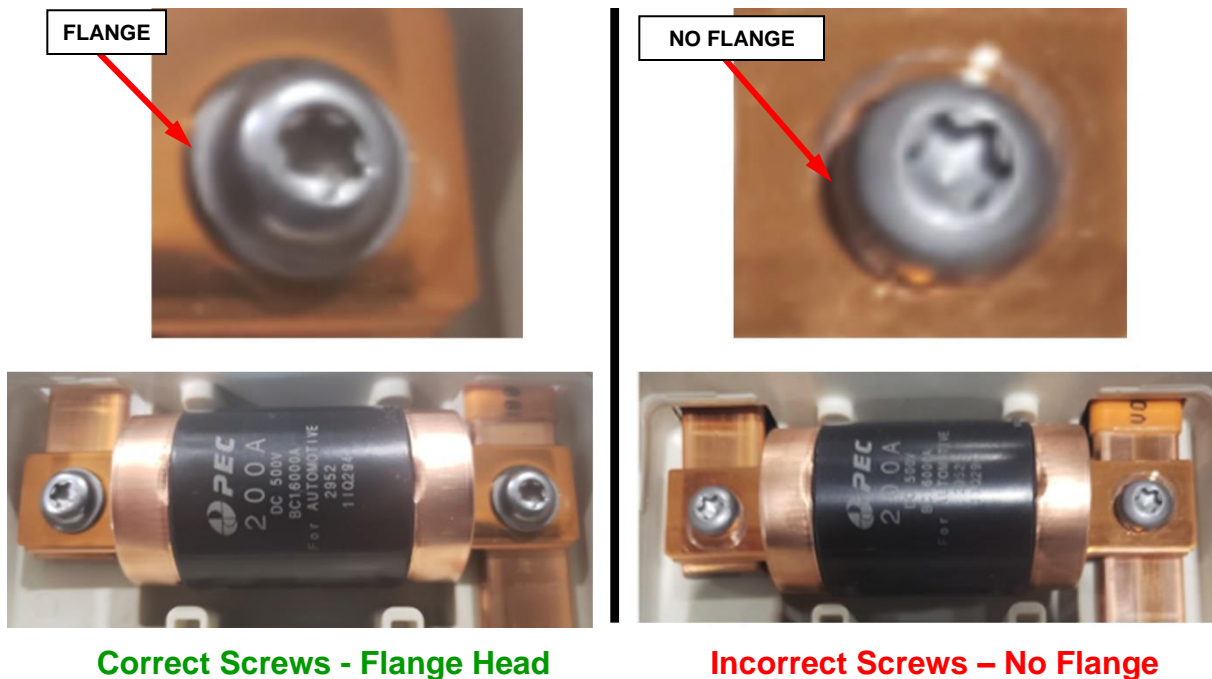
**Figure 9 – 200A Fuse Fastener Inspection**

3. Do the 200A fuse fasteners have a flange around the screw head or not as shown in (Figure 9)?
- **Correct Screws - Flange Head:** No further action required. Vehicle may be reassembled. Proceed to **Step 10**.
  - **Incorrect Screws – No Flange:** Continue with **Step 4**.

4. Remove the incorrect fasteners securing the 200A fuse then also remove the fuse (Figure 9).

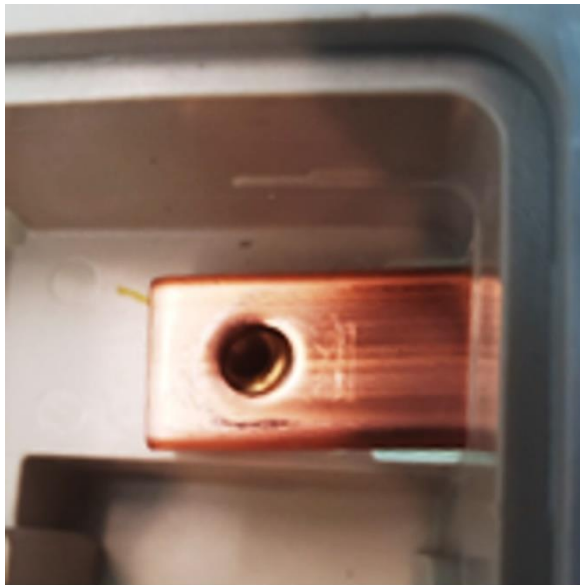
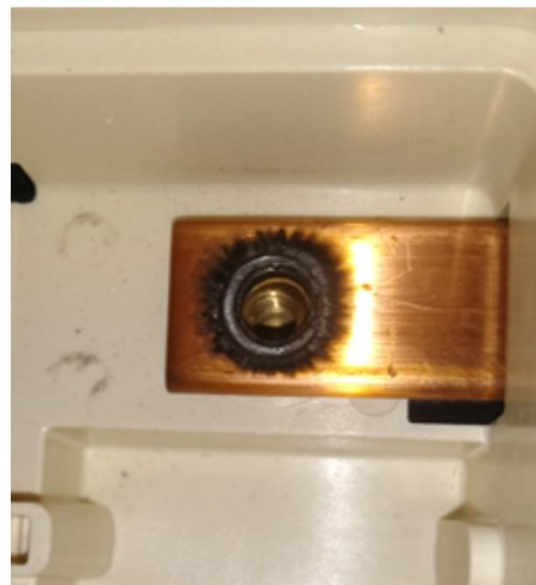
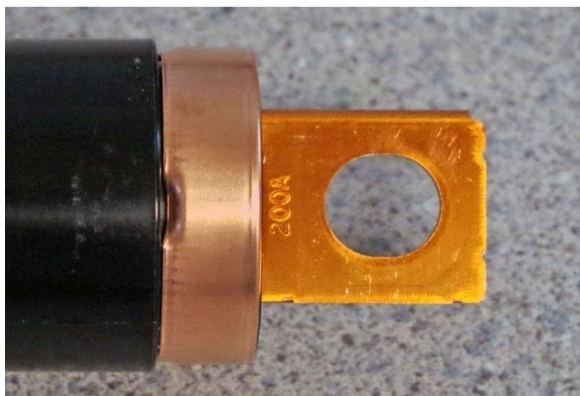
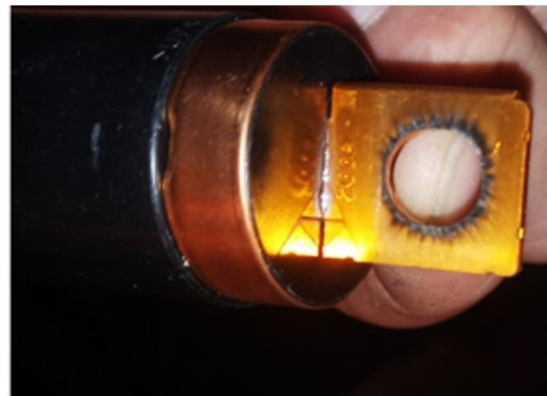
5. Inspect the 200A fuse and bus bar contacts for any signs of carbon marking as shown in (Figure 10).

**Good Contacts No Carbon Marking**

**Signs of Carbon Marking**

Inspect fuse tray 200A fuse for proper fasteners and signs of carbon marks on bus bars. If incorrect fasteners are found with no carbon marks on bus bars, replace the 200A fuse and fasteners. If carbon marks are found, photograph the fasteners and bus bar contacts then replace HV battery as directed by the service procedure.

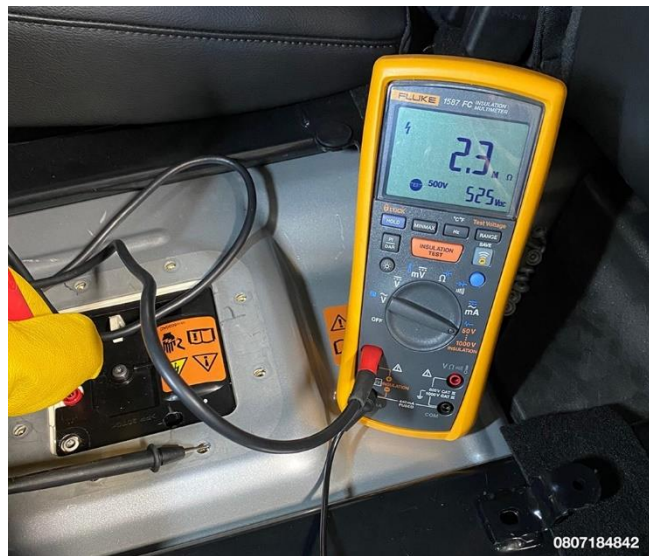
### Figure 11 – Measure and Record Isolation Resistance Between HV Positive Test Point and Chassis Ground

13. Using the Meter, Multi 126-1587 measure and record the isolation resistance between the high voltage positive test point and chassis ground (Figure 11).

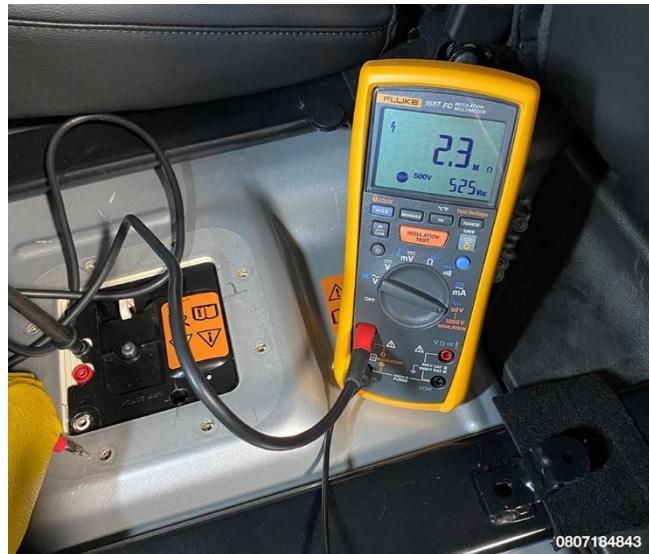
**Figure 12 – Measure and Record Isolation Resistance Between HV Negative Test Point and Chassis Ground**

14. Using the Meter, Multi 126-1587 measure and record the isolation resistance between the high voltage negative test point and chassis ground (Figure 12).
15. Isolation resistance should be 2.3 Mohms (+/- .2). If the measured isolation resistance is outside of this range, a loss of isolation condition exists within the high voltage circuitry. **Do not continue the High Voltage Power Up procedure until the condition causing the loss of isolation is corrected.**<sup>1</sup>
16. Install the test points access cover (1) to the battery pack and tighten the eight M6 Torx screws (2) to 8.8 N·m (78 in. lbs.) (Figure 13).

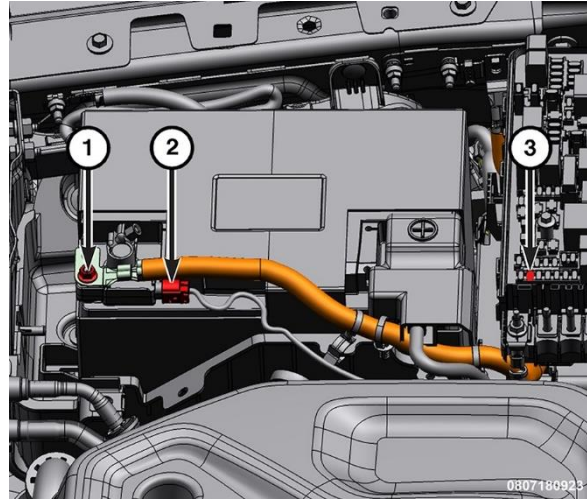
**Figure 14 – Negative Battery Cable, Fuse F09 and IBS Connector**

17. Remove the cover, connect the negative battery cable to the IBS and tighten the fastener (1) to 10N·m (7 ft. lbs.) (Figure 14).
18. Install the F09 (5 amp) IDCM fuse (3) in the Power Distribution Center (PDC) (Figure 14).
19. Connect the IBS harness connector (2) (Figure 14).

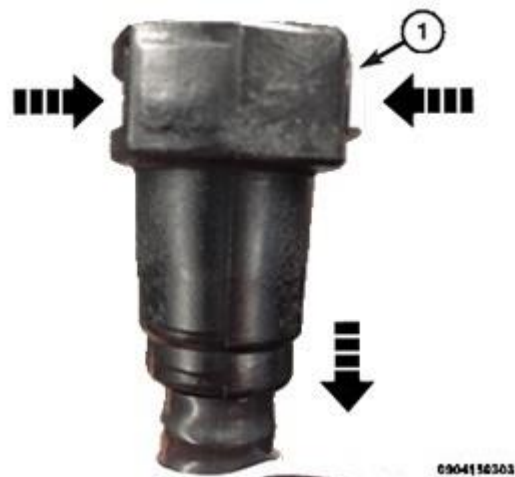
**Figure 18 – Hose Connections**

- Push in and hold both sides of the gray release (1) on the quick coupling (Figure 18).
- Pull the quick coupling away from air cleaner body cover.

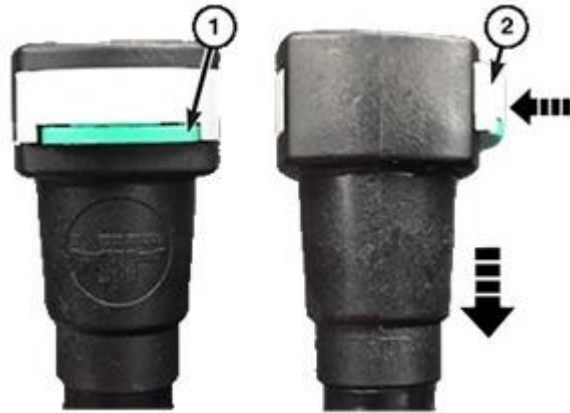
**Figure 19 – Hose Connections**

- Do not press on the green anti-tampering feature (1) (Figure 19).
- Push in and hold only the side of the release (2) with the green anti-tampering feature and pull the quick coupling away from air cleaner body cover.

8. Disconnect the fuel vapor purge hose quick coupling (2) from the air cleaner body cover (Figure 17).

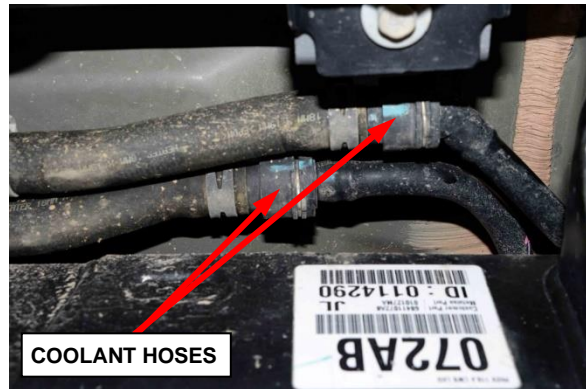
**Figure 21 – Coolant Hoses**

12. Raise and support the vehicle.
13. Position a drain pan under the coolant hoses (Figure 21).
14. Remove the coolant hoses from the coolant line and drain the power electronics cooling system (Figure 21).
15. Once the system is completely drained, reinstall the coolant hose to the coolant line (Figure 21).
16. Remove the fasteners (1) and the skid plate (2) from the vehicle (Figure 22).

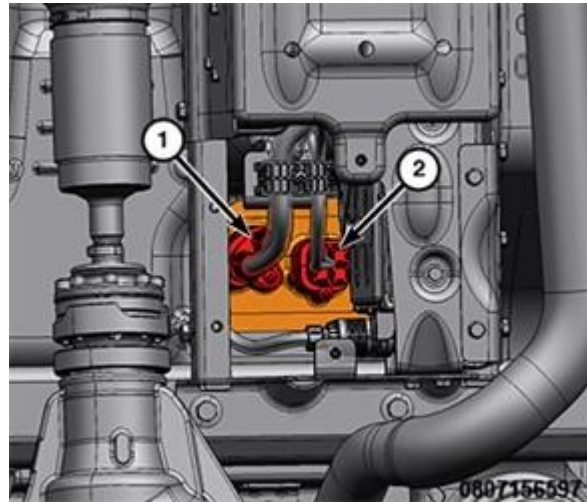
**Figure 23 – HV Battery Wiring Connectors**

17. Disconnect the HV wire harness connectors (1) and (2) from the HV battery (Figure 23).
18. Cap the HV cables using Covers, HEV Battery Terminal 2035100082.

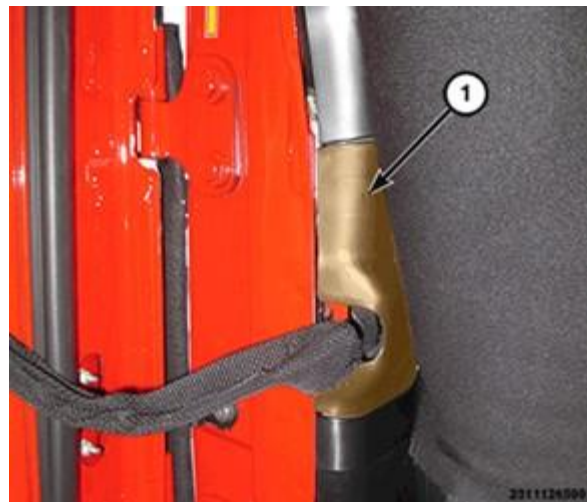
**Figure 24 – B-pillar Trim Cover**

19. Remove the support and lower the vehicle.
20. Using a trim stick, release and remove the B-pillar trim cover (1) (Figure 24).

48. Align and install the B-pillar trim cover (Figure 24).
49. Raise and support the vehicle.

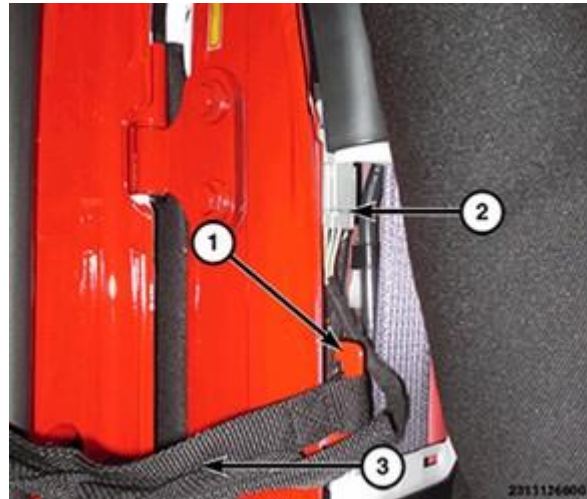
**Figure 25 – Harness to Support Bracket**

21. Disconnect the wire harness connector (2) and release the door tether from the support bracket (1) (Figure 25).

46. Install the door check strap bolt securing the door check and tighten to 9N·m (80 in. lbs.) (Figure 26).
47. Connect the wire harness connector and secure the door tether to the support bracket (Figure 25).

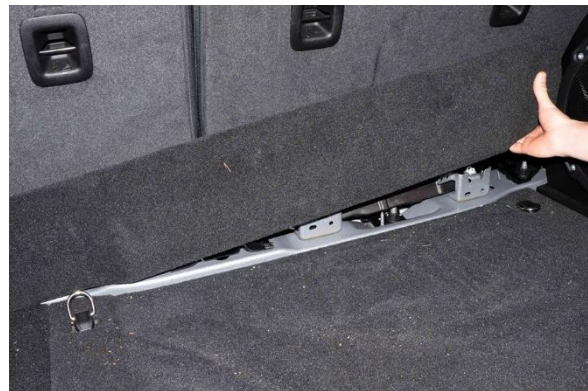
**Figure 30 – Gap Hider**

29. Remove the rear seat to load floor gap hider (Figure 30).

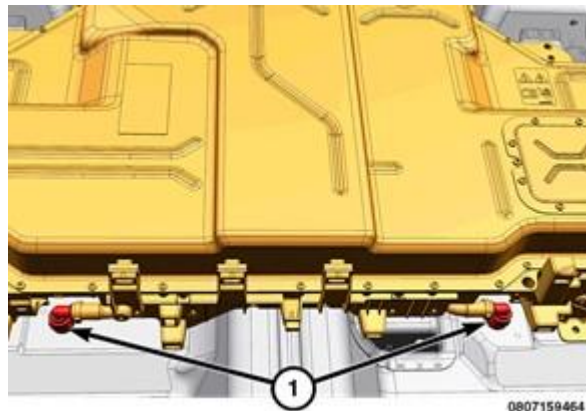
Figure 36 – HV Battery Coolant Connectors

39. Disconnect and plug the HV battery coolant line connectors (1) (Figure 36).

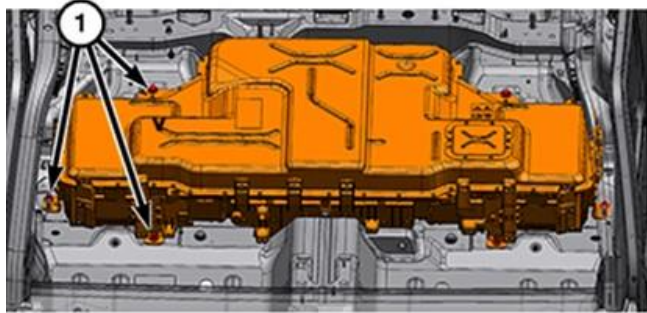
**Figure 37 – HV Battery Bolts**

40. Remove the bolts (1) securing the HV battery to the vehicle (Figure 37).

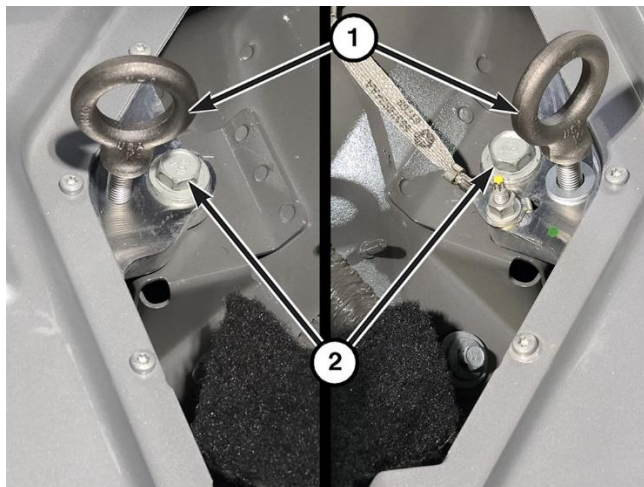
**Figure 39 – Eyebolt Installation**

42. Thread the other two Eyebolt, 10mm 2035203080 (1) into the threaded holes next to the HV battery pack mounting bolt holes (2) on the rear side of the HV battery pack (Figure 39).

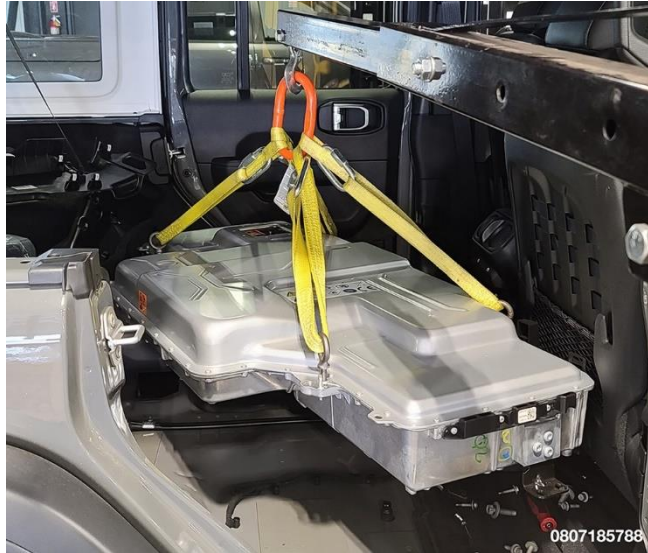
**Figure 40 – Lift Straps**

43. Connect the Lift Straps, HV Battery 2035200080 to the eyebolts and the lifting device. Adjust the straps so that the battery will be level during lifting as shown in the picture (Figure 40).
44. Remove the HV battery pack from the vehicle.

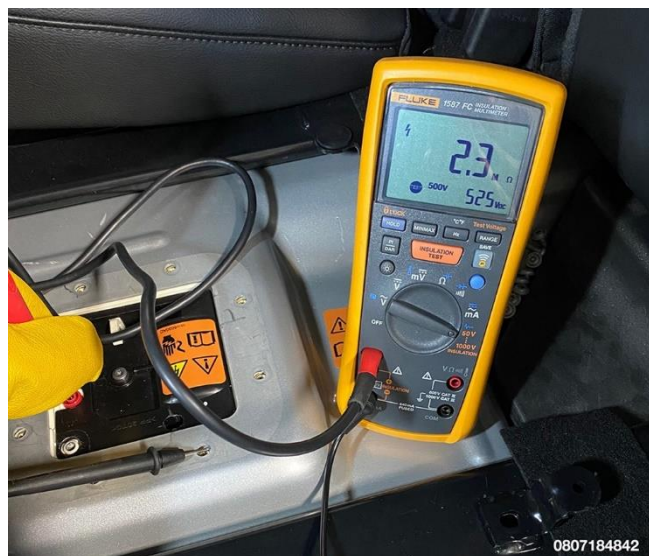
**Figure 42 – Measure and Record Isolation Resistance Between HV Positive Test Point and Chassis Ground**

58. Using the Meter, Multi 126-1587 measure and record the isolation resistance between the high voltage positive test point and chassis ground (Figure 42).

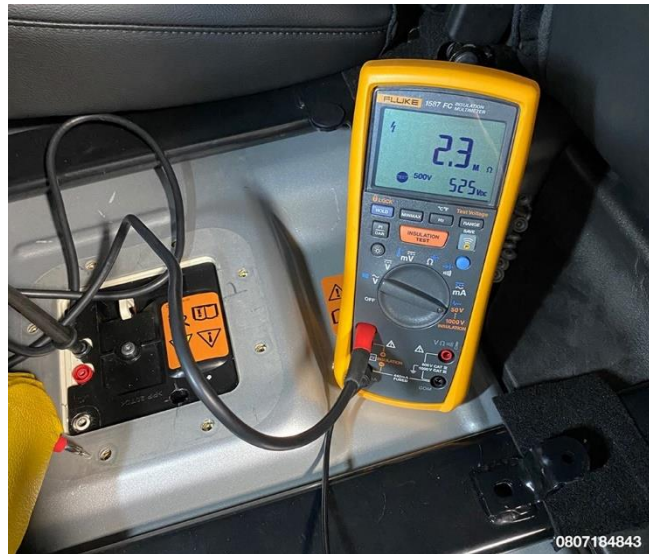
**Figure 43 – Measure and Record Isolation Resistance Between HV Negative Test Point and Chassis Ground**

59. Using the Meter, Multi 126-1587 measure and record the isolation resistance between the high voltage negative test point and chassis ground (Figure 43).
60. Isolation resistance should be 2.3 Mohms (+/- .2). If the measured isolation resistance is outside of this range, a loss of isolation condition exists within the high voltage circuitry. **Do not continue the High Voltage Power Up procedure until the condition causing the loss of isolation is corrected.**
61. If required, remove the lockout-tagout padlock from the service lockout loop (1) (Figure 44).
