Recall Inspection and Repair Instructions

NHTSA Recall #: 22V-814

Tiffin Motorhomes Recall #: TIF-127

Models Involved: 2023 Allegro Open Road, 2023 Allegro RED 340, 2022 and 2023 Allegro RED 360, 2022 and 2023 Allegro Breeze, 2022 and 2023 Allegro Bay, and 2022 and 2023 Phaeton Motorhomes, all equipped with the option for LP gas.

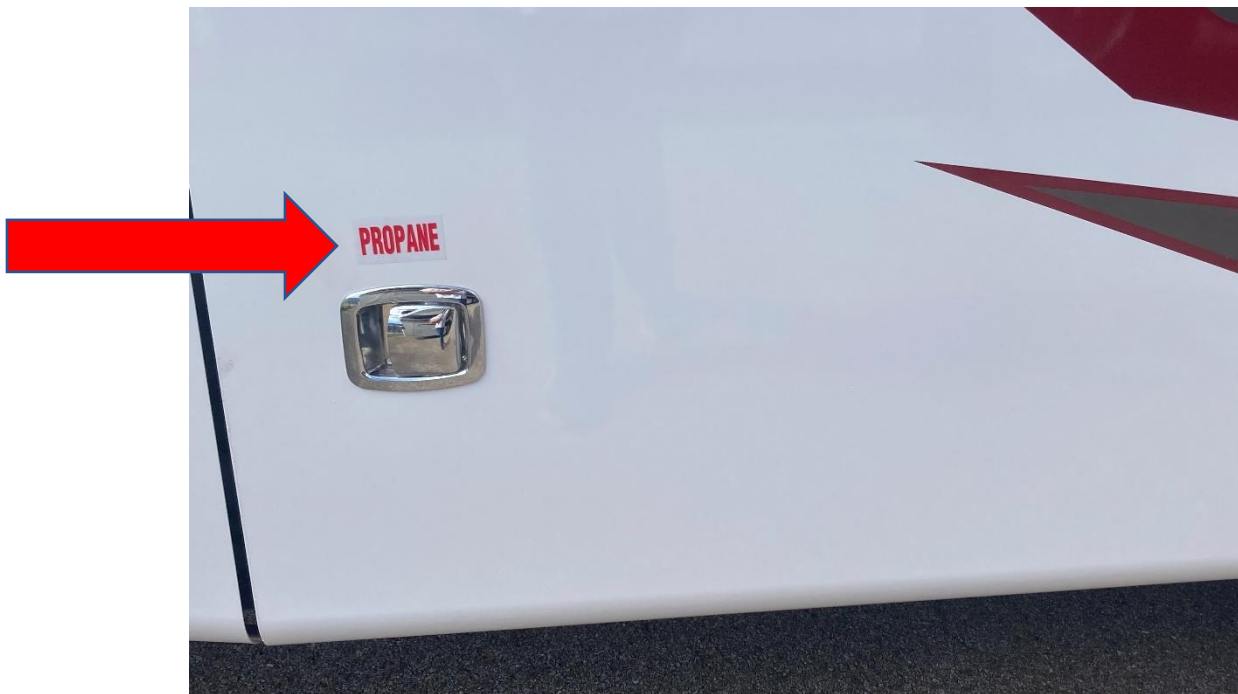
1. Locate the LP service tank on the motorhome. The compartment door for the LP service tank is marked with a red "**PROPANE**" sticker.

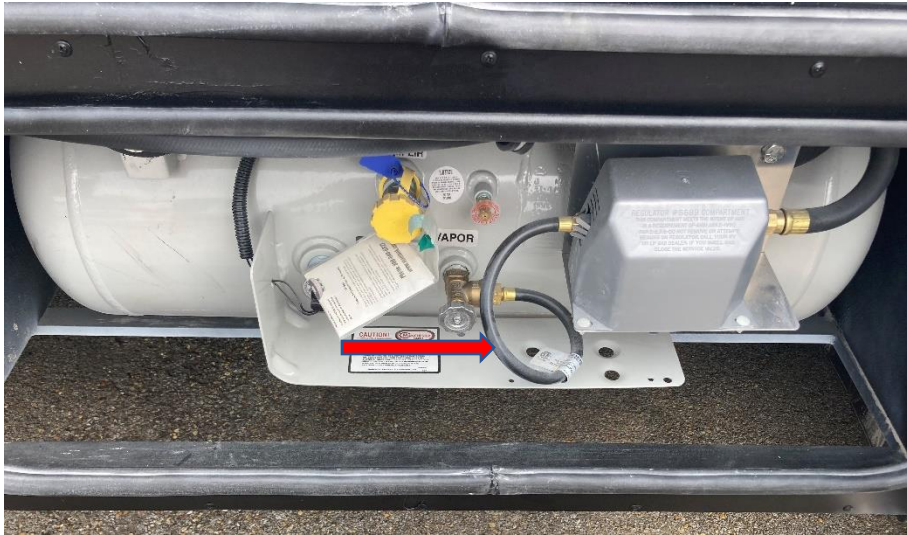
Figure 1 LPG tank style 4318

3. Figures 1, 2 and 3 have the LP hose marked with a red arrow.

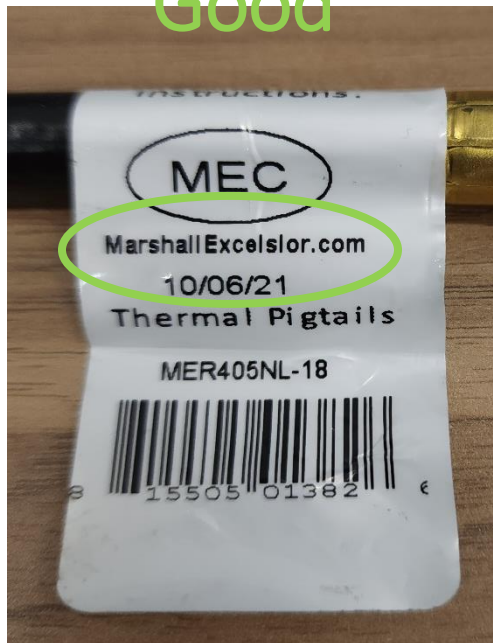
Figure 4

4. Identify which hose was originally installed on the unit to determine if the hose needs to be replaced. If the Marshall Excelsior hose with the white tag (Figure 4) is installed no further action is required.

Good

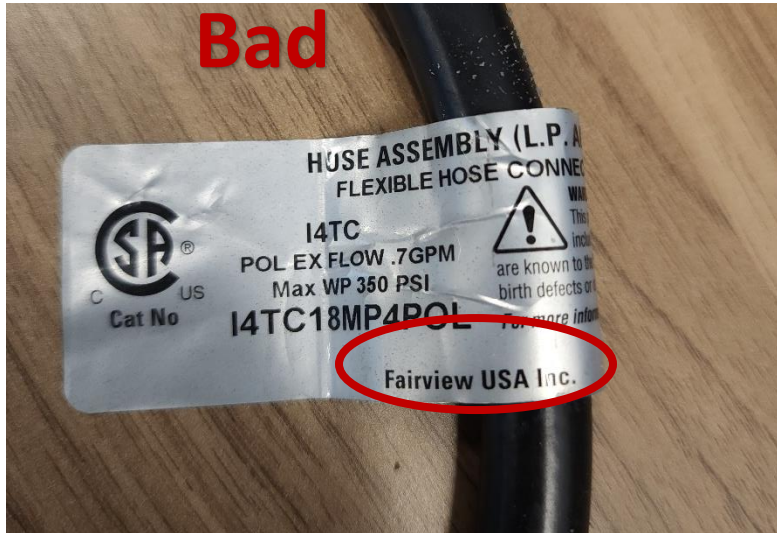
Figure 5

- 5. If the Fairview hose with the silver tag (Figure 5) is installed or there is no tag on the hose at all the hose will need to be changed out to the Marshall Excelsior with a white tag.

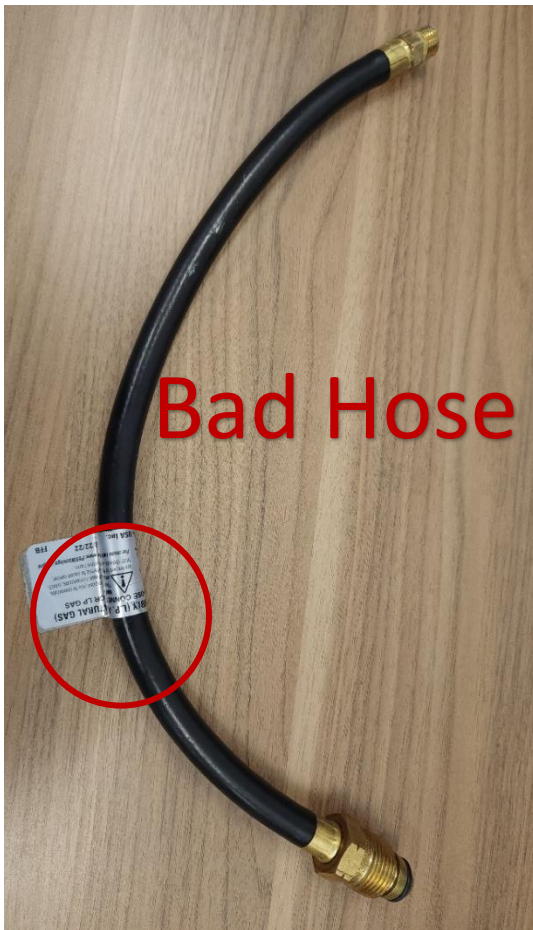
Figure 6

Secondary picture of the gas lines for reference (Figure 6 & Figure 7)
