SERVICE PROCEDURE

22522
March, 2023

SUBJECT: **SAFETY RECALL**

High-Voltage positive cables on certain 2021 through 2023 International® eMV™ Series trucks built 12/08/2020 through 10/14/2022 with feature codes 0008TLC (210 kWh Total Battery Capacity) or 0008TLD (315 kWh Total Battery Capacity)

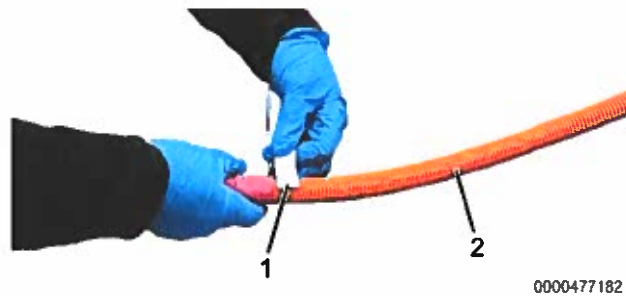
Figure 5. White Identification Tape

- 1. White identification tape
- 2. High-voltage positive cable

17. Overlap WHITE identification tape (Figure 5, Item 1) three times at one end. Continue to spiral wrap around high-voltage positive cable (Figure 5, Item 2). Conclude wrapping with three overlapping wraps on opposite end. Reference Figure 6 for proper tape pattern.
