Dealer Service Instructions for:

# **Safety Recall ZB3 / NHTSA 22V-866 Pursuit Vehicles Shifter Pawl**

**2022 (LD) Dodge Charger**  
**2022 (WD) Dodge Durango**

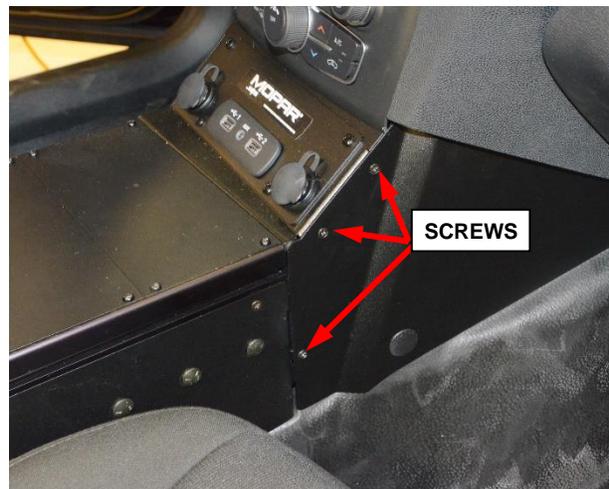
Figure 1 – Console Side Cover Screws

1. Apply the parking brake.
2. Lower the steering wheel, shift to the lowest gear position, and unlock the doors.
3. Disconnect and isolate the negative cable from the battery. If equipped with an Intelligent Battery Sensor (IBS), disconnect the IBS connector before disconnecting the negative cable from the battery.
4. Remove the 3 console side cover screws and the side covers from each side of the console (Figure 1).
5. Remove the screws 3 screws per side that attach the console power port panel to the console and set the panel aside (Figure 2).

14. Align the tabs and press the HVAC controls into place.
15. Install and securely tighten the screws 3 screws per side that attach the console power port panel to the console (Figure 2).
16. Install the 3 console side cover screws and the side covers to each side of the console (Figure 1).
17. Disengage the vehicles parking brake.
18. Connect the negative cable to the battery. If equipped with an Intelligent Battery Sensor (IBS), reconnect the IBS connector.
19. Verify shifter operation.

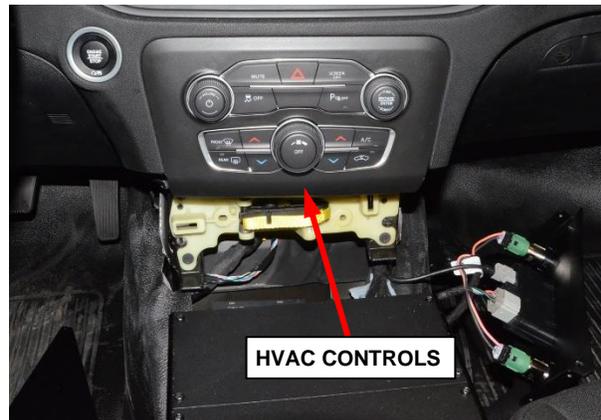
**Figure 3 – HVAC Controls**

6. Remove the HVAC controls. Pull by hand at the bottom and use a trim stick to release the top retainers (Figure 3).

**NOTE: The HVAC controls has six retainers and is very difficult to release, take care to remove it evenly so the retainers do not get damaged.**

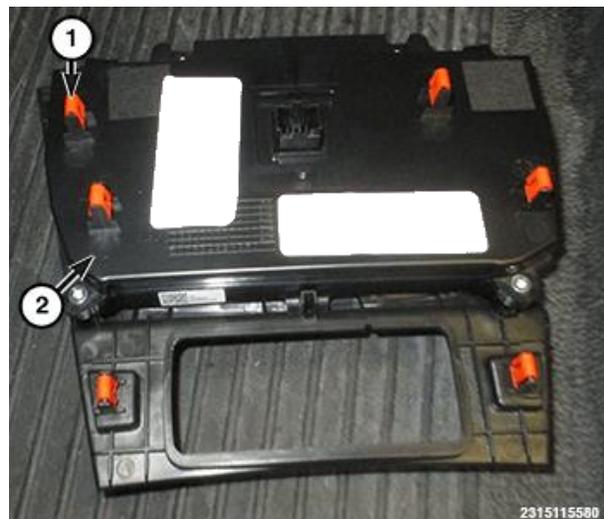
**Figure 4 – HVAC Control Retainers**

**NOTE: View of the backside of the HVAC controls (2), to show the six retainer (1) locations (Figure 4).**

10. Starting at the top of the instrument cluster bezel, press the bezel into place.
11. Return the shifter to Park.
12. View of the backside of the HVAC controls (2), to show the six retainer (1) locations (Figure 4).
13. Connect the HVAC controls electrical connector.

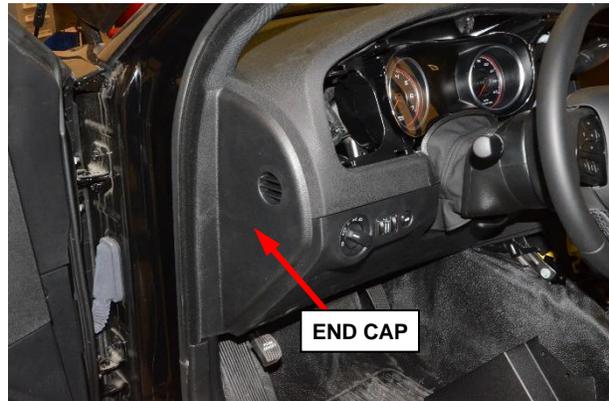
**Figure 5 – Instrument Panel End Cap**

9. Using a trim stick or equivalent, remove the driver side instrument panel end cap (Figure 5).

8. Align the tabs and install the driver side instrument panel end cap (Figure 5).
9. Lower the shifter and steering column.

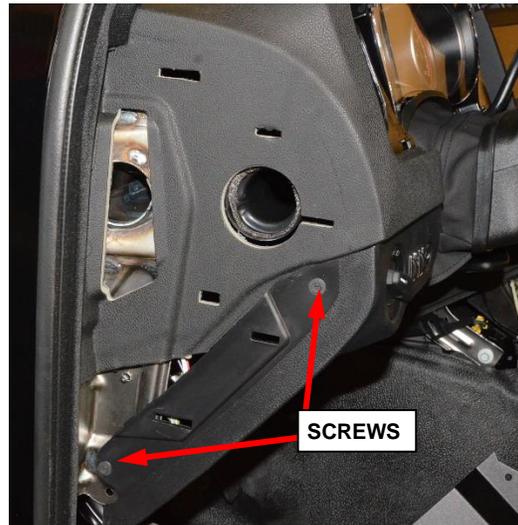
**Figure 6 – Knee Bolster Screws**

10. Remove the knee bolster screws (Figure 6).

6. Install the gap hider and securely tighten the screw (Figure 9).
7. Install the hood release handle to the knee bolster. Lift the retaining tab (2) and slide the handle (4) rearward. Connect the electrical connectors to the knee bolster. Install the knee bolster and securely tighten the screws (Figure 6-8).

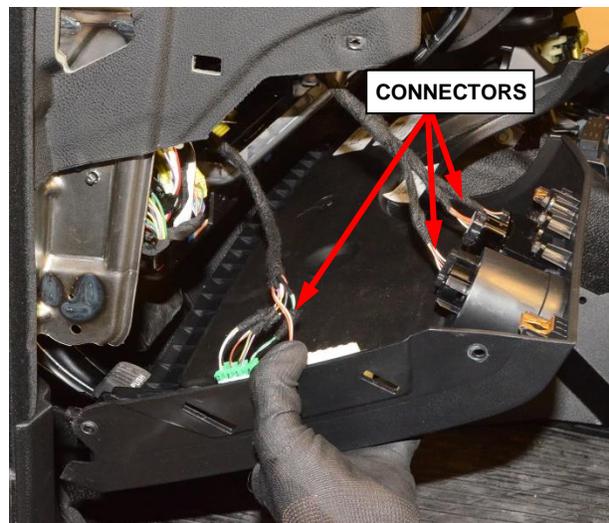
**Figure 7 – Knee Bolster Electrical Connectors**

11. Using a trim stick or equivalent, lower the knee bolster and disconnect the electrical connectors (as equipped) (Figure 7).

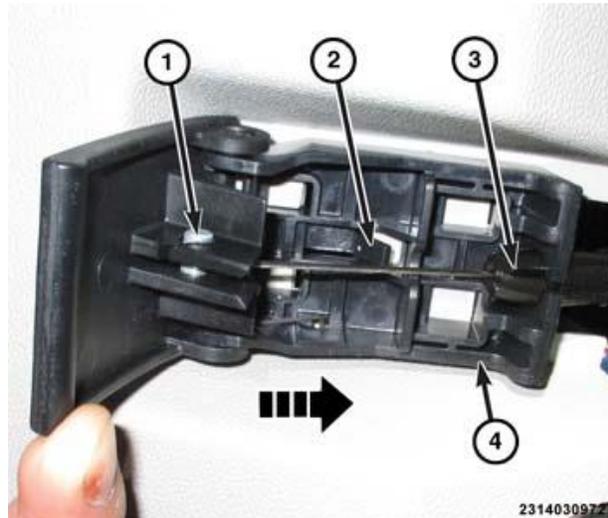
**Figure 8 – Hood Release**

12. Remove the hood release handle. Lift the retaining tab (2) and slide the handle (4) forward to remove it from the steering column opening cover (Figure 8).

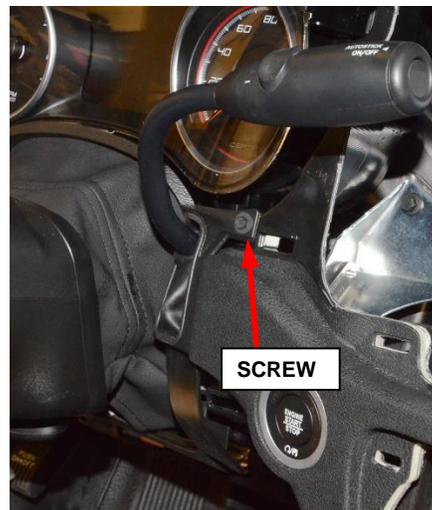
**Figure 9 – Shift Lever Trim and Boot**

13. Remove the screw holding the gap hider and boot to the instrument panel (IP) (Figure 9).

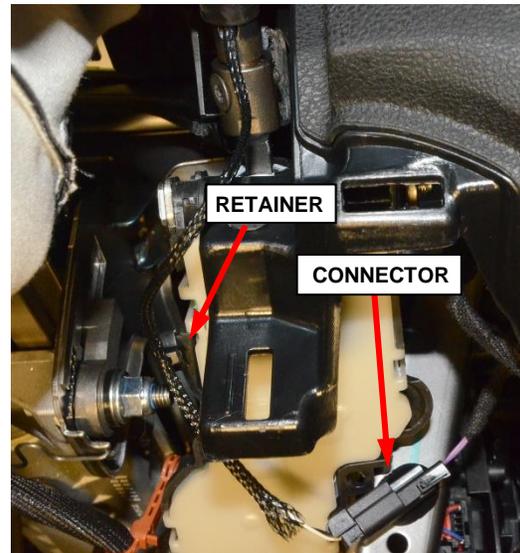
**Figure 10 – Shift Lever Electrical Connector and Retainer**

14. Disconnect the electrical connector and release the retainer from the shift lever harness (Figure 10).

4. Install the shift lever into the shifter assembly and install the NEW gearshift lever bolt and tighten to 15 N·m (11 ft. lbs.) (Figure 11).
5. Connect the wiring harness from the lever to the vehicle harness, then attach the wire harness retainer (Figure 10).

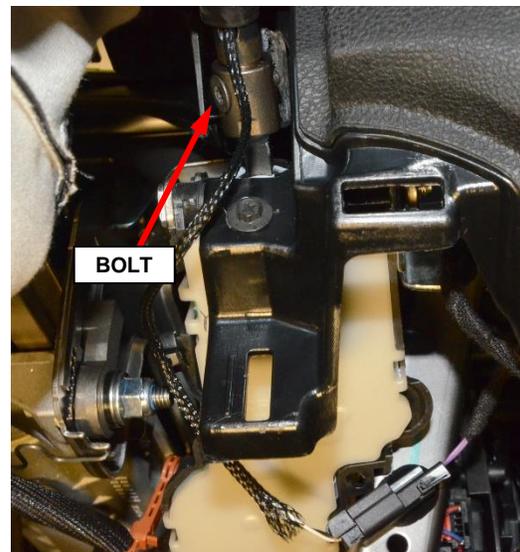
**Figure 11 – Shift Lever Bolt**

15. Remove and discard the shift lever bolt, then remove the shift lever from the shifter mechanism, and slide it through the gap hider using rose water if needed (Figure 11).

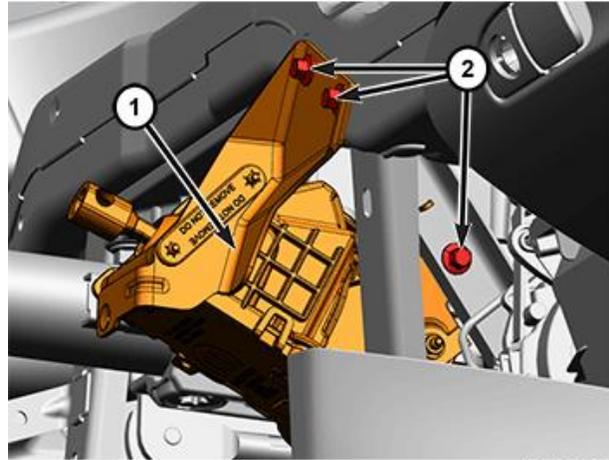
**Figure 12 – Shifter Screws**

16. Remove the three shifter screws (Figure 12).

2. Install the shifter assembly bolts and tighten to 8 N·m (71 in. lbs.) (Figure 12).
3. Feed shift lever with wiring through the gap hider using rose water to assist if needed.

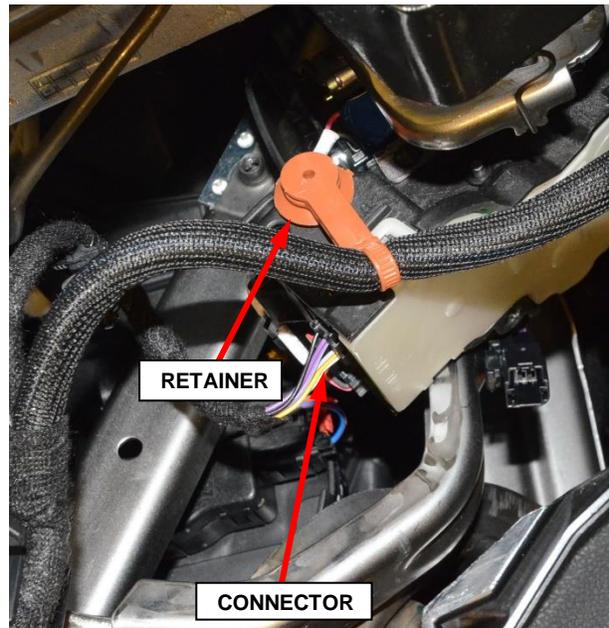
**Figure 13 – Shift Lever Electrical Connector and Retainer**

17. Position the shifter so the electrical connector is accessible (Figure 13).
18. Disconnect the electrical connector and harness retainer, then remove the shifter from the vehicle (Figure 13).

1. Position the shifter in the vehicle, connect the electrical connector and harness retainer. Position the shifter assembly in place on the instrument panel (Figure 13).

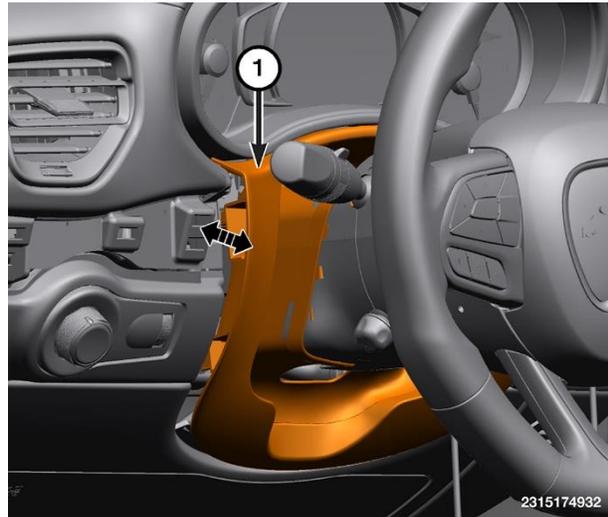
**Figure 14 – Gap Hider Panel**

4. Adjust the steering column to the full up position.
5. Using a trim stick or equivalent, release the gap hider (1) from the instrument panel (Figure 14).

22. Install the left center trim panel (1) to the instrument panel (Figure 16).
23. Install the end cap (1) to the instrument panel (Figure 15).
24. Seat the gap hider (1) to the instrument panel (Figure 14).

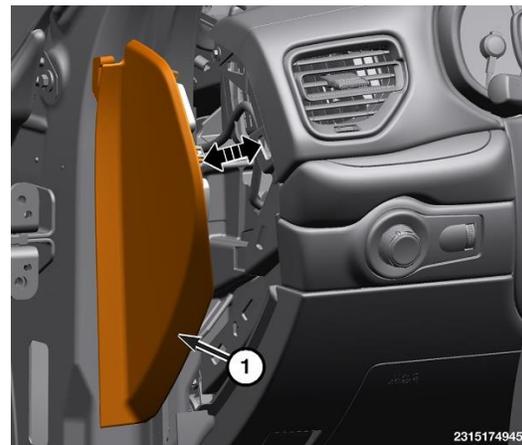
**Figure 15 – Instrument Panel End Cap**

6. Using a trim stick or equivalent, remove the end cap (1) from the instrument panel (Figure 15).

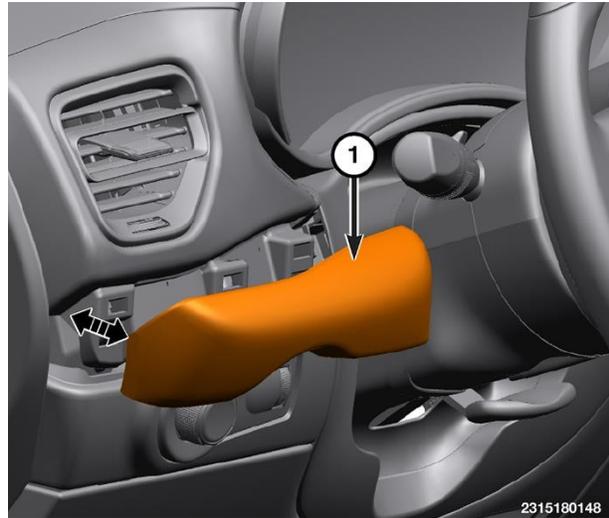
**Figure 16 – Left Center Trim Panel**

7. Using a trim stick or equivalent, release the retaining clips securing the left center trim panel (1) from the instrument panel (Figure 16).
8. Using a trim stick or equivalent, remove the headlamp switch from the trim.
9. Disconnect the headlamp switch electrical connector.
10. Remove the headlamp switch trim screw.
11. Remove the headlamp switch trim.
12. Remove the left silencer panel fasteners (Figure 17).
13. If equipped, disconnect the wire harness connector.
14. Remove the left silencer panel (2) (Figure 17).

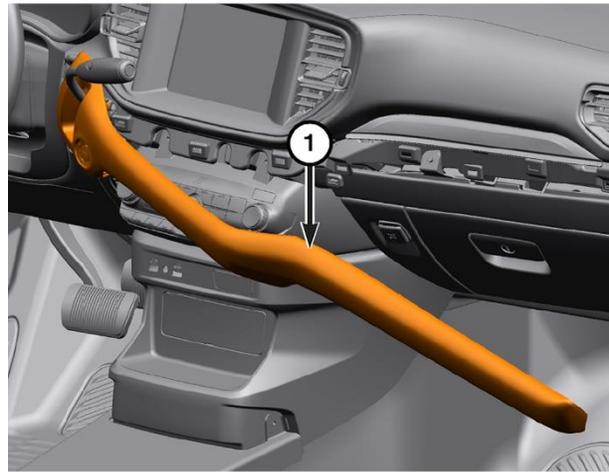
**Figure 18 – Right Center Trim Panel**

15. Using a trim stick or equivalent, release the retaining clips securing the right center trim panel (1) from the instrument panel and disconnect the wire harness connector for the Keyless Ignition Node (KIN). Let the right center trim panel (1) hang from the shifter lever (Figure 18).

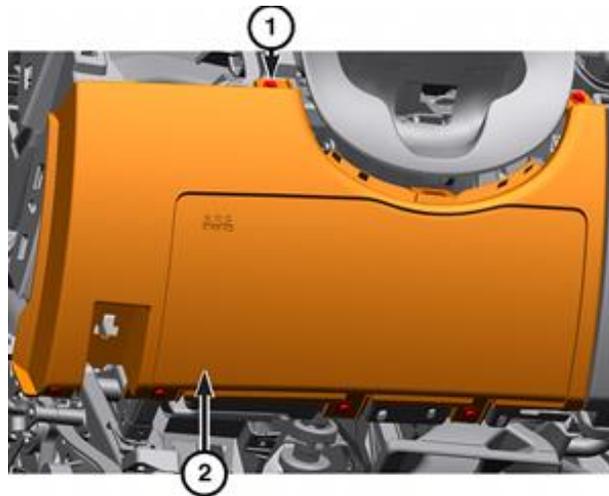
**Figure 19 – Steering Column Opening Cover**

16. Remove the top and bottom fasteners (1) that secure the steering column opening cover (2) to the instrument panel (Figure 19).

17. Reattach the hood release handle to the steering column opening cover (Figure 20).
18. Install and securely tighten the top and bottom fasteners (1) that secure the steering column opening cover (2) to the instrument (Figure 19).

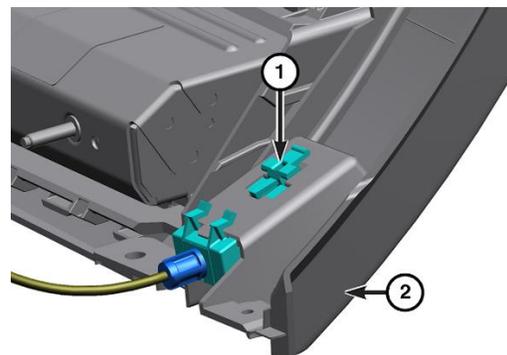
**Figure 20 – Hood Release Handle**

17. Working under the left side of the instrument panel, pull down the hood release handle and release the retaining tab (1) and slide the handle assembly forward to release from the steering column opening cover (2) (Figure 20).

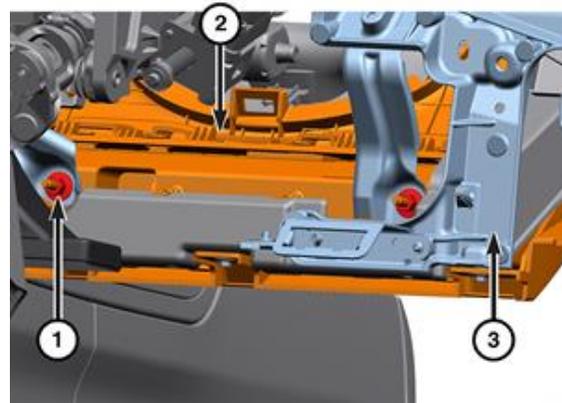
**Figure 21 – Air Bag Housing Fasteners**

18. Working under the left side of the instrument panel, remove the two nuts (1) that secure the airbag housing (2) to the instrument panel support structure (3) (Figure 21).

16. Working under the left side of the instrument panel, install the two nuts (1) that secure the airbag housing (2) to the instrument panel support structure (3) and tighten to 9 N·m (80 in. lbs.) (Figure 21).

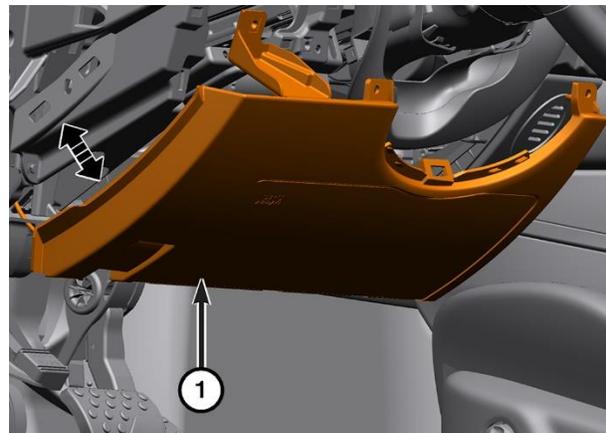
**Figure 22 – Column Opening Cover & Knee Bag**

19. Partially remove the steering column opening cover (1) and the knee airbag as one unit from the instrument panel (Figure 22).

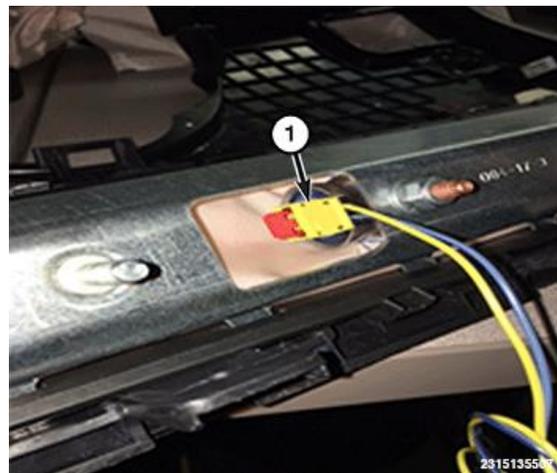
**Figure 23 – Knee Bag Connector**

20. Pull the steering column opening cover out far enough to access and disconnect the wire harness connector from the knee airbag (1). Remove the steering column cover from the vehicle (Figure 23).

13. Connect the gearshift lever electrical connector (1) (Figure 25).
14. Install left lower floor duct screw and duct (Figure 24).
15. Connect the wire harness connector to the knee airbag (1) and install the steering column cover to the vehicle (Figure 23).

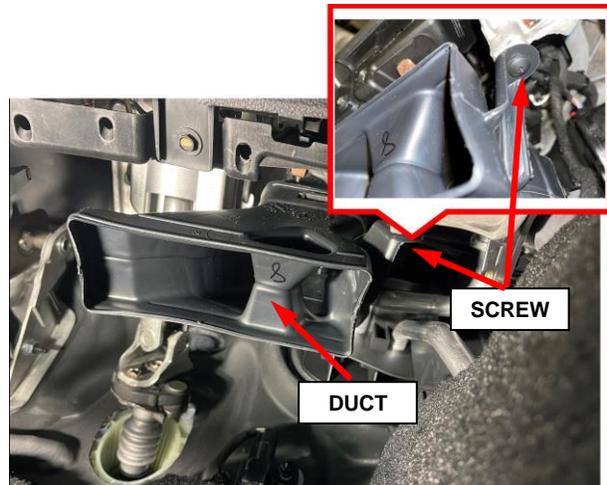
**Figure 24 – Floor Duct**

21. Remove left lower floor duct screw and duct (Figure 24).

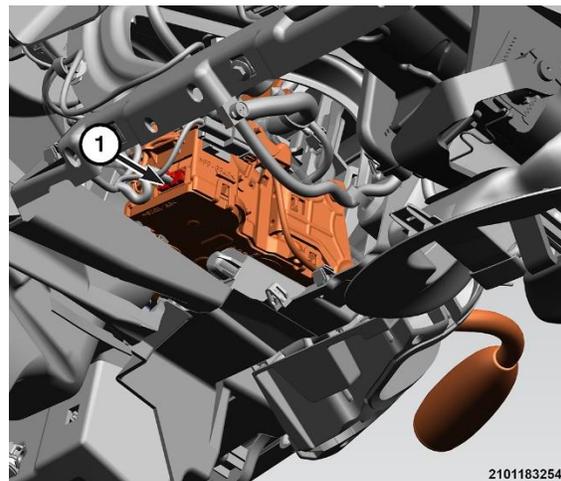
**Figure 25 – Shifter Electrical Connector**

22. Disconnect the gearshift electrical connector (1) and harness retainers (Figure 25).

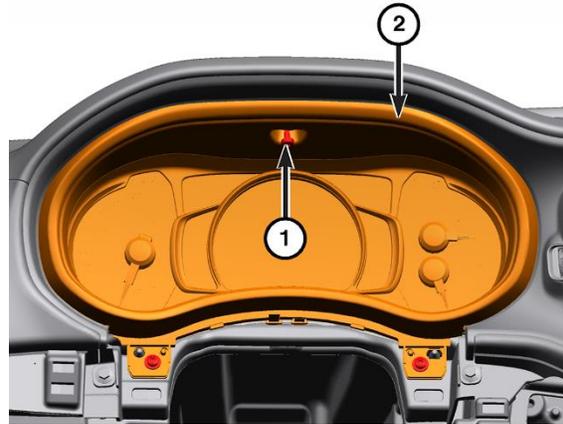
**Figure 26 – IC Fasteners**

23. Remove the fasteners (1) that secure the instrument cluster (2) (Figure 26).

12. Install and securely tighten the fasteners (1) that secure the instrument cluster (2) (Figure 26).

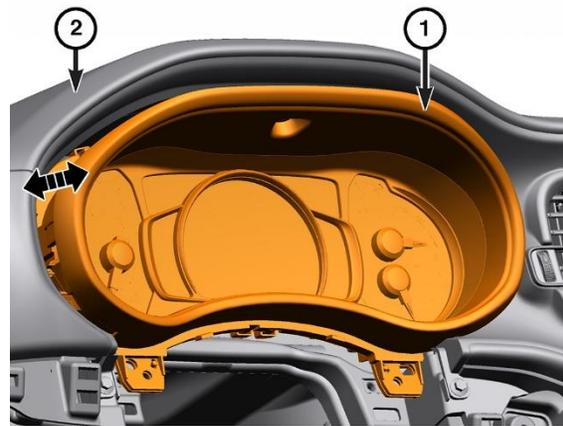
**Figure 27 – IC Removal**

24. Slide the instrument cluster toward the rear of the vehicle to release it from the instrument panel (2) (Figure 27).
25. Disconnect the instrument cluster wire harness connector on the back of the cluster housing (1) (Figure 27).
26. Remove the instrument cluster (1) from the vehicle (Figure 27).

10. Install the radio display and bezel to the instrument panel, and securely tighten 4 radio display bezel screws (Figure 28).
11. Connect the instrument cluster wire harness connector on the back of the cluster housing (1) and install the cluster to the vehicle (Figure 27).

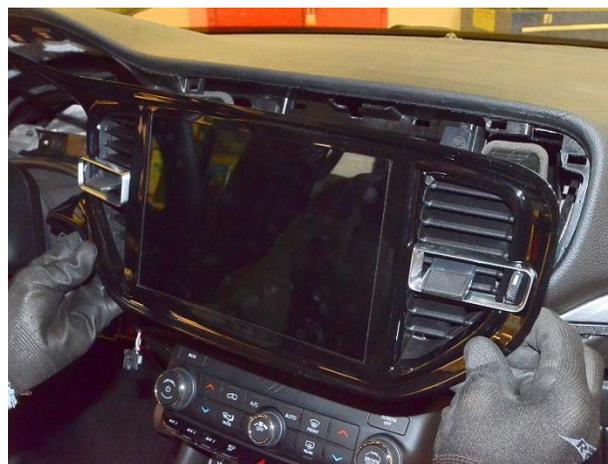
**Figure 28 – Radio Display and Bezel**

27. Remove 4 radio display bezel screws, then using a trim stick or equivalent, remove the radio display and bezel from the instrument panel (Figure 28).

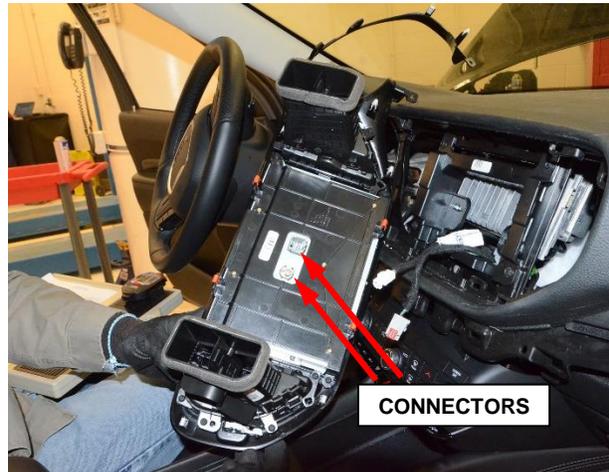
**Figure 29 – Radio Display Connectors**

**CAUTION: Pulling the antenna cable straight out of the radio without pulling on the locking antenna connector could damage the cable or radio.**

28. Disconnect radio display electrical connectors (Figure 29).

8. Install and securely tighten the fasteners (1) securing the Radio Receiver Module (RRM) bracket (2) to the instrument (Figure 30).
9. Connect the radio display electrical connectors (Figure 29).

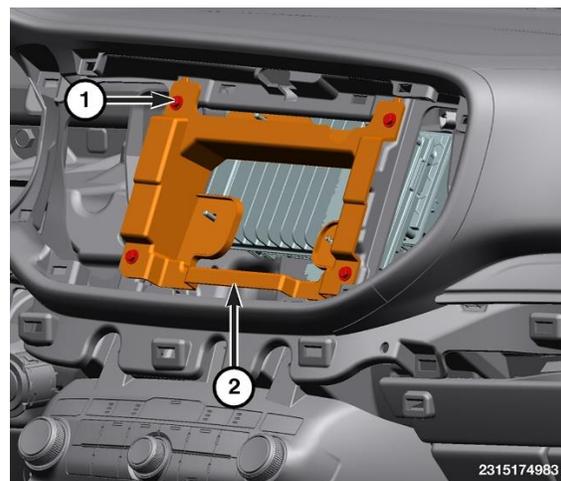
**Figure 30 – RRM Bracket**

29. Remove the fasteners (1) securing the Radio Receiver Module (RRM) bracket (2) to the instrument panel (Figure 30).

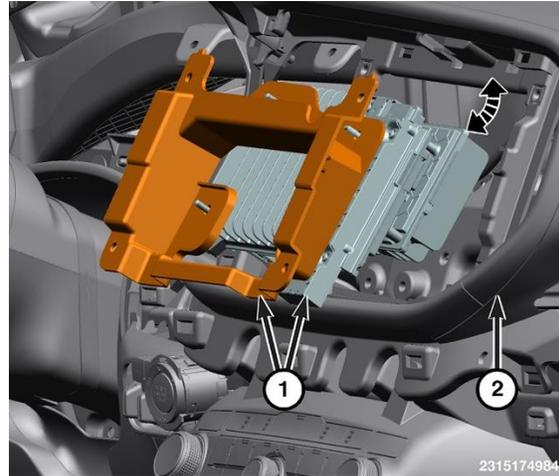
**Figure 31 – RRM**

- 30. Pull the lower part of the RRM and bracket (1) out and down far enough to access the back of the RRM (Figure 31).
- 31. Disconnect the electrical connector, antennas, and if equipped, the USB connector.
- 32. Remove the RRM from the instrument panel.

6. Connect the shift lever electrical connector (Figure 32).
7. Connect the RRM electrical connector, antennas, and if equipped, the USB connector, and position the RRM in the instrument panel (Figure 31).

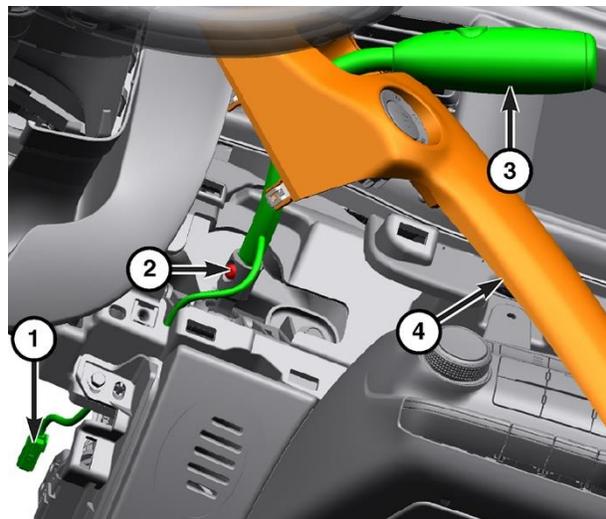
**Figure 32 – Move Right Center Trim Panel**

- 33. Position the right center trim panel (4) toward the end of the shifter lever (3) (Figure 32).
- 34. Disconnect the wire harness connector (1) for the shifter lever (3) (Figure 32).
- 35. Loosen the fastener (2) and remove the shifter lever (3) and right center trim panel (4) from the vehicle (Figure 32).

5. Install the shifter lever (3) and right center trim panel (4) to the vehicle. Connect the wire harness connector for the Keyless Ignition Node (KIN). Install and tighten the shift lever fastener (2) to 15 N·m (11 ft. lbs.) (Figure 32).

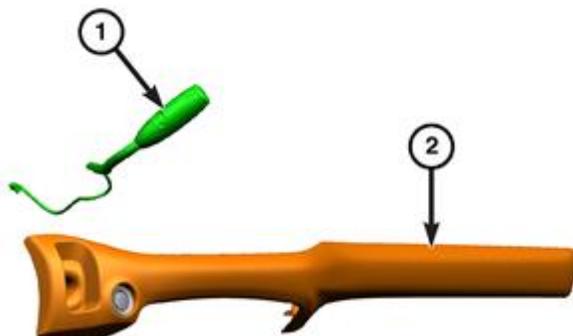
**Figure 33 – Remove Right Center Trim Panel from Shifter**

- 36. Remove the shifter lever (1) from the right center trim panel (2) (Figure 33).

3. Install the knee bolster bracket and securely tighten two bolts (Figure 35).
4. Using rosewater as needed, install the shifter lever (1) from the right center trim panel (2) (Figure 33).

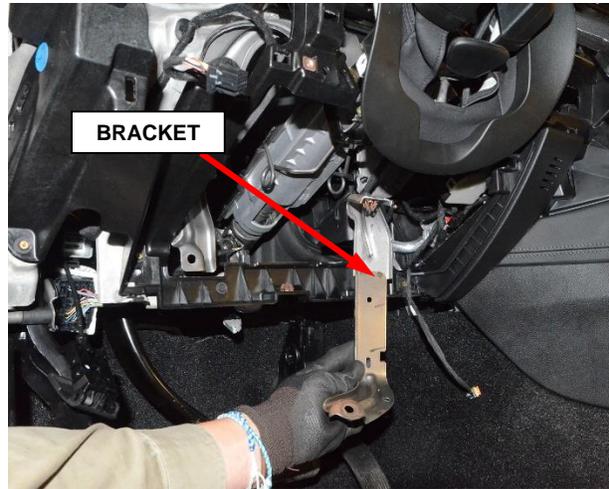
Figure 34 – Knee Bolster Bracket to IP

- 37. Remove the 2 bolts retaining the knee bolster bracket to the IP (Figure 34).

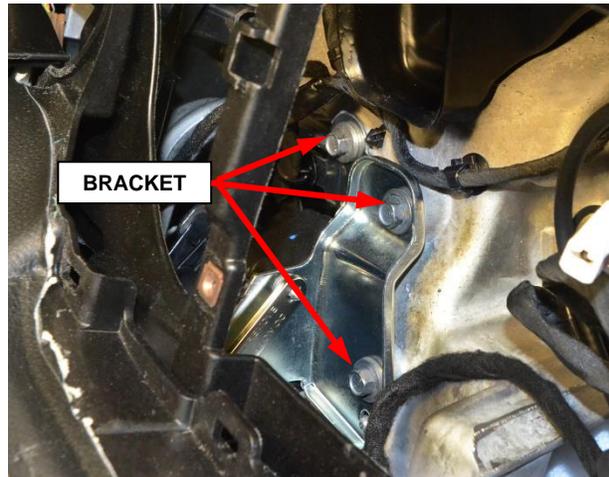
Figure 35 – Shifter Bolts

- 38. Remove the bolts retaining the shifter to the IP (Figure 35).

1. Position the new shifter into the IP (Figure 36).
2. Install the bolts retaining the shifter to the IP and tighten to 8 N·m (71 in. lbs.) (Figure 35).

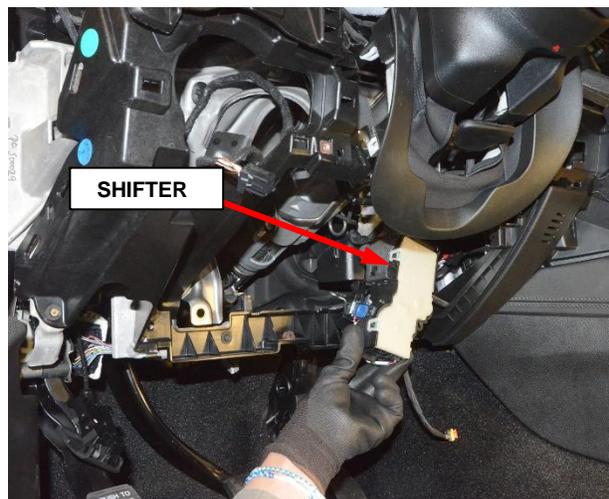
Figure 36 – Shifter

- 39. Remove the shifter from the IP from the bottom (Figure 36).
