SERVICE PROCEDURE

22524 / 22541
JANUARY, 2023

SUBJECT: SAFETY RECALL 22524 Variation 22541
Hex Flange Lock Nut on certain International® MV™
Series trucks built 01/21/2022 thru 07/26/2022.

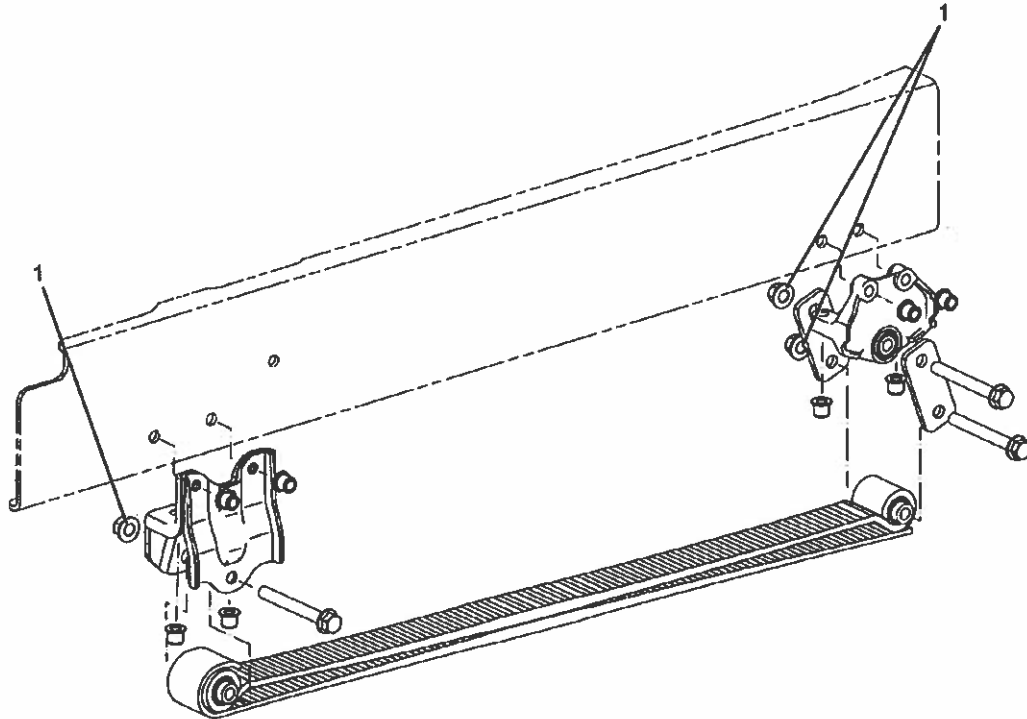
Figure 1. Typical Steer Axle Shackle

1. Nut (3)

7. Access nuts (Figure 1, Item 1) securing the front steer axle shackle.

NOTE: After installation of each nut, ensure at least one thread is protruding past the top edge of the nut.

8. Remove and replace nuts (Figure 1, Item 1). Using a torque wrench, tighten nuts to 330-370 lb-ft (450-500 N·m).
9. Repeat Steps 7 and 8 for opposite side.

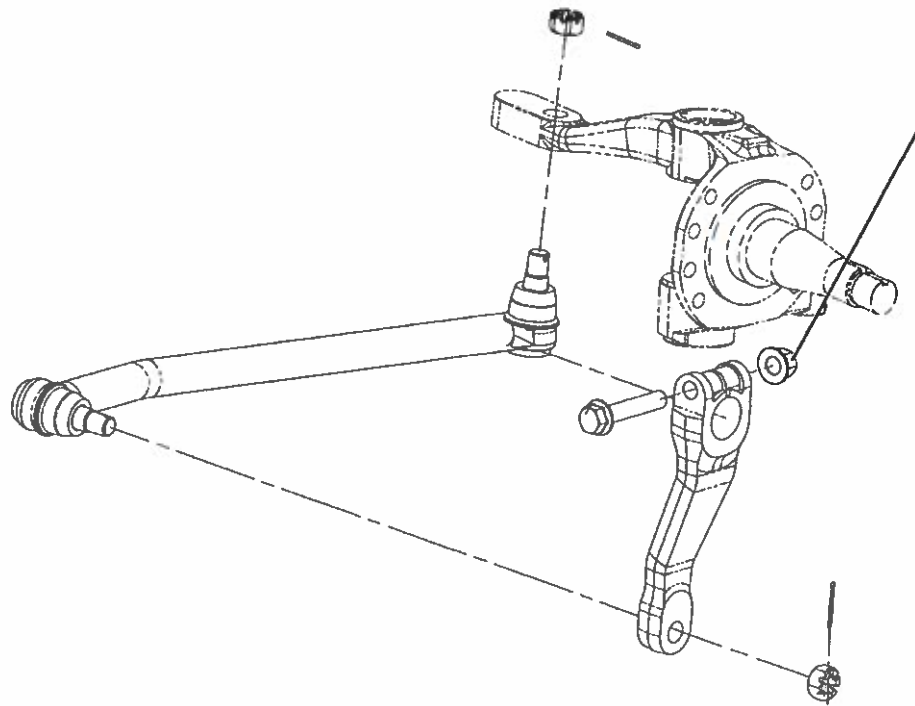
Figure 2. TRW Pitman Arm Nut

1. Nut

10. Access Pitman arm nut (Figure 2, Item 1).

NOTE: After installation of each nut, ensure at least one thread is protruding past the top edge of the nut.

11. Remove and replace nut. Using a torque wrench and backup wrench positioned on bolt, tighten nut to 330-370 lb-ft (450-500 N·m).
12. Raise vehicle, remove front axle jack stands, and lower vehicle.
13. Using jack, raise rear axles and support vehicle on jack stands.

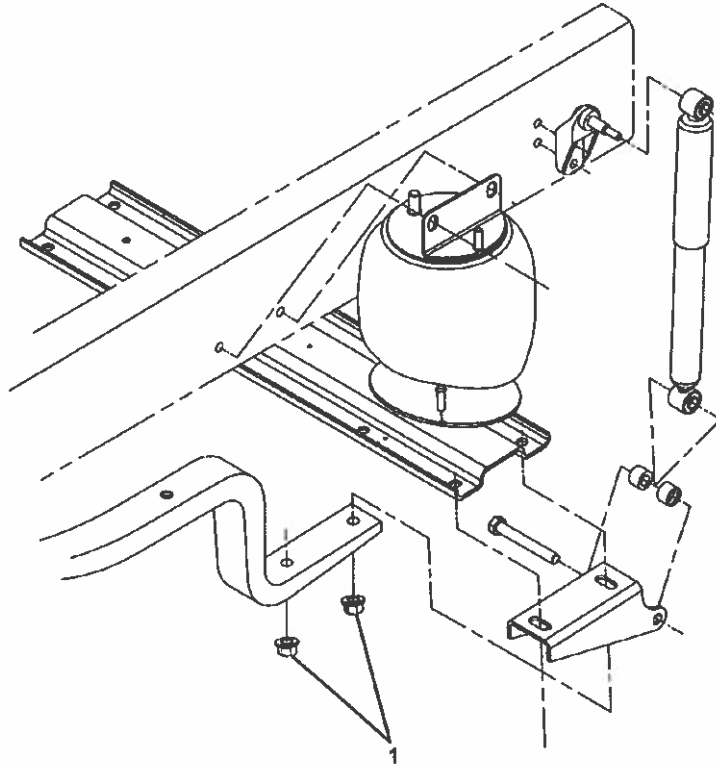
Figure 3. Cross Brace

1. Nut (2)
14. Access two nuts (Figure 3, Item 1) securing rear axle(s) to cross brace.

NOTE: After installation of each nut, ensure at least one thread is protruding past the top edge of the nut.

15. Remove and replace nuts one at a time. Using a torque wrench, tighten nuts to 150-205 lb-ft (203-278 N-m).
16. Repeat Steps 14 through 15 for opposite side.
17. Raise vehicle, remove jack stands, and lower vehicle.
18. Close and latch hood.
19. Remove wheel chocks.
