SERVICE PROCEDURE

SAFETY RECALL 22524 Variation 22540

Hex Flange Lock Nut on certain International® HV[™] and MV[™] Series trucks built 01/19/2022 thru

DEFECT DESCRIPTION

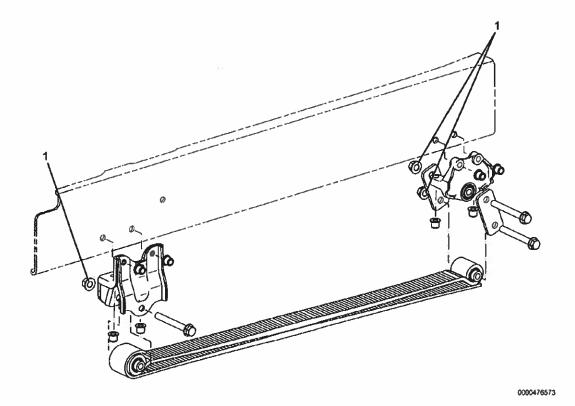
Figure 1. Typical Steer Axle Shackle

A specific hex flange lock nut used in several, but not all, steering and / or suspension locations may have not been properly formed and heat treated to Navistar's specifications and can result in a loss of joint tension as the vehicle ages. A loss of joint tension in these joints may affect vehicle handling and could contribute to a vehicle crash.

1. Nut (3)

7. Access three nuts (Figure 1, Item 1) securing the front steer axle shackle.

NOTE: After installation of each nut, ensure at least one thread is protruding past the top edge of the nut.

- 8. Remove and replace nuts one at a time. Using a torque wrench, tighten three nuts to 330-370 lb-ft (450-500 N·m).
- 9. Repeat Steps 7-8 for opposite side.
- 10. Raise vehicle, remove jack stands, and lower vehicle.
- 11. Using jack, raise rear axles and support vehicle on jack stands.

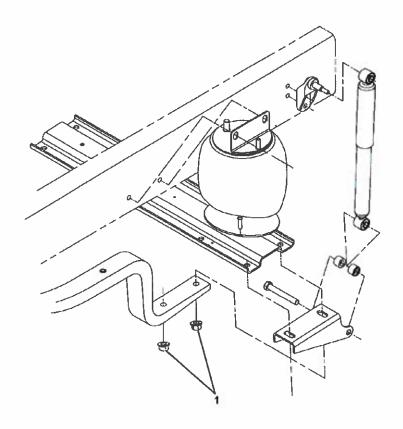
Figure 2. HAS Single Axle Cross Brace

- 1. Nut (2)
- 12. Access two nuts (Figure 2, Item 1) securing rear axle(s) to cross brace.

NOTE: After installation of each nut, ensure at least one thread is protruding past the top edge of the nut.

- 13. Remove and replace nuts one at a time. Using a torque wrench, tighten three nuts to 150-205 lb-ft (203-278 N⋅m).
- 14. Repeat Steps 12-13 on opposite side.
- 15. Raise vehicle, remove jack stands, and lower vehicle.
- 16. Close and latch hood.
- 17. Remove wheel chocks.
