SERVICE PROCEDURE

SUBJECT: SAFETY RECALL 22524 Variation 22547
Hex Flange Lock Nut on a certain IC Bus® RE
Series commercial bus built on 05/12/2022.

VEHICLE RECALL 22547

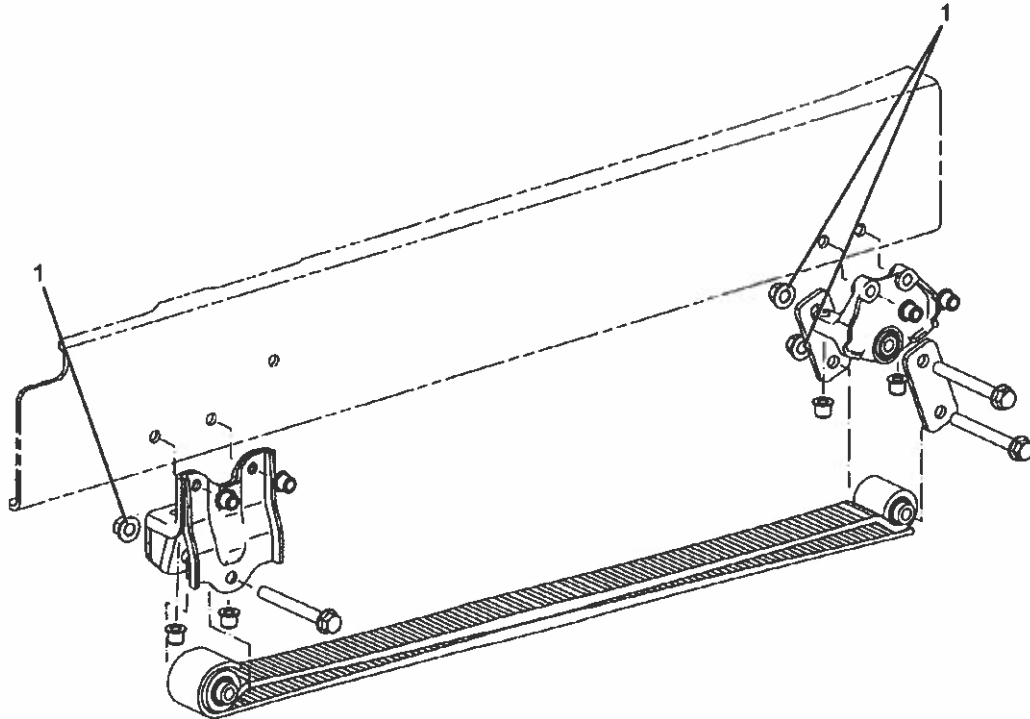
Figure 1. Steer Axle Shackle

A specific hex flange lock nut used in several, but not all, steering and / or suspension locations may have not been properly formed and heat treated to Navistar specifications and can result in a loss of joint tension as the vehicle ages. A loss of joint tension in these joints may affect vehicle handling and could contribute to a vehicle crash.

1. Nut (3)

6. Access nuts (Figure 1, Item 1) securing the front steer axle shackle.

NOTE: After installation of each nut, ensure at least one thread is protruding past the top edge of the nut.

7. Remove and replace nuts (Figure 1, Item 1). Using a torque wrench, tighten nuts to 330 - 370 lb-ft (450 - 500 N·m).
8. Repeat Steps 6 and 7 for opposite side.

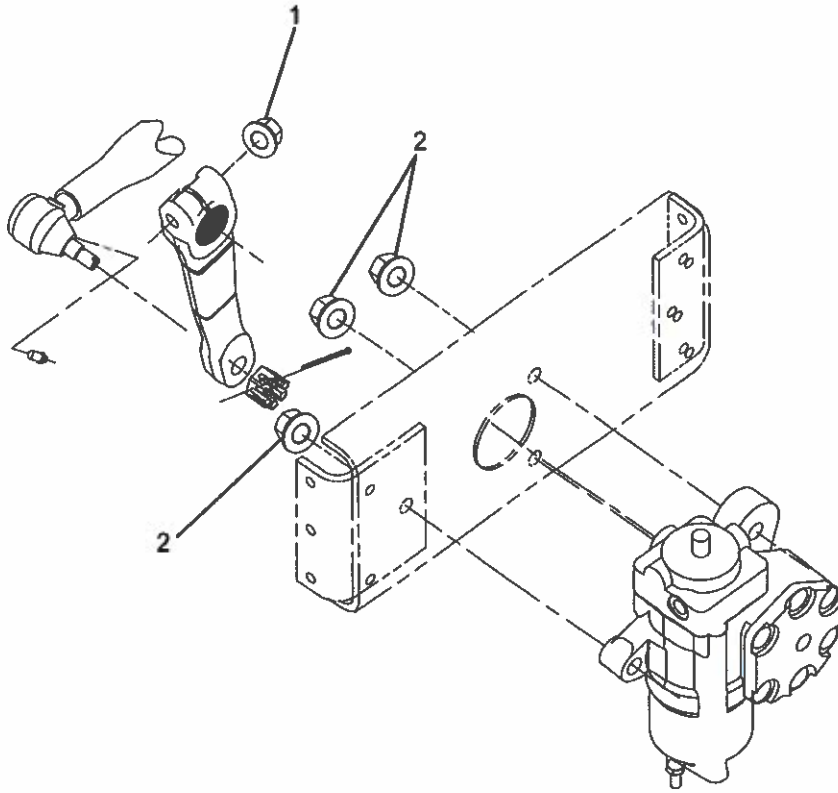
Figure 2. TRW Pitman Arm Nut and Steering Gear Mounting

1. Pitman arm nut
2. Steering gear mounting nut (3)

9. Access Pitman arm nut (Figure 2, Item 1) securing pinch bolt.

NOTE: After installation of each nut, ensure at least one thread is protruding past the top edge of the nut.

10. Remove and replace nut. Using a torque wrench and backup wrench positioned on bolt, tighten nut to 330 - 370 lb-ft (450 - 500 N·m).
11. Access three steering gear mounting nuts (Figure 2, Item 2).

12. Remove and replace nuts one at a time. Using a torque wrench and backup wrench positioned on bolt, tighten nut to 330 - 370 lb-ft (450 - 500 N·m).
