# SERVICE PROCEDURE

22524 / 22555  
JANUARY, 2023

**SUBJECT:** SAFETY RECALL 22524 Variation 22555  
Hex Flange Lock Nut on certain International® HV™  
Series trucks built 03/17/2022 thru 07/25/2022.

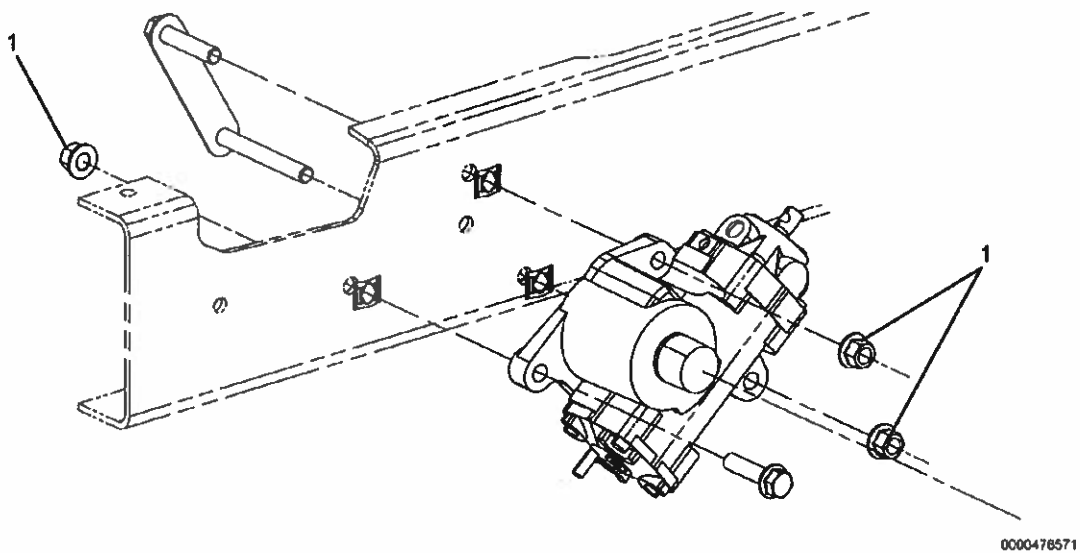
**Figure 1. Sheppard Main Steering Gear Mounting Nuts (Driver-side)**

1. Main steering gear mounting nut (3)
6. Access main steering gear mounting nuts (Figure 1, Item 1).
7. Remove only one mounting nut at a time. Discard nut.

**NOTE: After installation of each nut, ensure at least one thread is protruding past the top edge of the nut.**

8. Install new mounting nut.
9. Using a torque wrench and backup wrench positioned on bolt, tighten mounting nut to 330 - 370 lb-ft (450 - 500 N·m).
10. Repeat steps 7 - 9 for additional mounting nuts.

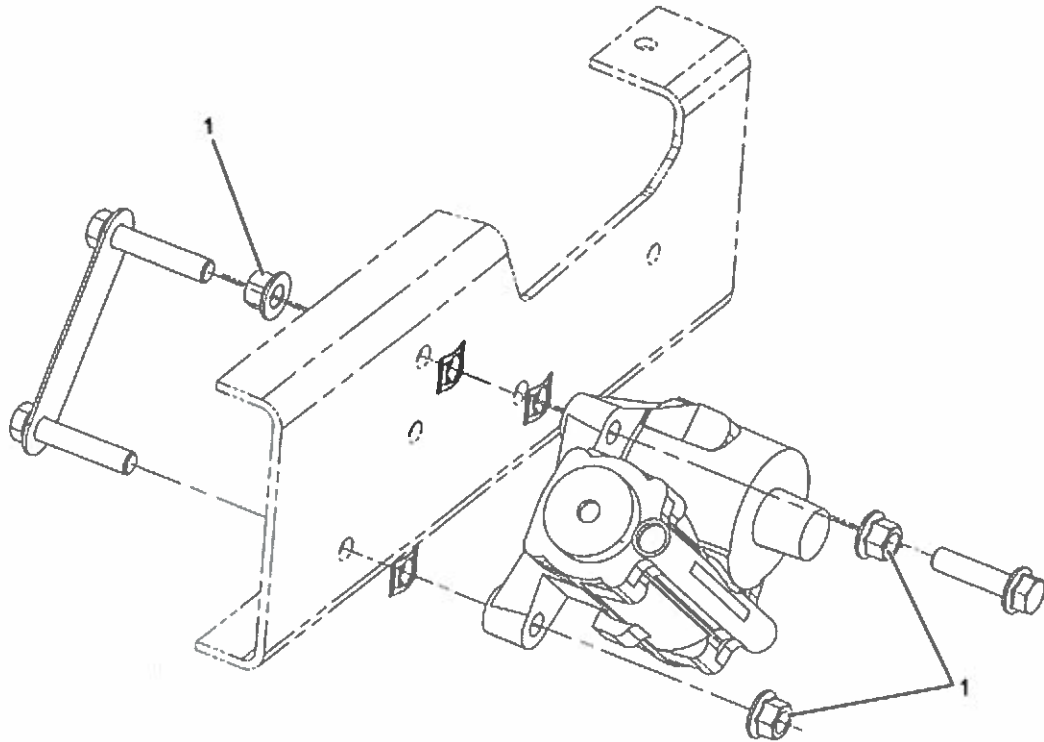
**Figure 2. Sheppard Slave Steering Gear Mounting Nuts (Passenger-side)**

1. Slave steering gear mounting nut (3)
11. Access slave steering gear mounting nuts (Figure 2, Item 1).
12. Remove only one mounting nut at a time. Discard nut.

**NOTE: After installation of each nut, ensure at least one thread is protruding past the top edge of the nut.**

13. Install new mounting nut.
14. Using a torque wrench and backup wrench positioned on bolt, tighten mounting nut to 330 - 370 lb-ft (450 - 500 N-m).
15. Repeat Steps 12-14 for additional mounting nuts.
16. Using jack, raise rear axles and support vehicle on jack stands.

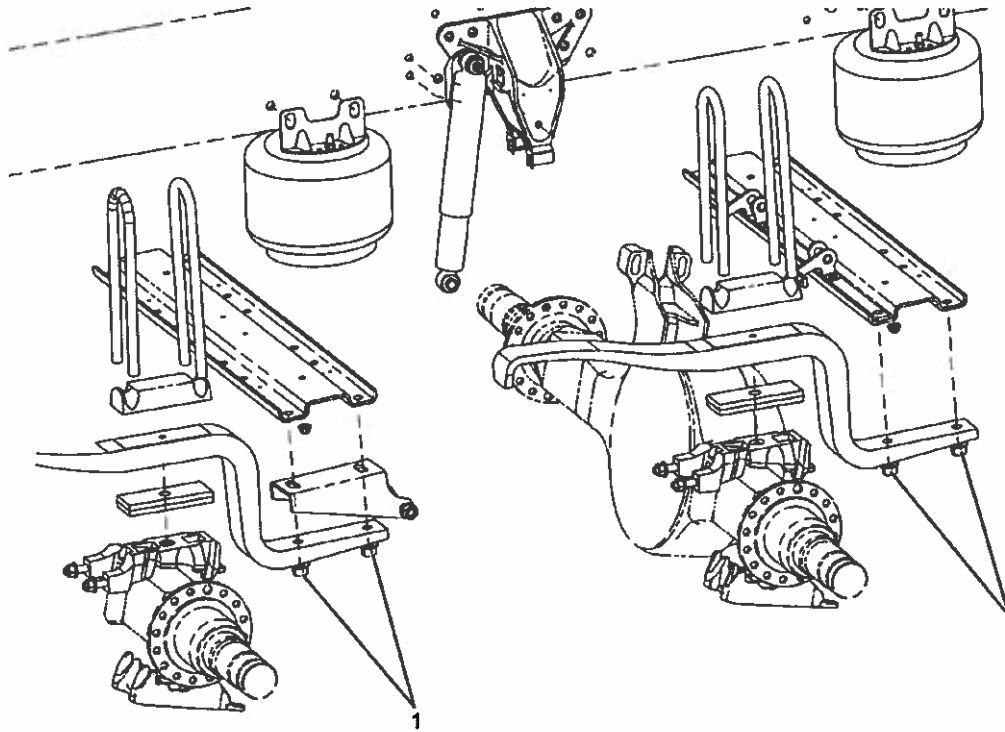
**Figure 3. HAS Cross Brace**

1. Nuts (4)

17. Access four nuts (Figure 3, Item 1) securing rear springs to cross brace.

**NOTE: After installation of each nut, ensure at least one thread is protruding past the top edge of the nut.**

18. Remove and replace nuts. Using a torque wrench, tighten nuts to 330 - 370 lb-ft (450 - 500 N·m).

19. Repeat Steps 17-18 for opposite side.

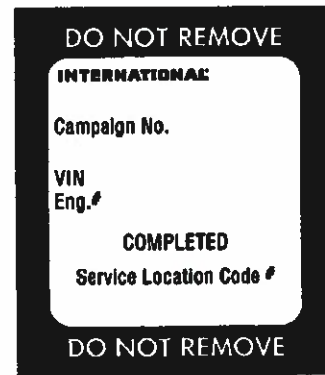
Each vehicle corrected in accordance with this campaign must be marked with a CTS-1075 Campaign Identification Label.

Complete the label and attach on a clean surface next to the vehicle identification number (VIN) plate.
