# SERVICE PROCEDURE

22524 / 22554  
JANUARY, 2023

**SUBJECT:** SAFETY RECALL 22524 Variation 22554  
Hex Flange Lock Nut on certain International® HX®  
Series trucks built on 07/21/2022 thru 07/22/2022.

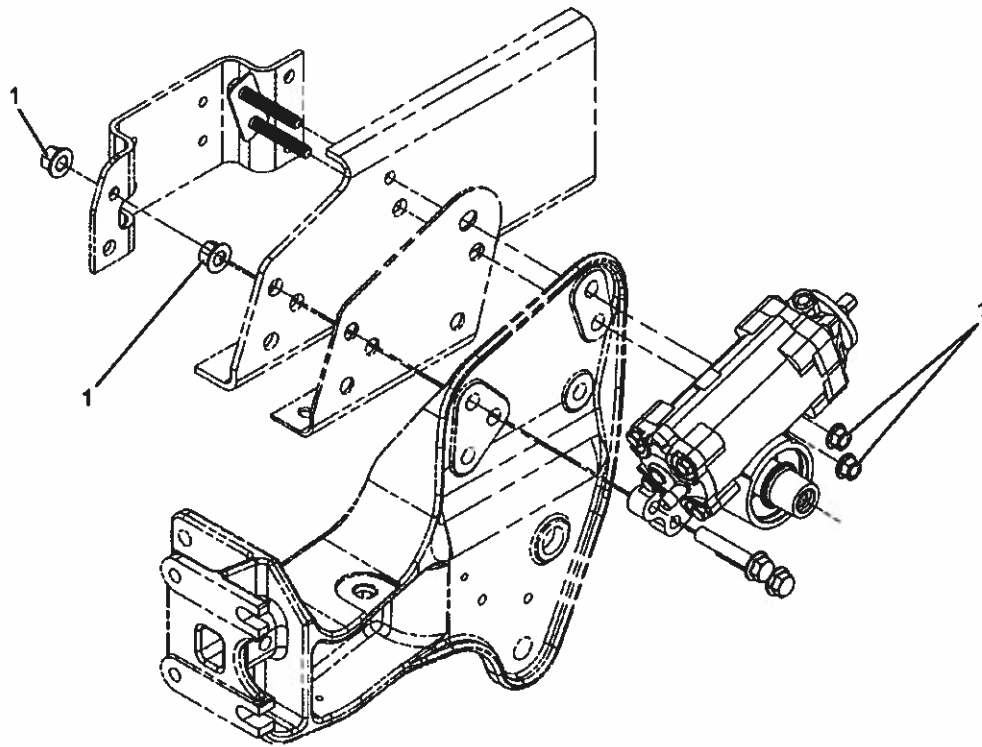
**Figure 1. Sheppard Main Steering Gear Mounting Nuts (Driver-Side)**

A specific hex flange lock nut used in several, but not all, steering and/or suspension locations may have not been properly formed and heat treated to Navistar's specifications and can result in a loss of joint tension as the vehicle ages. A loss of joint tension in these joints may affect vehicle handling and could contribute to a vehicle crash.

1. Main steering gear mounting nut (4)

6. Access main steering gear mounting nuts (Figure 1, Item 1).

7. Remove only one mounting nut at a time. Discard nut.

**NOTE: After installation of each nut, ensure at least one thread is protruding past the top edge of the nut.**

8. Install new mounting nut.

9. Using a torque wrench and backup wrench positioned on bolt, tighten mounting nut to 330 - 370 lb-ft (450 - 500 N·m).

10. Repeat Steps 7-9 for additional mounting nuts.

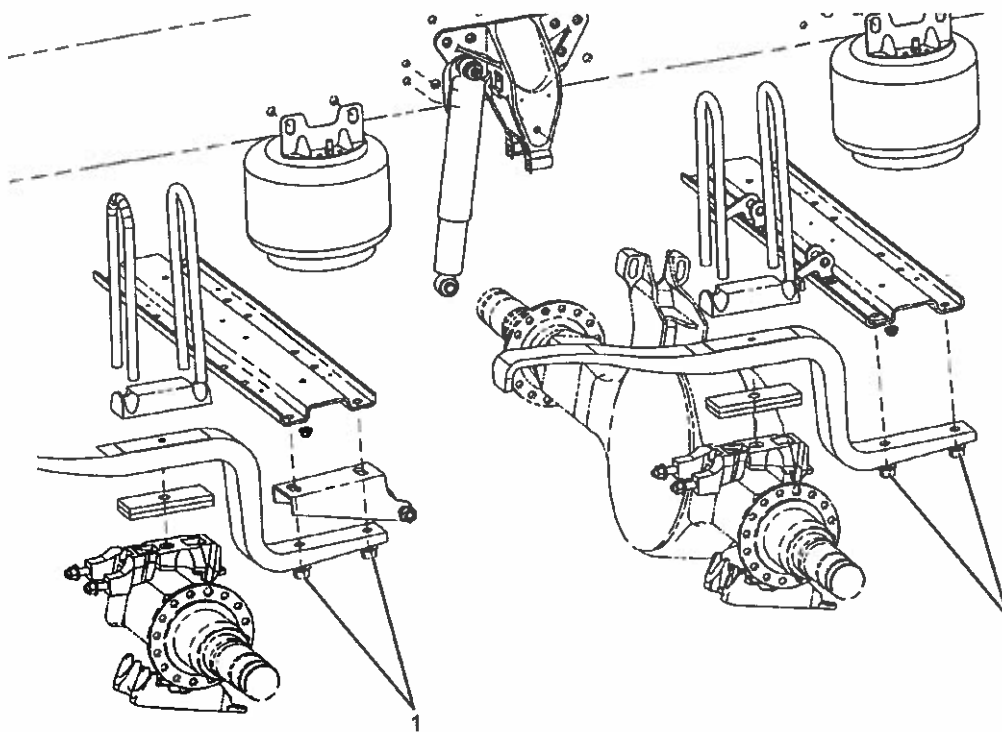
**Figure 2. HAS Cross Brace Nuts**

1. Nut (4)
12. Access four nuts (Figure 2, Item 1) securing rear air spring(s) to cross brace.

**NOTE: After installation of each nut, ensure at least one thread is protruding past the top edge of the nut.**

13. Remove and replace nuts. Using a torque wrench, tighten nut to 330 - 370 lb-ft (450 - 500 N·m).
14. Repeat Steps 12-13 for opposite side.
15. Raise vehicle, remove jack stands, and lower vehicle.
16. Close and latch hood.
17. Remove wheel chocks.
