SERVICE PROCEDURE

22525 / 22560
JANUARY, 2023

SUBJECT: SAFETY RECALL 22525 Variation 22560
Hex Flange Lock Nut on certain IC Bus® CE Series
and Electric CE Series vehicles built 03/01/2022
thru 08/17/2022.

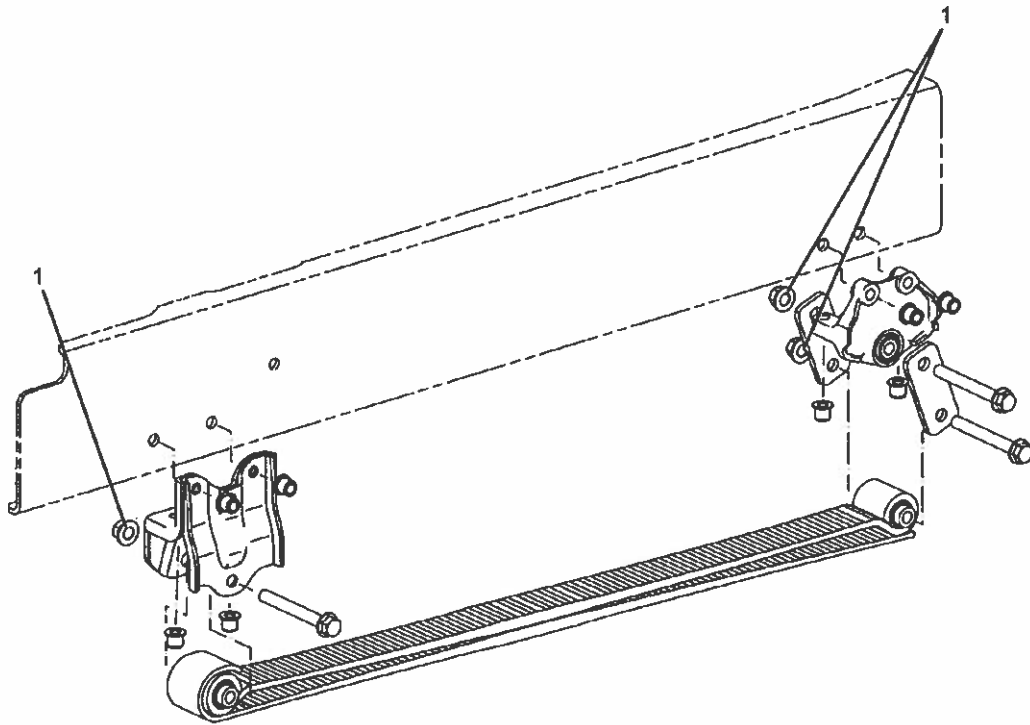
Figure 1. Steer Axle Shackle

1. Nut (3)

7. Access nuts (Figure 1, Item 1) securing the front steer axle shackle.

8. Remove and replace nuts (Figure 1, Item 1). Using a torque wrench, tighten nuts to 330 - 370 lb-ft (450 - 500 N·m).

9. Repeat Steps 7 and 8 for opposite side.

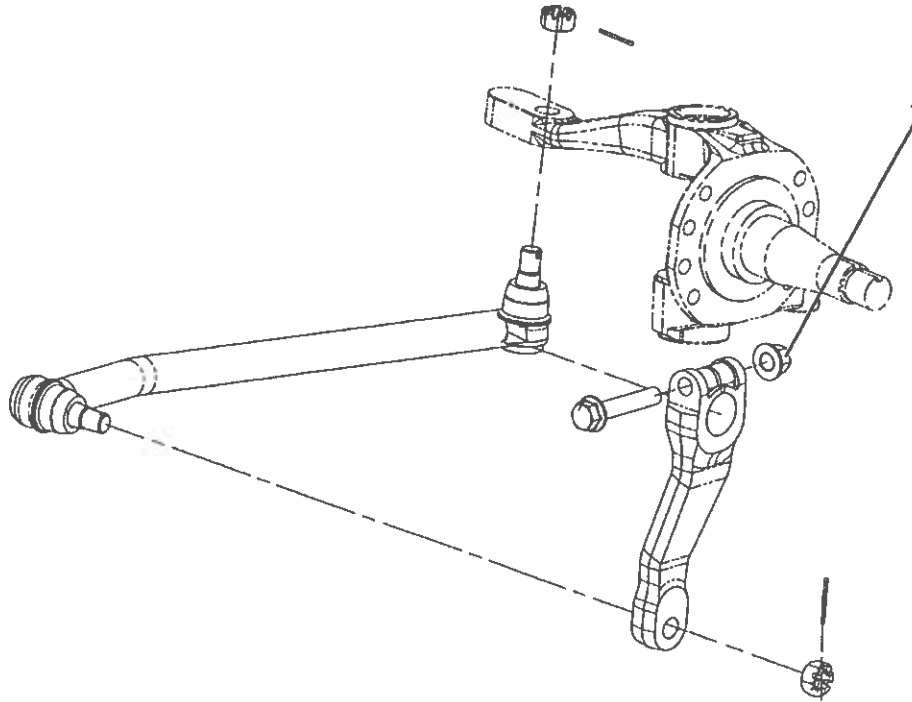
Figure 2. TRW Pitman Arm Nut

1. Nut

10. Access Pitman arm nut (Figure 2, Item 1).

11. Remove and replace nut. Using a torque wrench and backup wrench positioned on bolt, tighten nut to 330 - 370 lb-ft (450 - 500 N·m).
12. Raise vehicle, remove jack stands, and lower vehicle.
15. Close and latch hood.
16. Remove wheel chocks.
