# Recall Campaign Bulletin

Campaign No. 2023010005, January 2023

SUBJECT: **Model C-Class (203 platform)**  
**Model Year 2002-2005**

## **Check Sliding Roof Bonding**

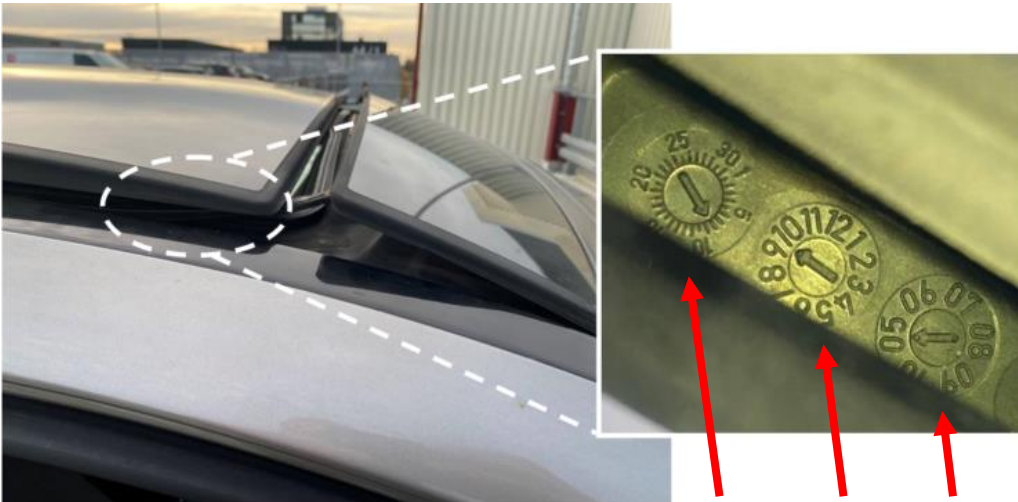
**Figure 1** (The manufacturing date in the sample picture is 08 day / 10 month / 5 year) (10/08/2005)

1. **Open** panoramic sliding sunroof **approx. 3 cm** and check manufacturing date (Figure 1).
  - i** Carry out check with a mirror as shown in Figure 2.
  - i** To position the mirror, the wind deflector must be pushed downward by hand.
  - i** Vehicles with a registration date that does **not** match with the manufacturing date of the panoramic sliding sunroof can also be affected.

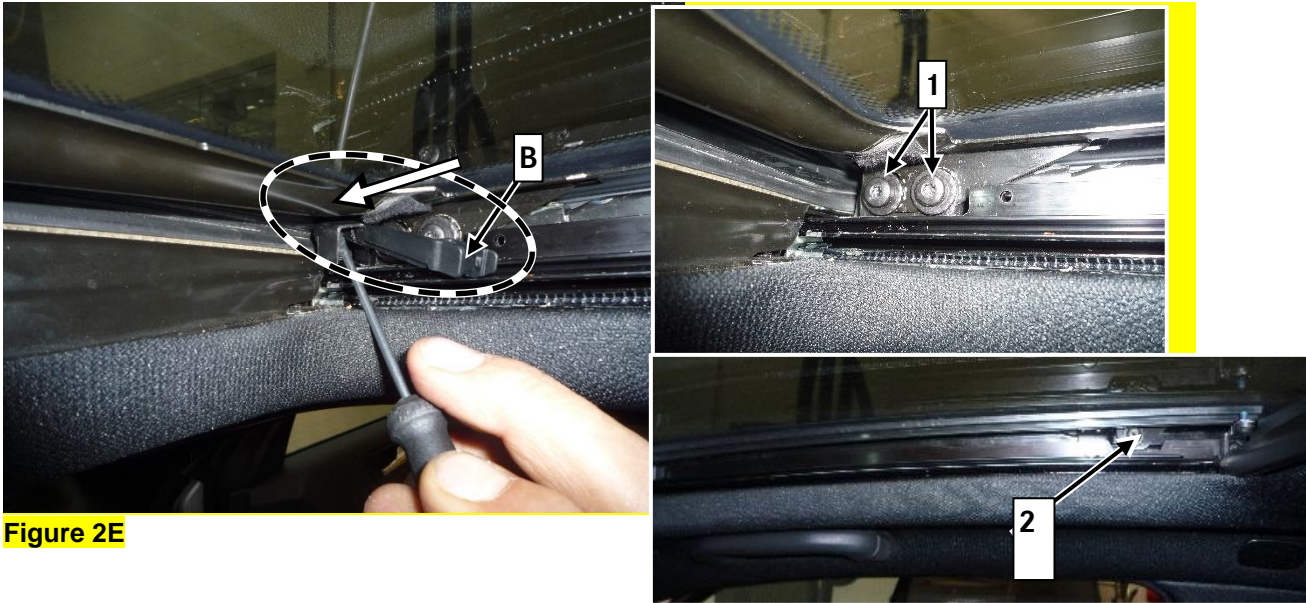
Figure 2E

- i** If the emergency opening function of the panoramic sliding sunroof is **not** operational (**Figure 2**), remove the pleated rubber on the **right and left**.  
 To do so, pull out the pleated rubber upwards (**Figure 2A**) and pull it out of the front guide (**Figure 2B**) in the direction of the arrow. Then tilt the rail (**Figure 2C, A**) out to the front by hand and remove the holder (**Figure 2D, B**). To remove the holder, first unclip it at the rear with a screwdriver and press it upwards (**Figure 2D, B**). Then press the holder to the front in the direction of the arrow (**Figure 2E, B**) and take it out.

Now on both sides loosen the front two glass panel screws (**Figure 2E, 1**) and center glass panel screws (**Figure 2E, 2**) and lift the sliding sunroof by hand just enough to be able to read off the production date.

- Nm** Screws of tilting/sliding roof panel: **5Nm**.

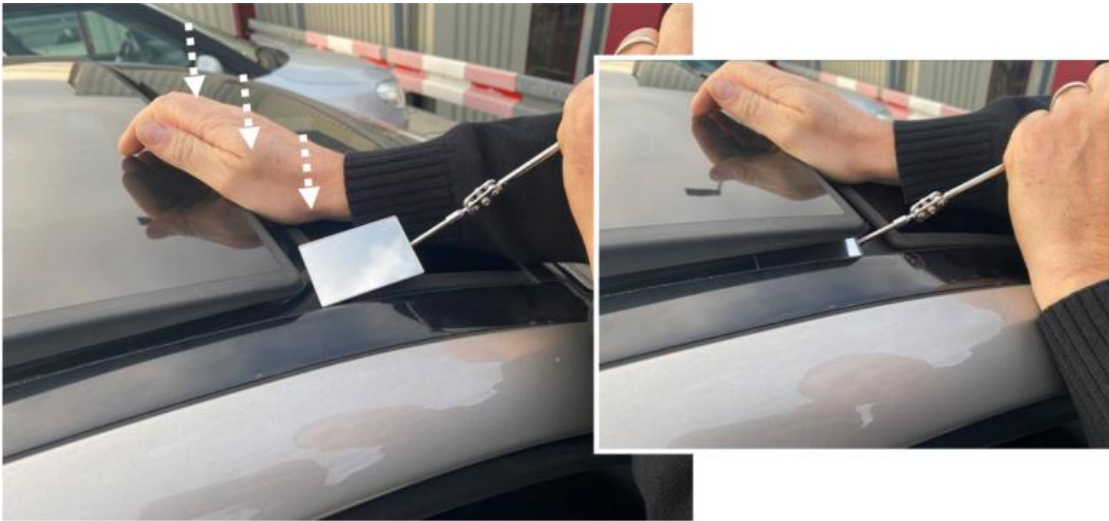
Figure 3

- i** Special caution must be exercised during the check.
    - i** The suction cup tool may be used for this check.
  3. Position suction cup tool (Figure 3) and pull as **vertically** as possible (tolerance of  $\pm 10$  degrees) using lifting tool.

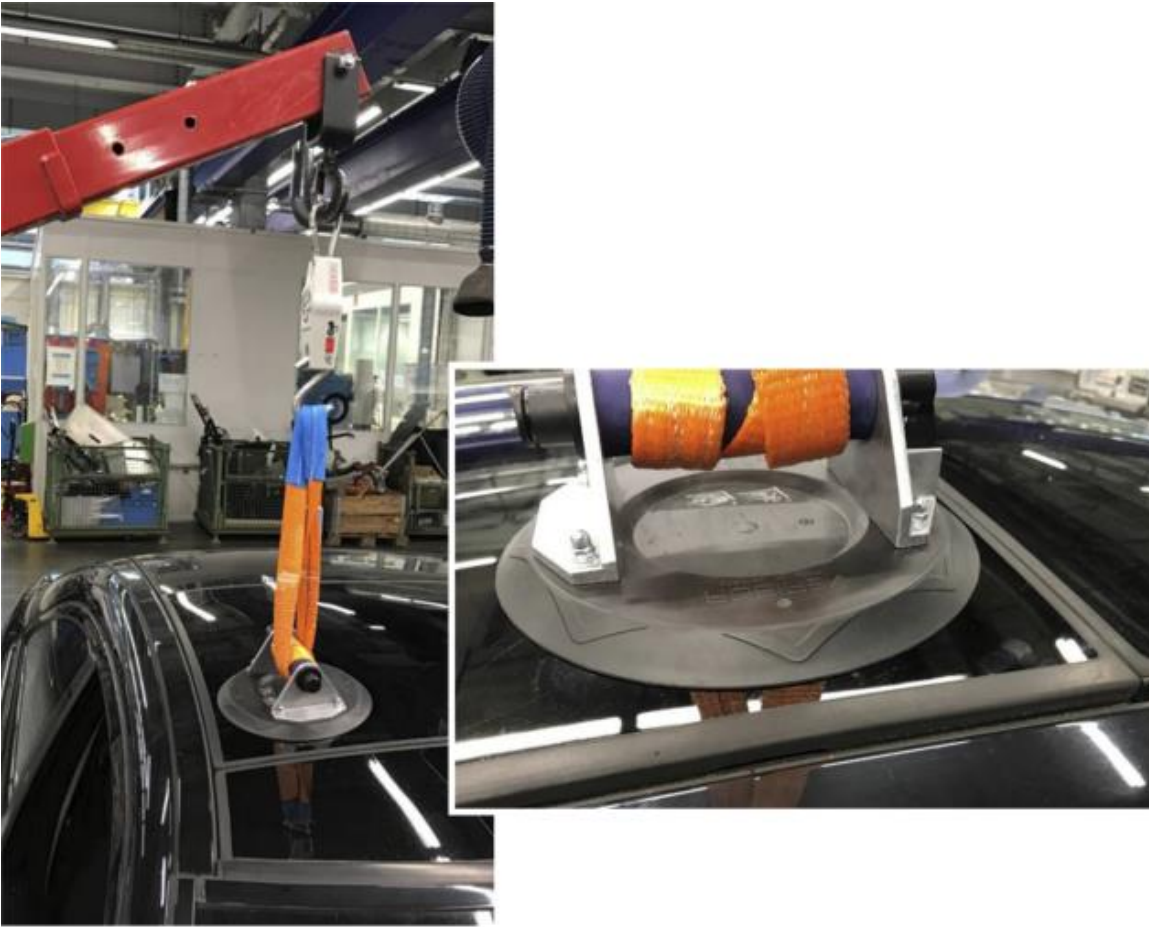
Figure 4

- i** The hanging scale **must** be adjusted as per the operating instructions before use.
    - i** Specified force **500N /700N** (Figure 4).
    - i** Before the start of the measurement, the "(auto) hold function" of the hanging scale (see operating instructions) **must** be deactivated.

- No** "hold function" may be activated so that the current tractive force is always displayed.
    - i** Position suction cup tool at 4 positions in the sequence **1, 2, 3, 4:** (Figure 4).

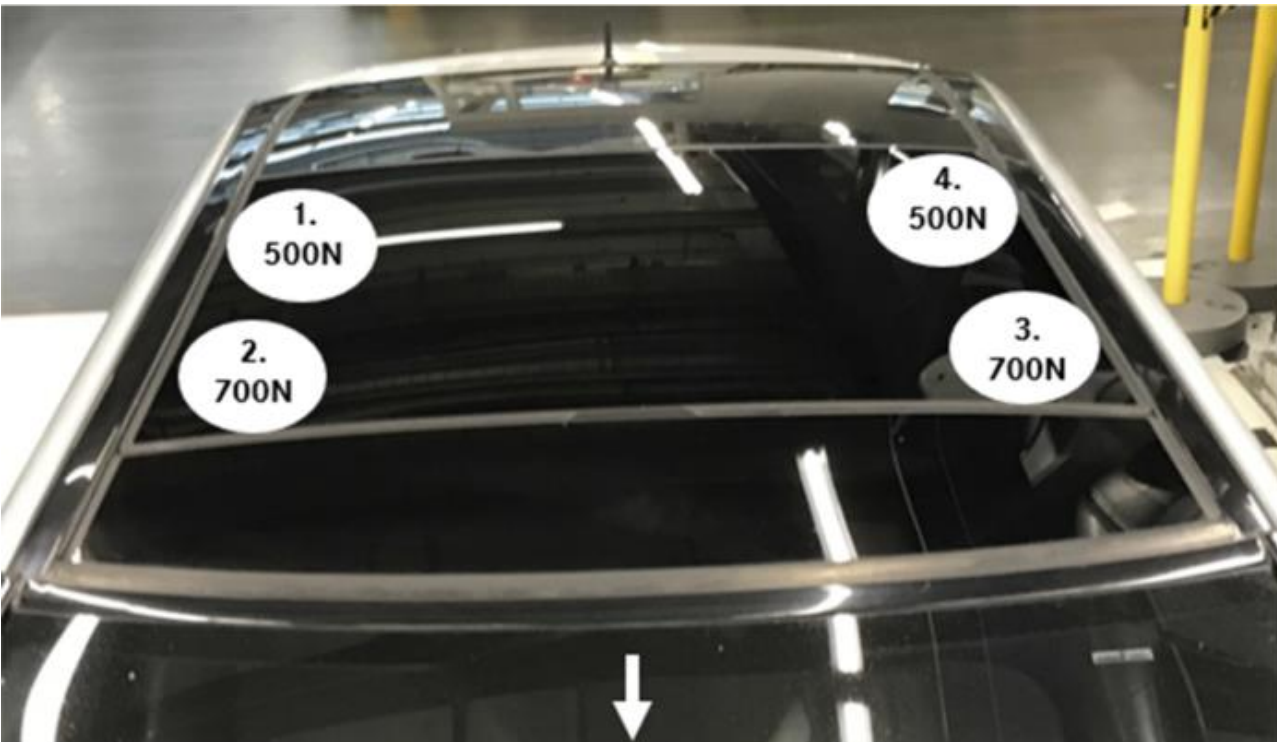
Figure 5 (test sequence 1, 2, 3, 4 – arrow indicates direction of travel)

**i** If the panoramic sliding sunroof panel detaches from the padding of the tilting/sliding sunroof frame at one of the test positions (see Figure 5), the glass cover must be replaced.
