Recall Campaign Bulletin

Campaign No. 2023010003, February 2023 Revision A 2/14/2023 Revision B 2/2/2024 Revision C 3/7/2024 Revision D 3/12/2024

SUBJECT: Model GLE/ML and GLE Coupe (166 and 292 platform) Model Year 2016-2020

Check for Water entry in the Spare Wheel Well

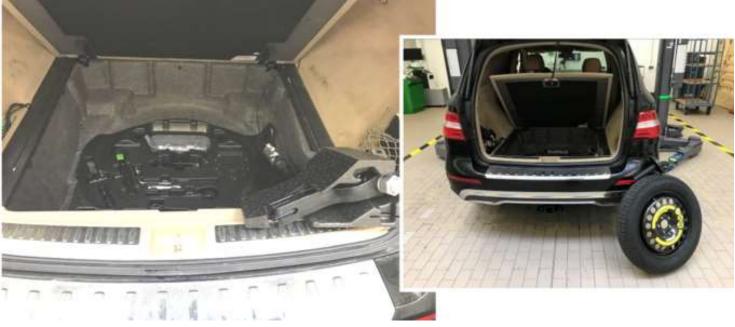
Figure 1

- 1. Open trunk.
- 2. Lift spare wheel well cover and secure it from falling down.
- 3. In vehicles with spare tire option code 690, remove spare tire and cover (Figure 1).

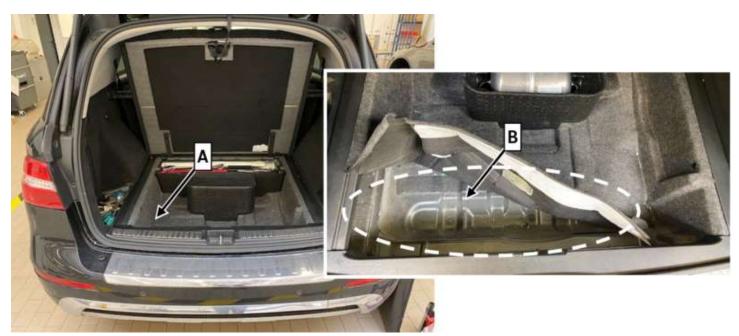
Figure 2

4. Lift left rear felt insert (A, Figure 2) and check for humidity or water deposits in marked area (B, Figure 2).

- **a.** If humidity or water deposits are *not* present in the area (B, Figure 2): Carry out **work procedure A**.
- b. If humidity or water deposits are present in the area (B, Figure 2): Carry out check/test procedure 2.

i Only required if humidity or water deposits are detected in checked area (B, Figure 2).

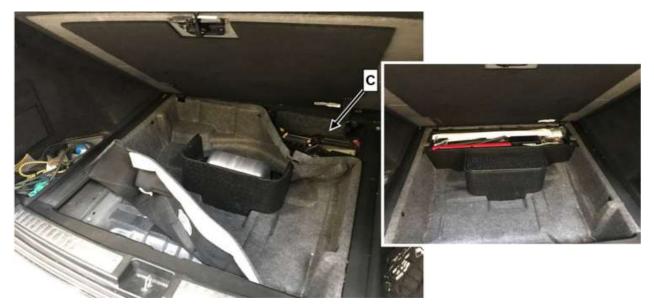
Figure 3

- **1.** Lift right front felt insert (C, Figure 3).
 - i First remove tool insert.

- **a.** If humidity or water deposits are *not* present in area (C, Figures 3 and 4): Carry out **work procedure A** and install remaining parts.
- b. If humidity or water deposits are present in area (C, Figures 3 and 4): Carry out work procedures A and B.

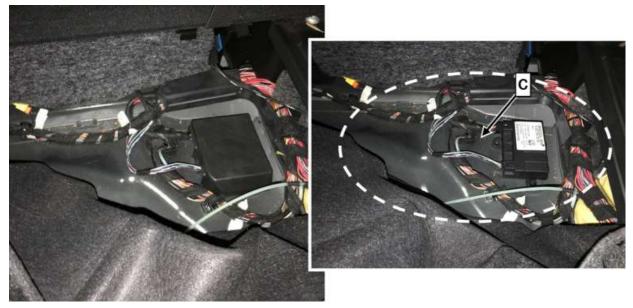
Figure 4

2. Check area around fuel system control unit for humidity or water deposits (C, Figure 4).
