# Recall Campaign Bulletin

Campaign No. 2023010003, February 2023

SUBJECT: **Model GLE/ML and GLE Coupe (166 and 292 platform)**  
**Model Year 2016-2020**

## **Check for Water entry in the Spare Wheel Well**

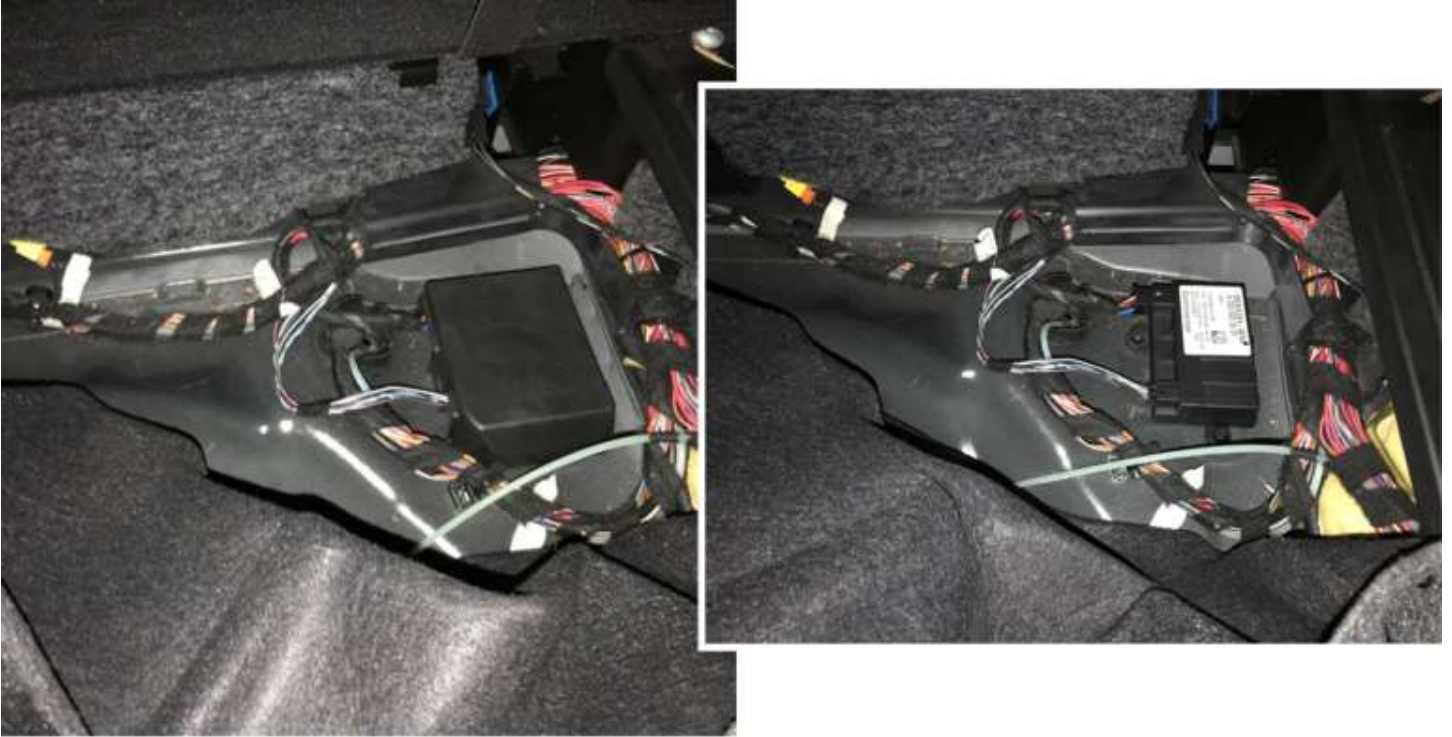
**Figure 6**

1. Replace fuel system control unit (Figure 6).

**i** For basic data, see AR47.20-P-5717GQ.

2. Assemble in reverse order.
-

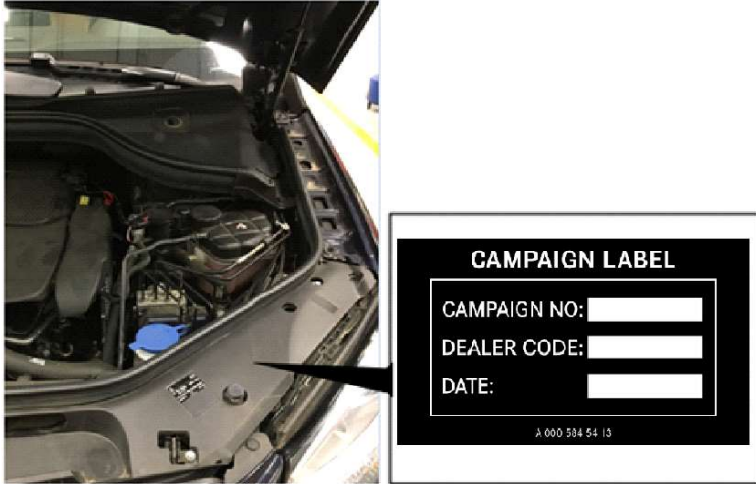
**Figure A**

Apply Proof of Correction Label (A 000 584 54 13) to area identified in **Figure A**. Fill in the blank areas of the label. The "Campaign No." for the California Proof of Correction Label is unique and must be entered as such (230103), your "Dealer Code", and the "Date" of the repair, using a black permanent marker.

**i** Note: Clean bonding surface prior to affixing label.
