R22BU

**SUBJECT: R22BU: Ford 7.3L 100-Gallon Gasoline Supply Line Routing**

## R22BU: Gasoline Supply Line Rubbing Condition on Ford 7.3L

**Models Affected:** Certain model year 2022 and 2023 Blue Bird Visions, equipped with the 7.3L gasoline engine and 100-gallon fuel tank.

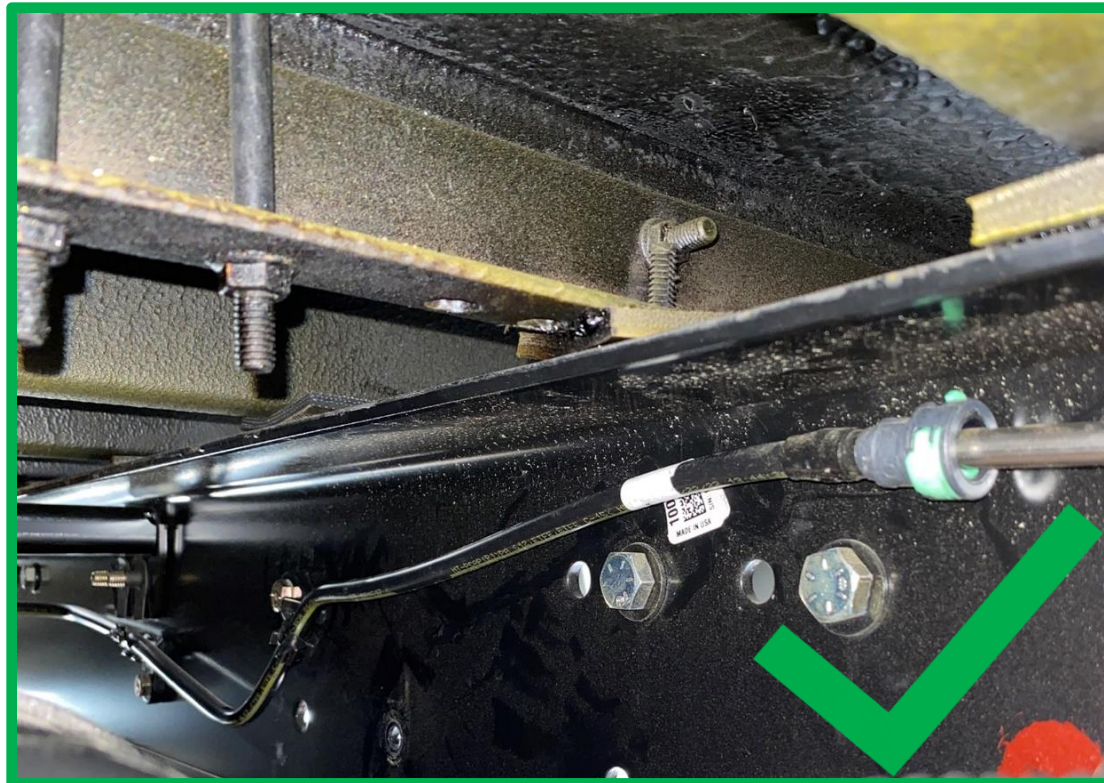
FIGURE 1

**Corrective Action:** Inspect the fuel supply line for proper routing and determine if further action(s) are necessary. Possible corrective actions are relocating clamp position and/or replacement of the fuel supply line. Reference Figures 1-4 for proper routing and securement.

- **Repair A – Inspection Only** - Inspection finds no physical damage to the fuel line, and is routed properly, per Figure 1
  - No action required
- **Repair B – Inspect and Re-route** - Inspection finds no physical damage to the gasoline fuel pressure line, but it is routed improperly

- Remove and replace the fuel line. Ensure proper routing, per Figure 1, 2, 8, and 9 and secure.
    - It may be necessary to re-locate the fuel line anchor on the tank. If so, cut a 1-inch section of Item 2 listed below and secure to the tank. Then secure the line to the bulb seal with Item #1. See Figure 10

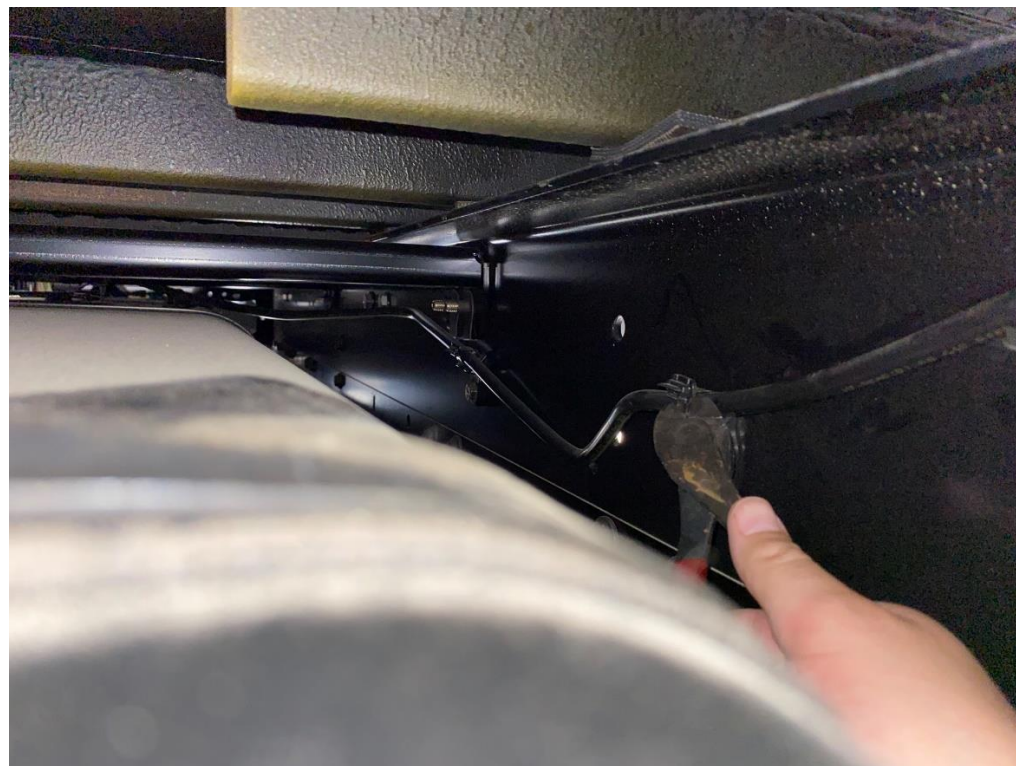
FIGURE 5

**Issue:** Improper routing and securement of the fuel line could cause unintended contact with certain fasteners on the chassis and cause a potential fuel leak.

- Remove tie-wrap securing fuel line, per Figure 5
  - Re-locate, clock, and install tie-wrap anchor, per Figure 6, 7, and 8. If missing, install item 4, 5, and 6 from the parts list below into the location noted in Figure 7.
