Subject: R22CA: LPG Supply Line & RH Park Brake Cable Interference on Ford 6.8L

IMPORTANT SAFETY RECALL NOTICE

NHTSA Recall Number: 22V-736 School Bus

LPG Supply Line & RH Park Brake Cable Interference

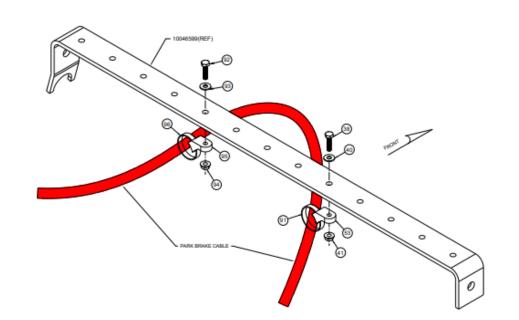
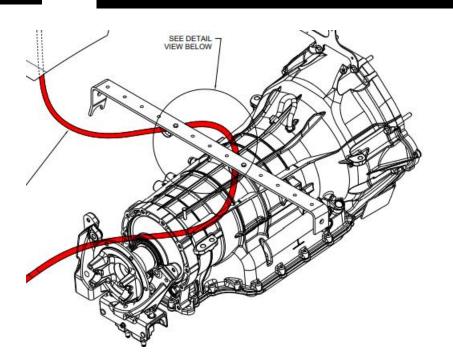
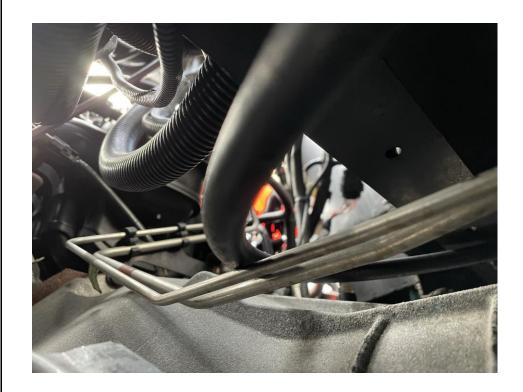
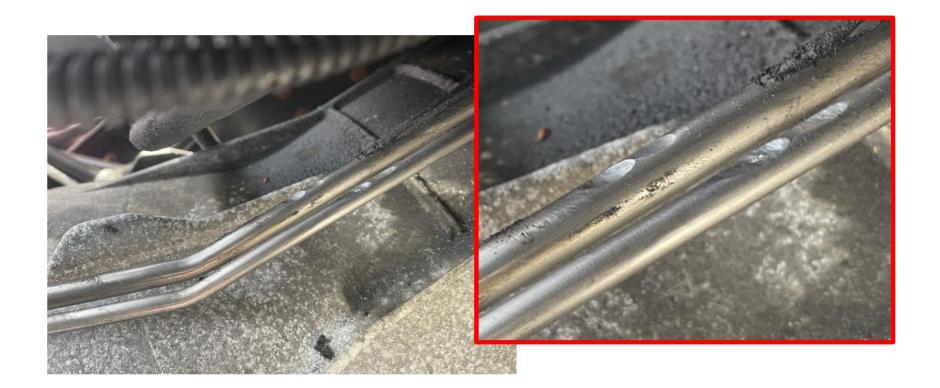
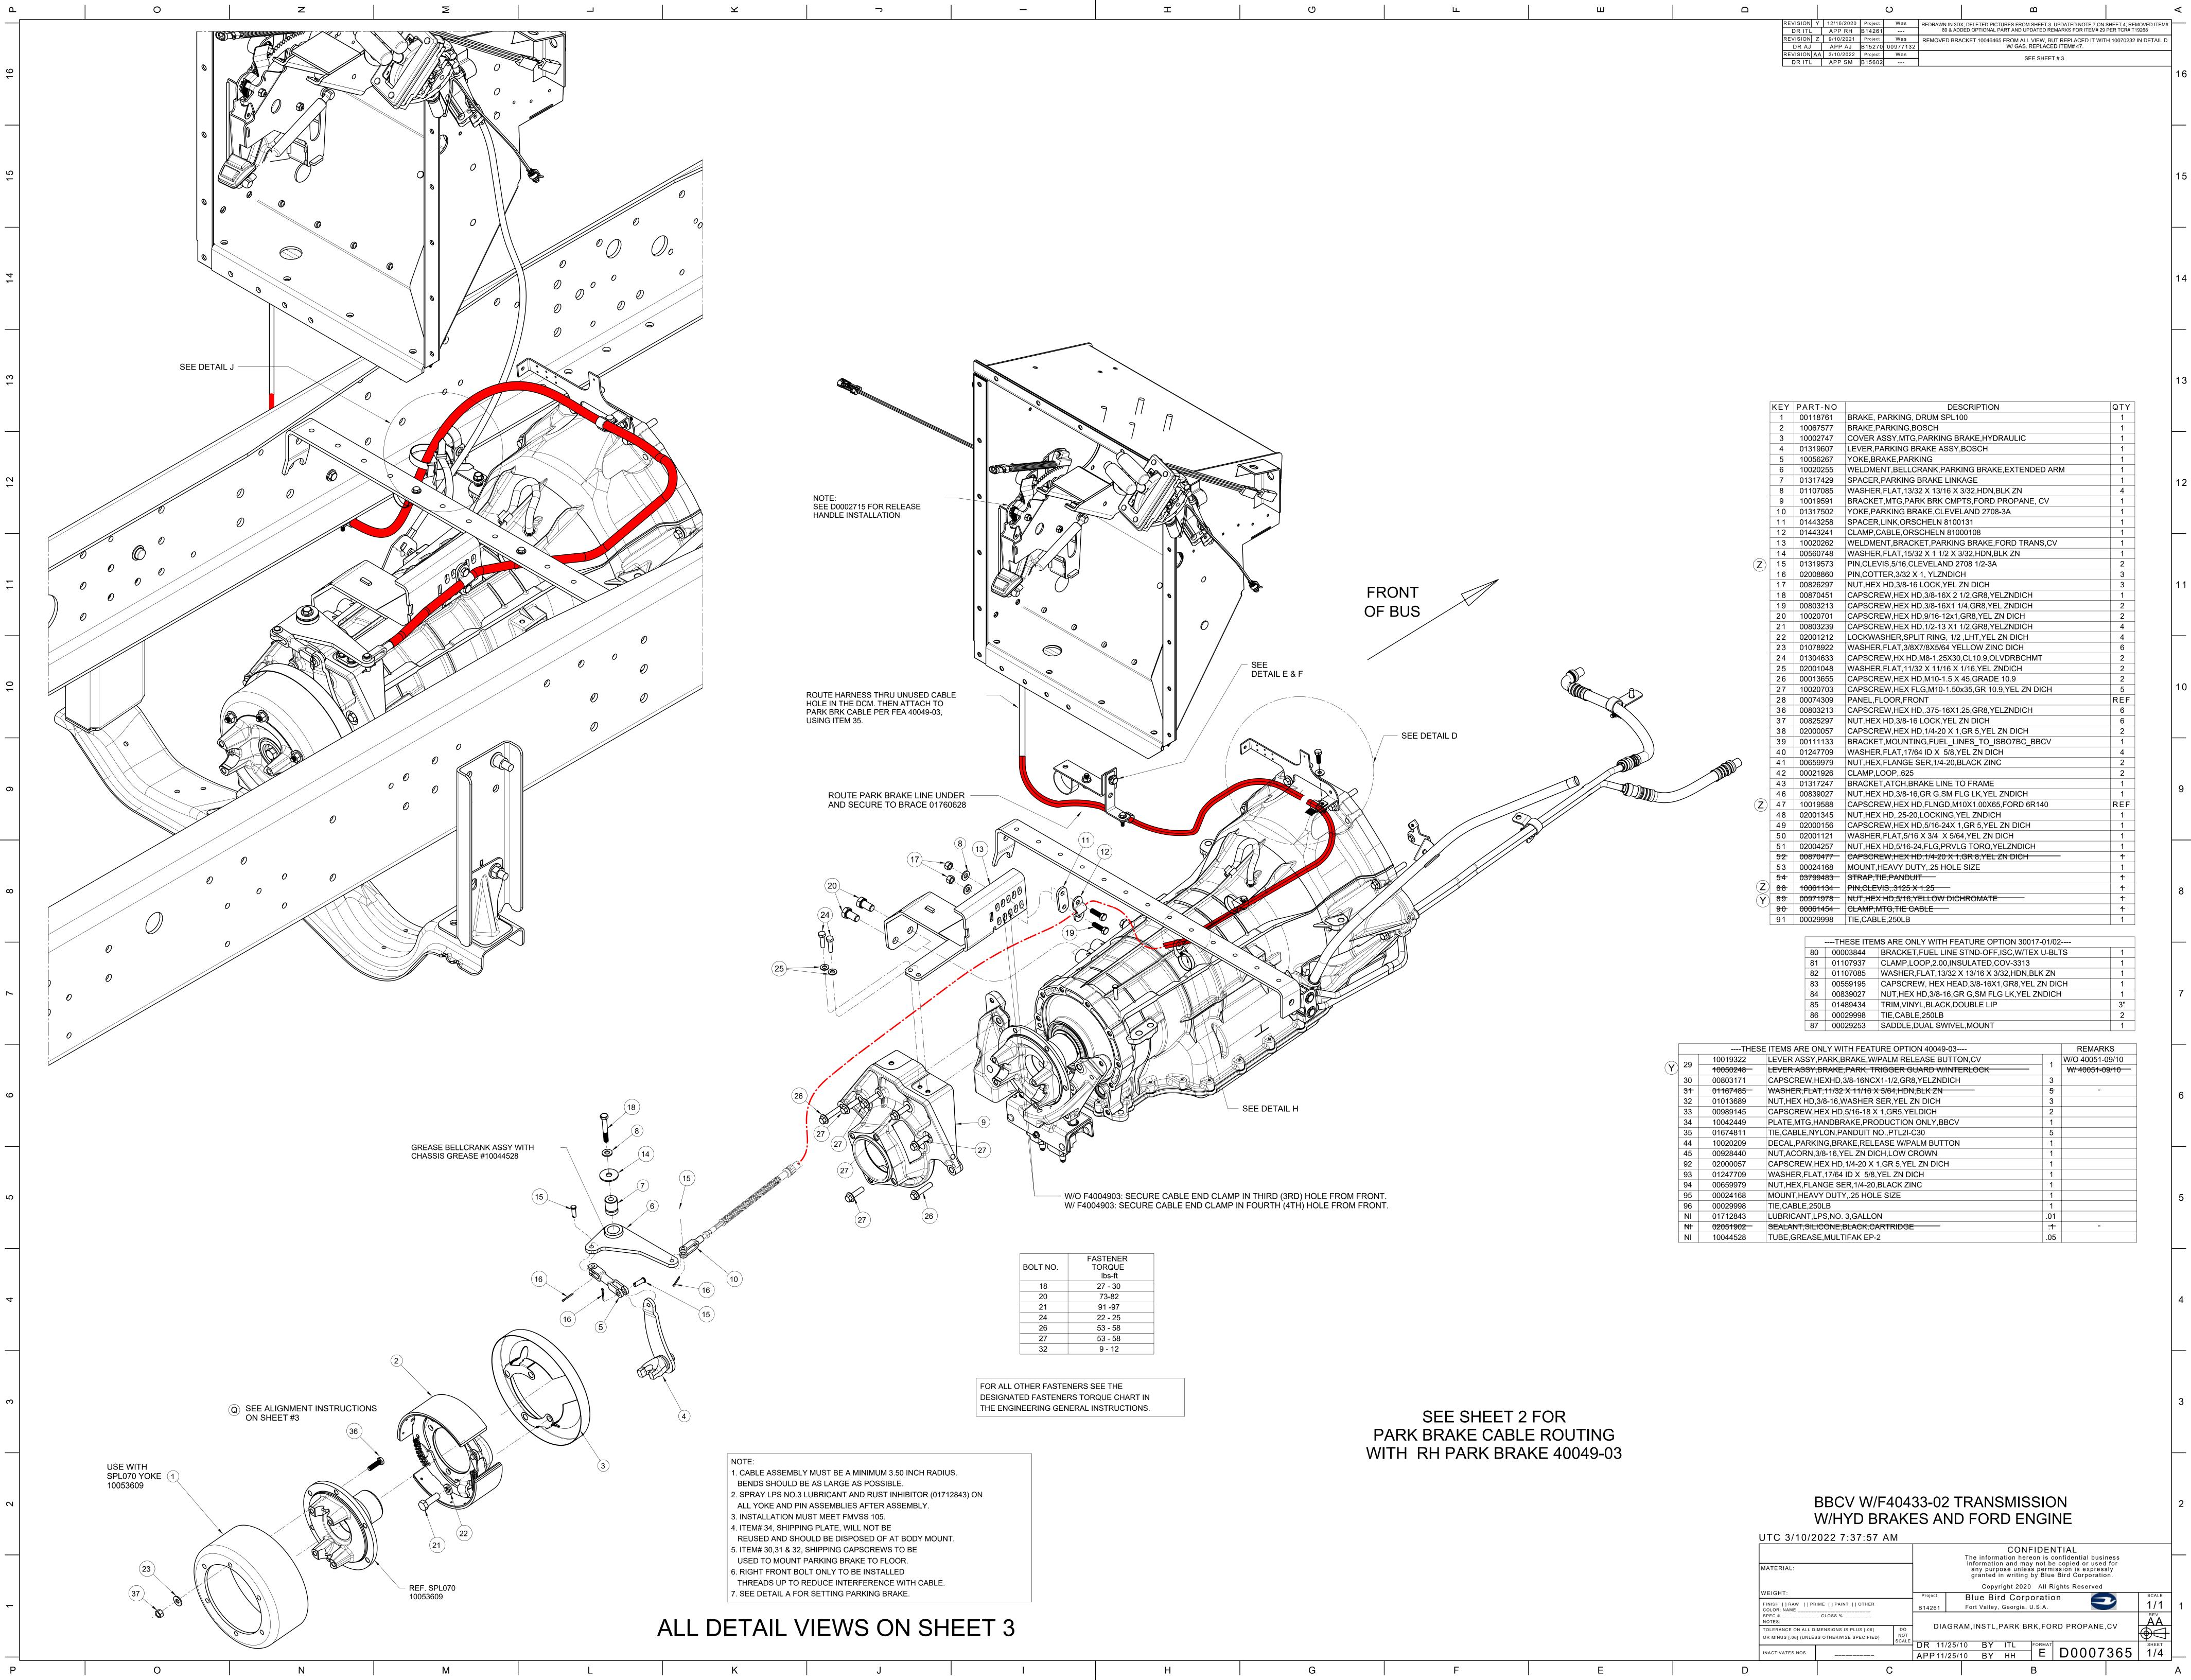
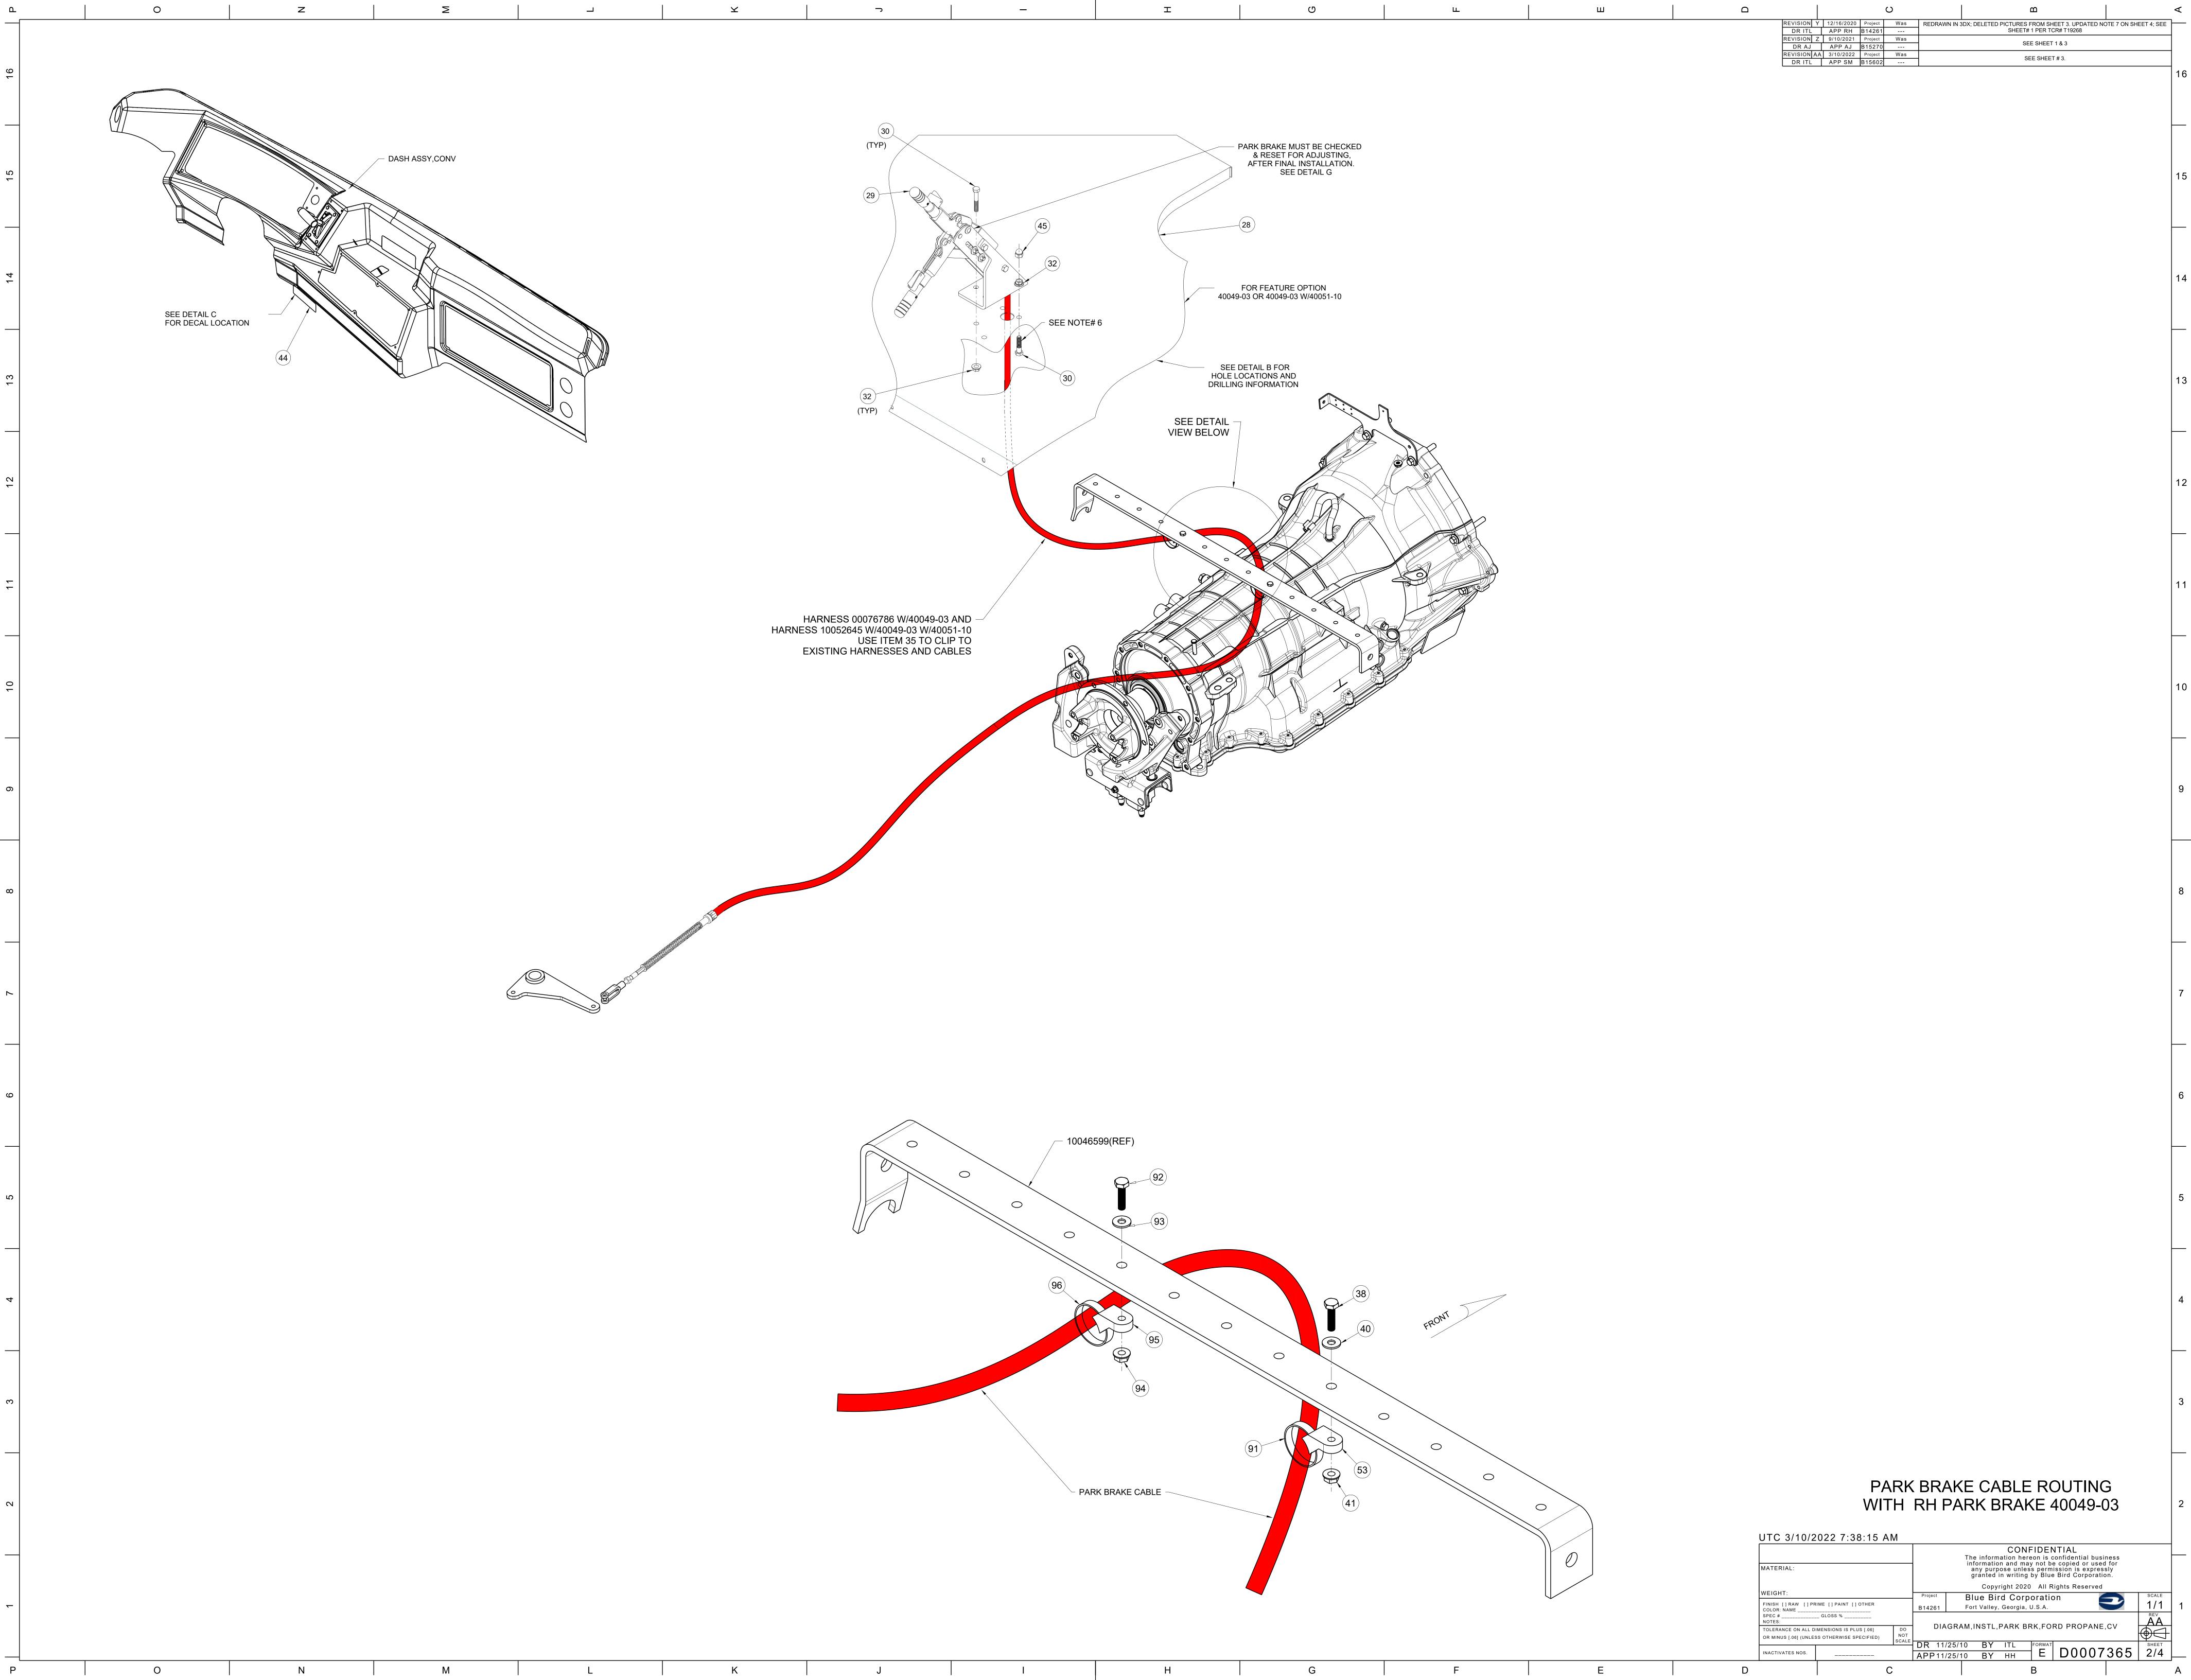
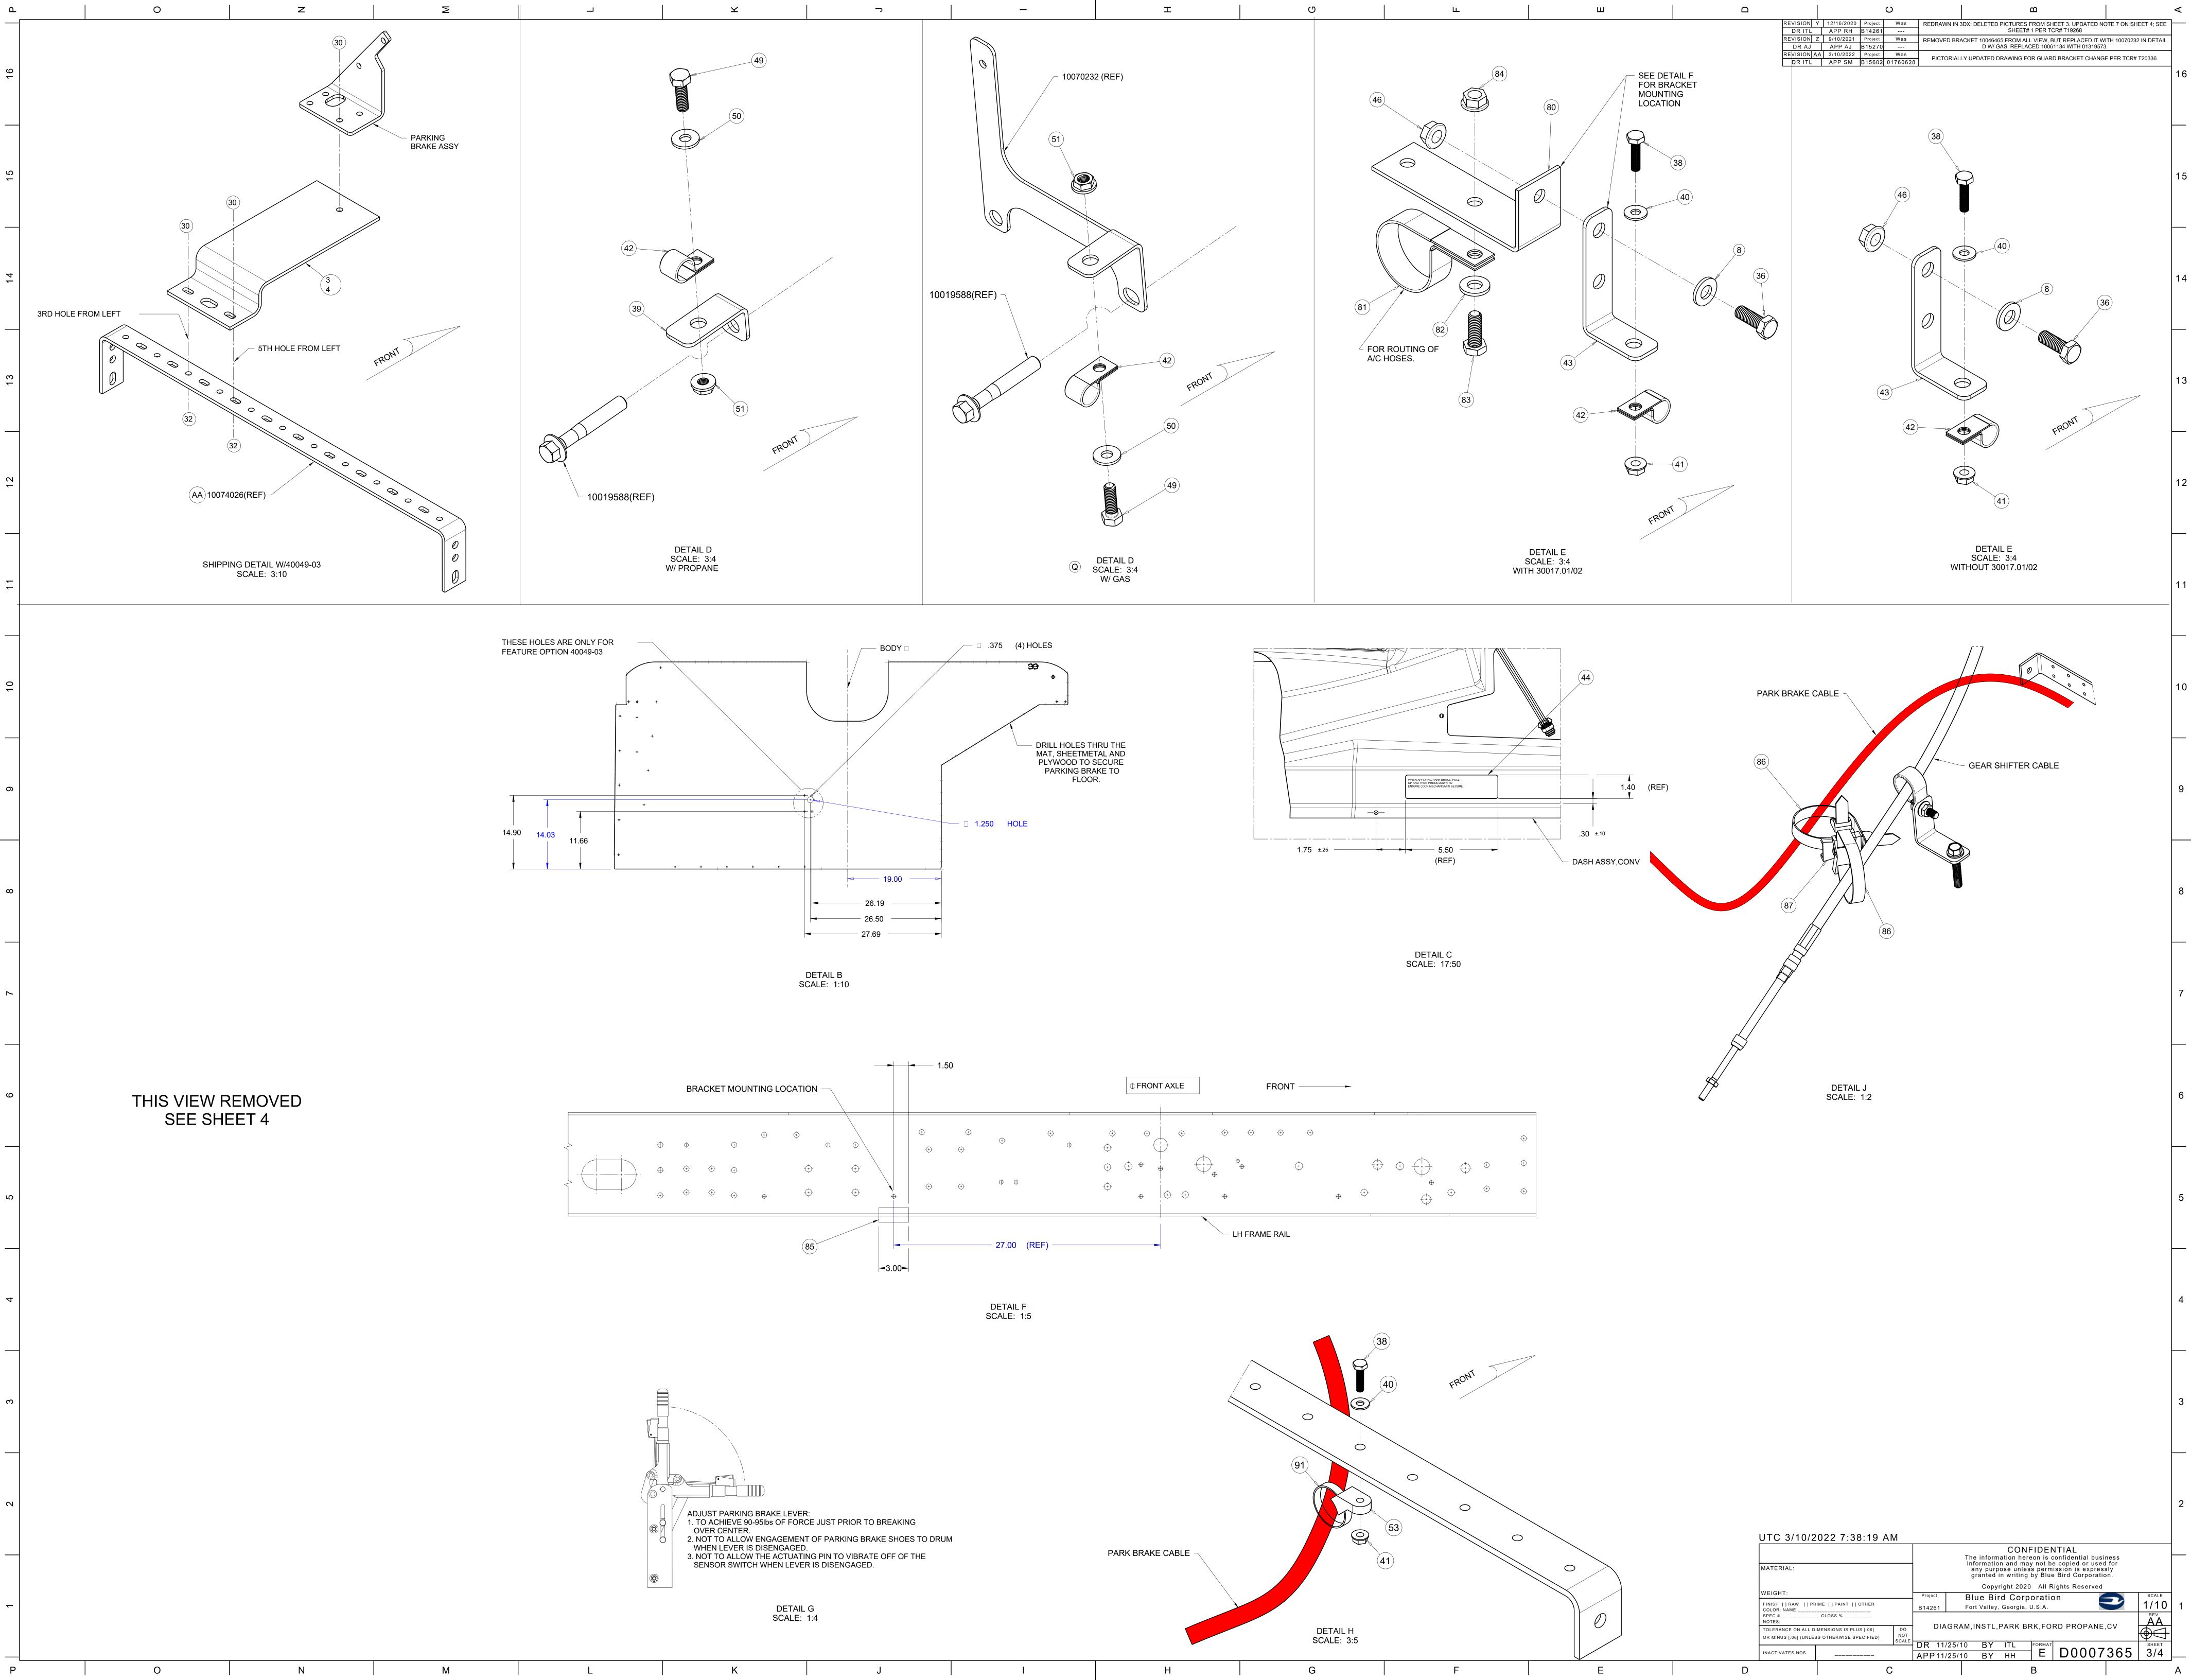
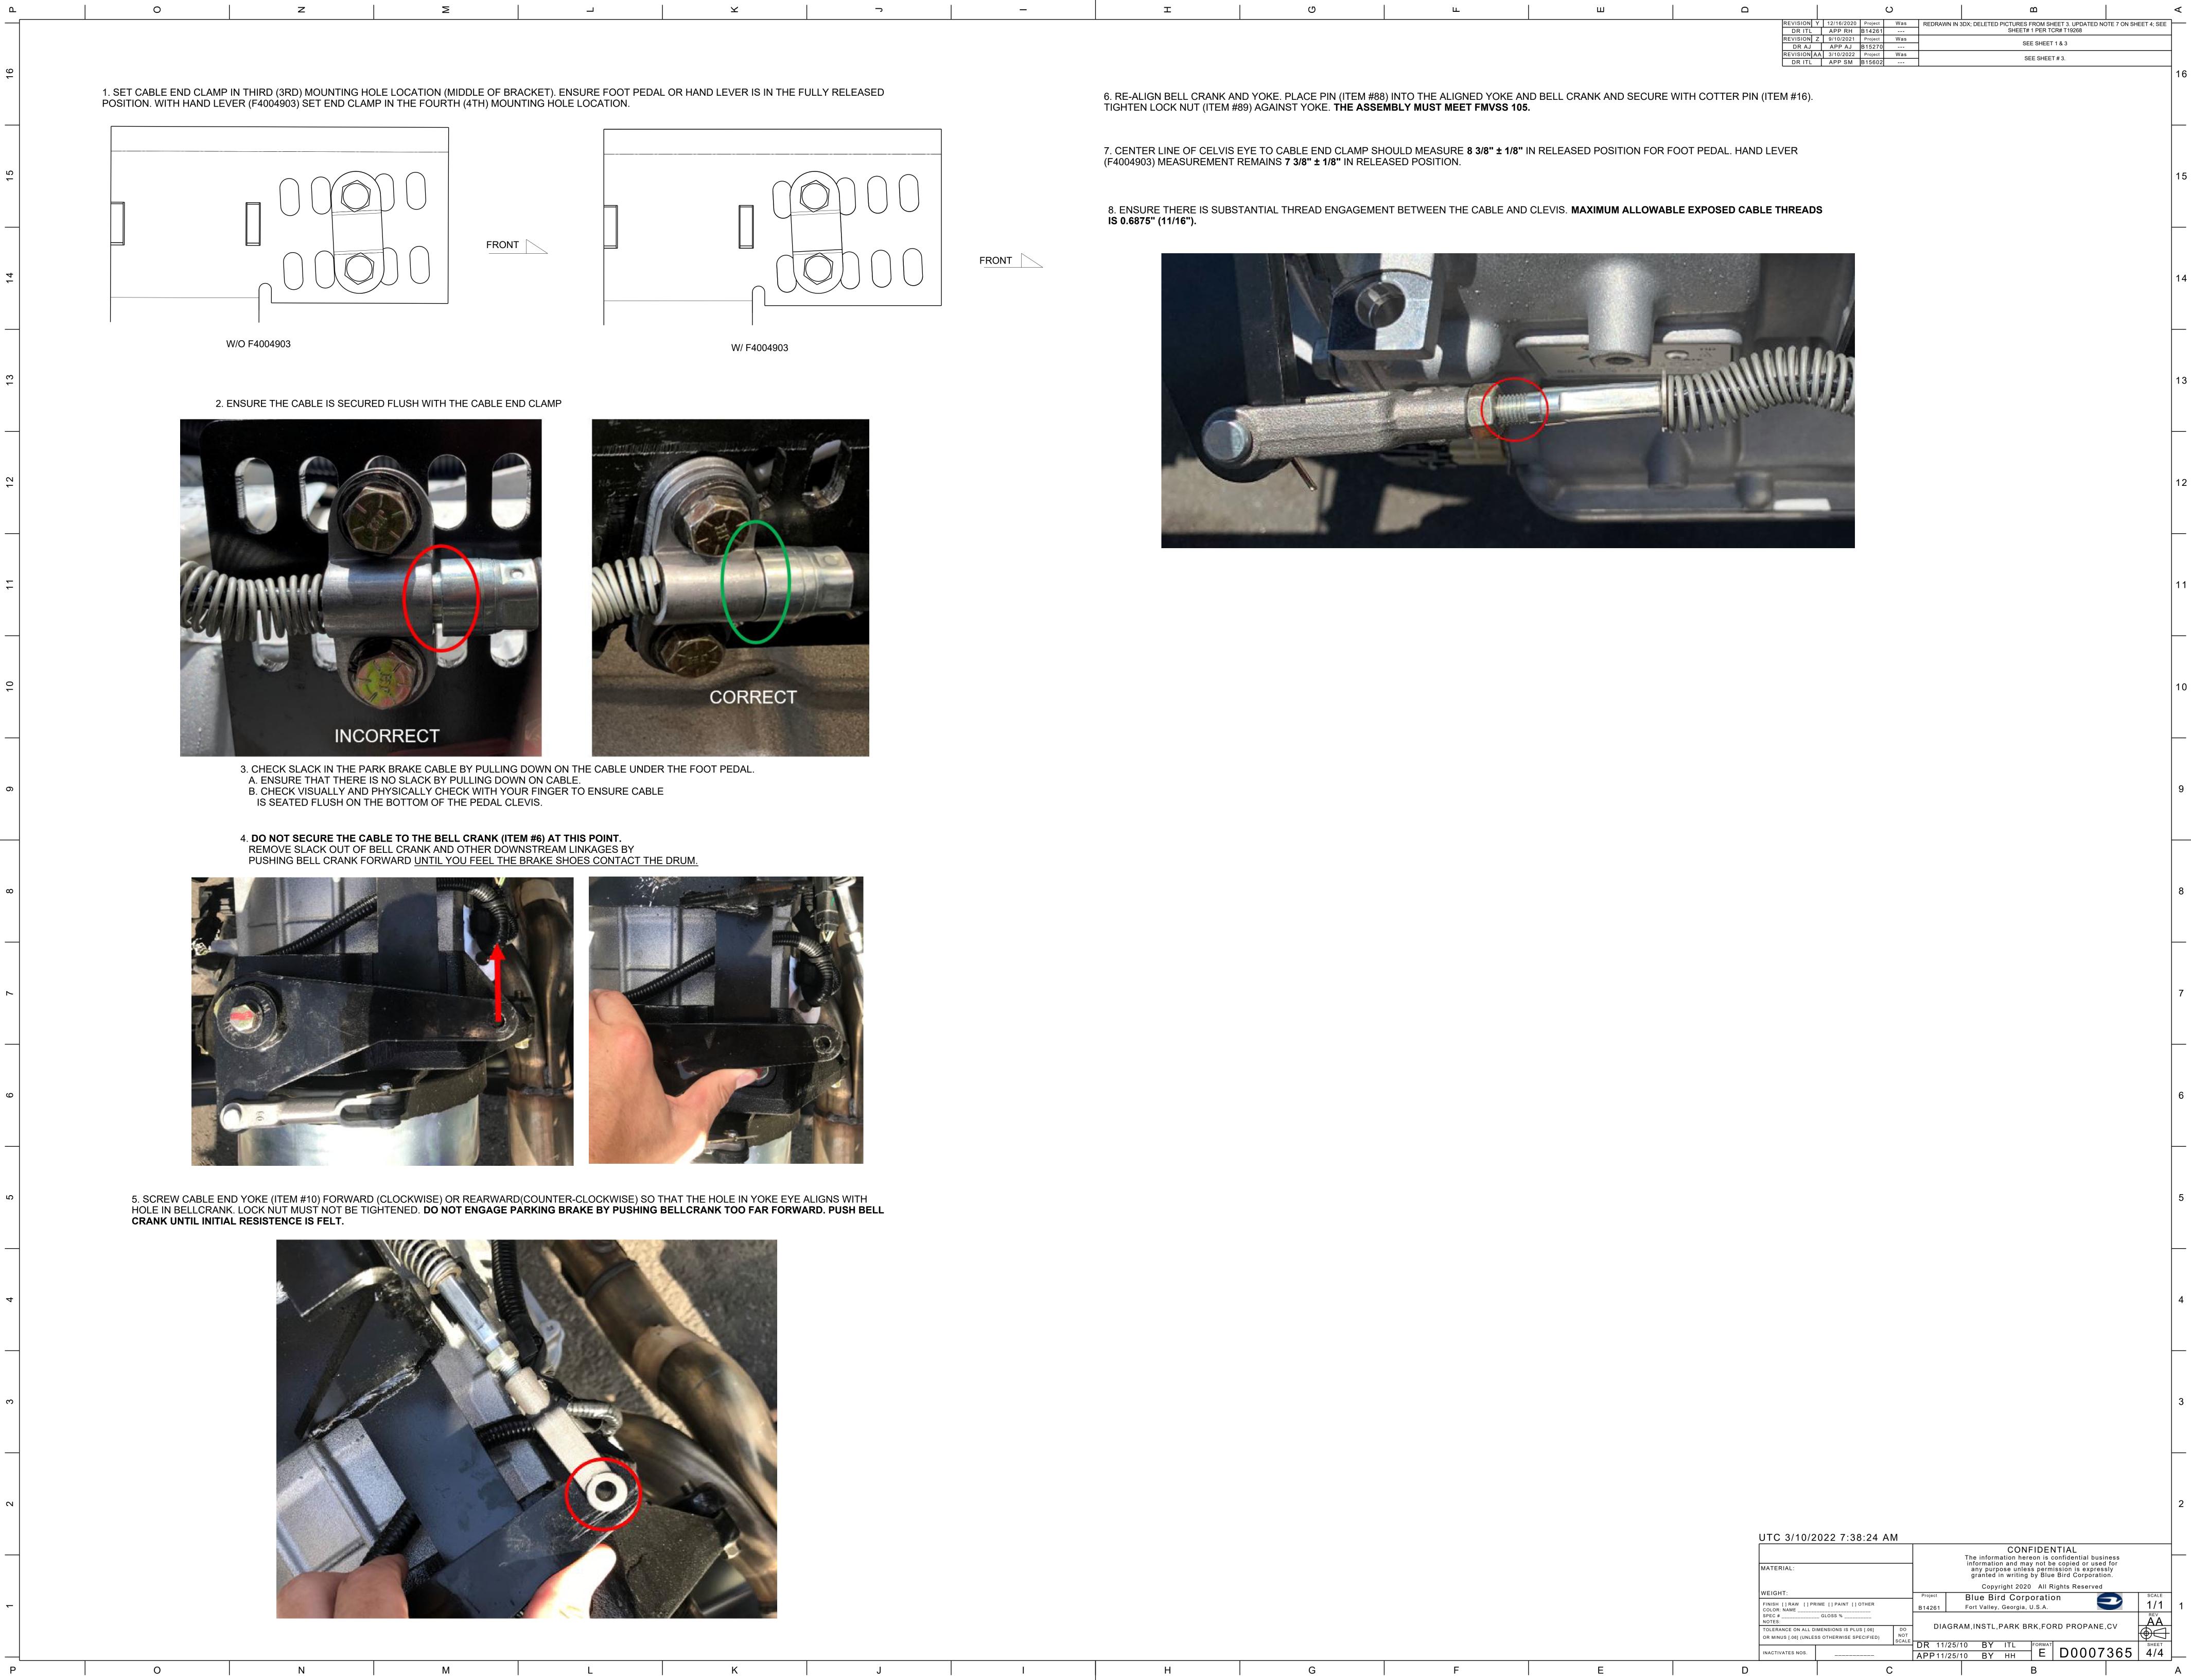
LPG Supply Line & RH Park Brake Cable Interference

Issue: RH mounted park brake lever cable may not be secured and/or routed properly. In certain cases, the park brake cable may lay on the propane fuel lines causing damage. Additionally, an improperly secured RH park brake cable may damage/dislodge the automatic transmission vent which could allow water/dust/debris to enter transmission assembly and cause subsequent damage.

Corrective Action: Inspect unit for proper RH park brake cable routing and securement. If routed and secured per D0007365, no additional action is required. If routing and securement is not per D0007365, re-route and/or re-secure per D0007365.

- Step 1: Inspect suspect area and verify park brake cable is secure. Ensure cable tie mounts are in place & torqued properly to the chassis routing bracket at 76 in-lbs.
- Step 2: Replace and/or re-torque HD cable tie mounts, as necessary.
- Step 3: Ensure transmission vent is in place. Replace if necessary.
- Step 4: Inspect Liquid Propane fuel lines for any damage and replace, as needed.
