N222364860 Driver Front Airbag Inflator May Rupture

Release Date: September 2022 Revision: 00

Condition	General Motors has decided that a defect, which relates to motor vehicle safety, exists in certain front-driver airbag modules produced for use as service replacements in 2011–2012 model year Chevrolet Silverado 1500, Tahoe, and Suburban vehicles and 2011–2012 model year GMC Sierra 1500, Yukon, and Yukon XL vehicles. In these vehicles, the front-driver airbag modules may contain an inflator that was built with a supplier-manufacturing defect that may result in inflator rupture during deployment. An inflator rupture may cause metal fragments to pass through the airbag and into the vehicle interior, which
	may result in injury or death to vehicle occupants.
Correction

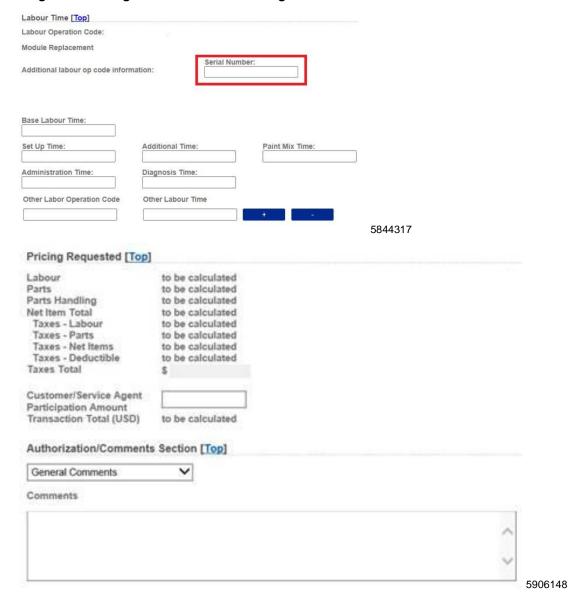
Steering Wheel Airbag Serial Number Recording

Note: Do not discard or destroy the box containing the new steering wheel airbag assembly, it will be used to return the vehicle airbag. *DO NOT DEPLOY ANY AIRBAG*.

Remove the steering wheel airbag assembly. Refer to Steering Wheel Airbag Replacement in SI.

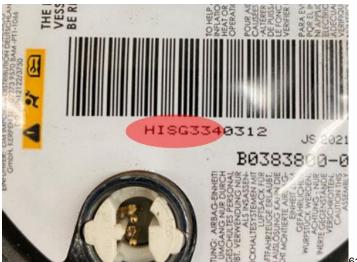
6148316

2. Locate the lot number on the back of the airbag inflator.

- If the lot number begins with HISG334 or HITG334, proceed to step three.
- If the lot number **does not begin** with HISG334 or HITG334, no further action is required. Reinstall the steering wheel airbag assembly. Refer to *Steering Wheel Airbag Replacement* in SI.

- Record the serial number of the removed Steering Wheel Airbag.
- 4. Record the serial number of the New Service Steering Wheel Airbag.
- Replace the steering wheel airbag assembly. Refer to Steering Wheel Airbag Replacement in SI. Do Not Deploy the AIRBAG.
