PREVOST

**SAFETY
RECALL**

SR22-05C

DATE :	September 2022	SECTION :	06 ELECTRICAL
SUBJECT:	ALTERNATOR BELTS REPLACEMENT

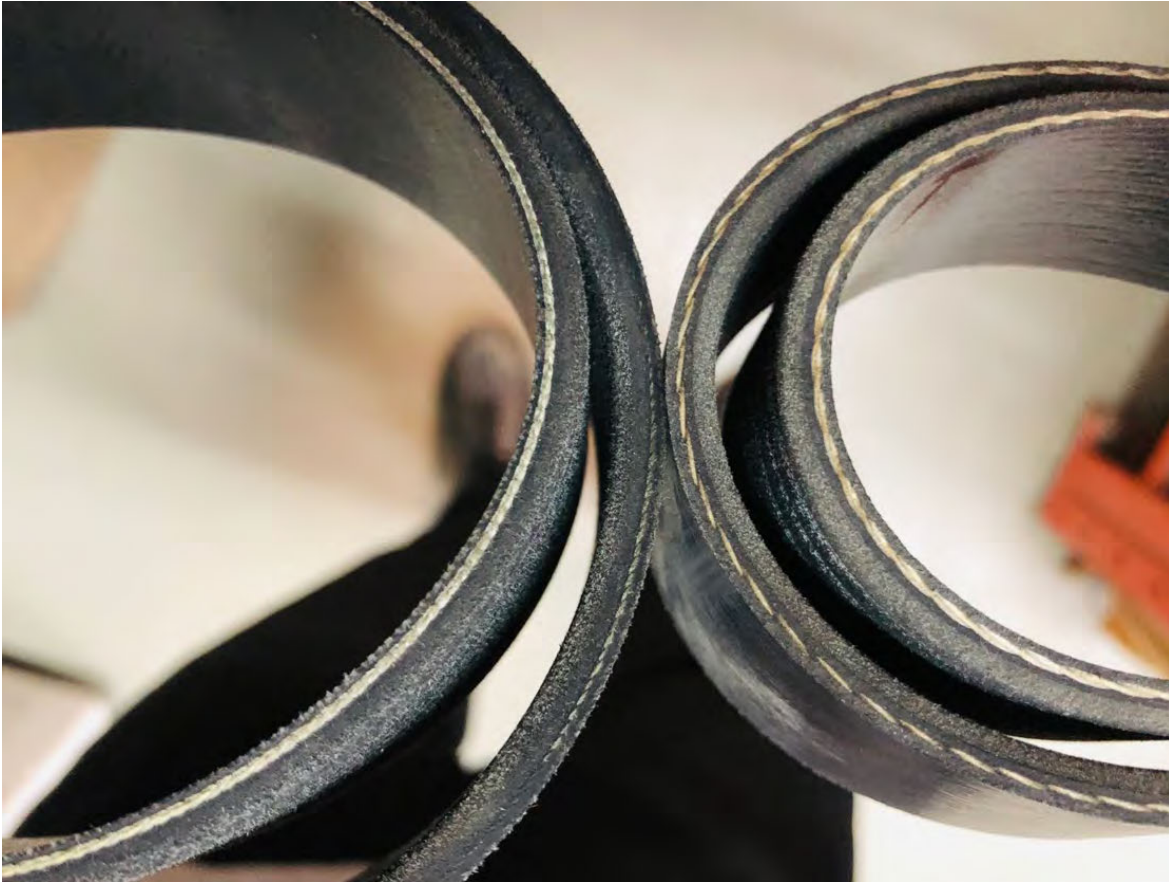
Aramid reinforced cord belt (left) vs new polyester cord belt (right).

7. Inspect the alternator belt(s) (refer to the picture above).
 - If the belts are polyester reinforced reinstall them.
 - If the belts are reinforced with aramid cords, complete the inspection and replace them with new polyester belts (see interchange table).
8. Reverse the procedure to reinstall the other belts on the vehicle.

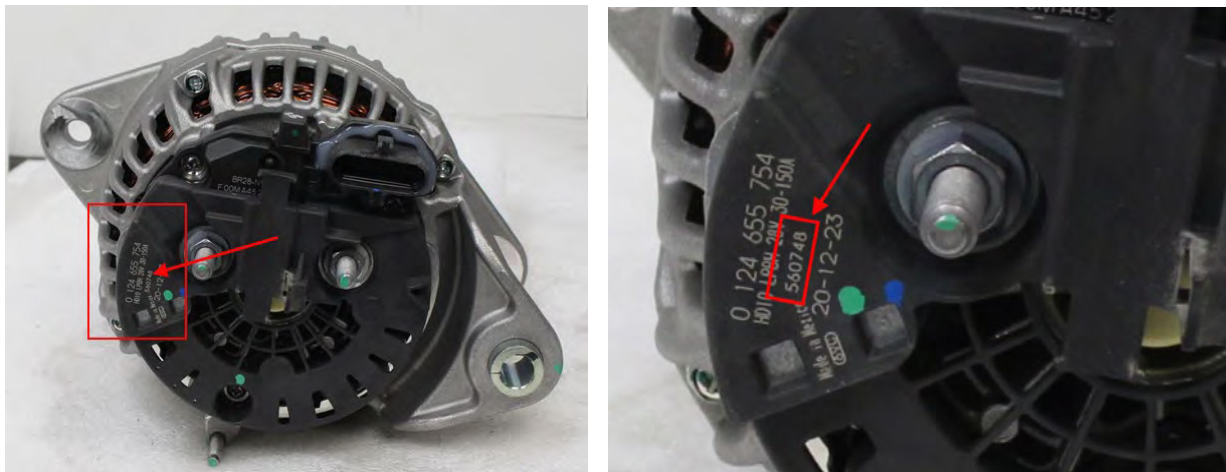
- BOSCH HD10 OEM alternator will have a Prevest part number stamped on the back cover (as well as Bosch part numbers).

- These identification marks (numbers) can either be printed in white or stamped/molded in the plastic cover (150amp HD10 with white marking shown).

- Slack the manual adjustment screw.
 - Remove the tensioner.
 - Remove the belts.
4. Remove the water pump belt.
 5. Remove the right hand alternator(s) belt.
 6. Spin all alternators and make sure no bearing noises are coming from the alternator(s). Replace alternator(s) as needed (Only OEM alternator(s) with noisy bearings are covered by this safety recall; See *OEM Alternator Identification* below).

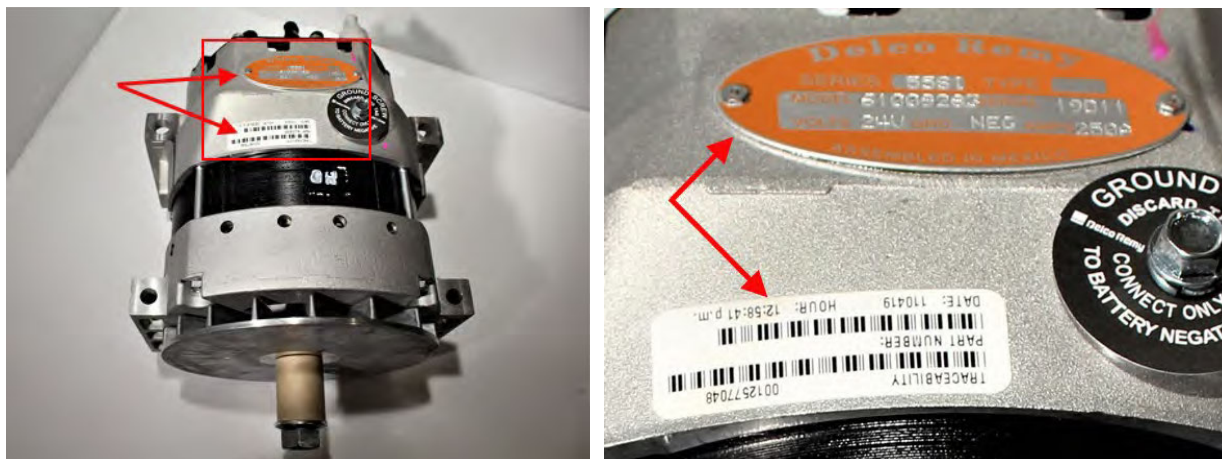
- REMY 55S Alternator will have a Delco-Remy identification plate riveted to the body as well as a bar code sticker next to the ground stud as shown.
