**PREVOST**

**SAFETY  
RECALL**

**SR22-05B**

DATE :	September 2022	SECTION :	06 ELECTRICAL
SUBJECT:	ALTERNATOR BELTS REPLACEMENT

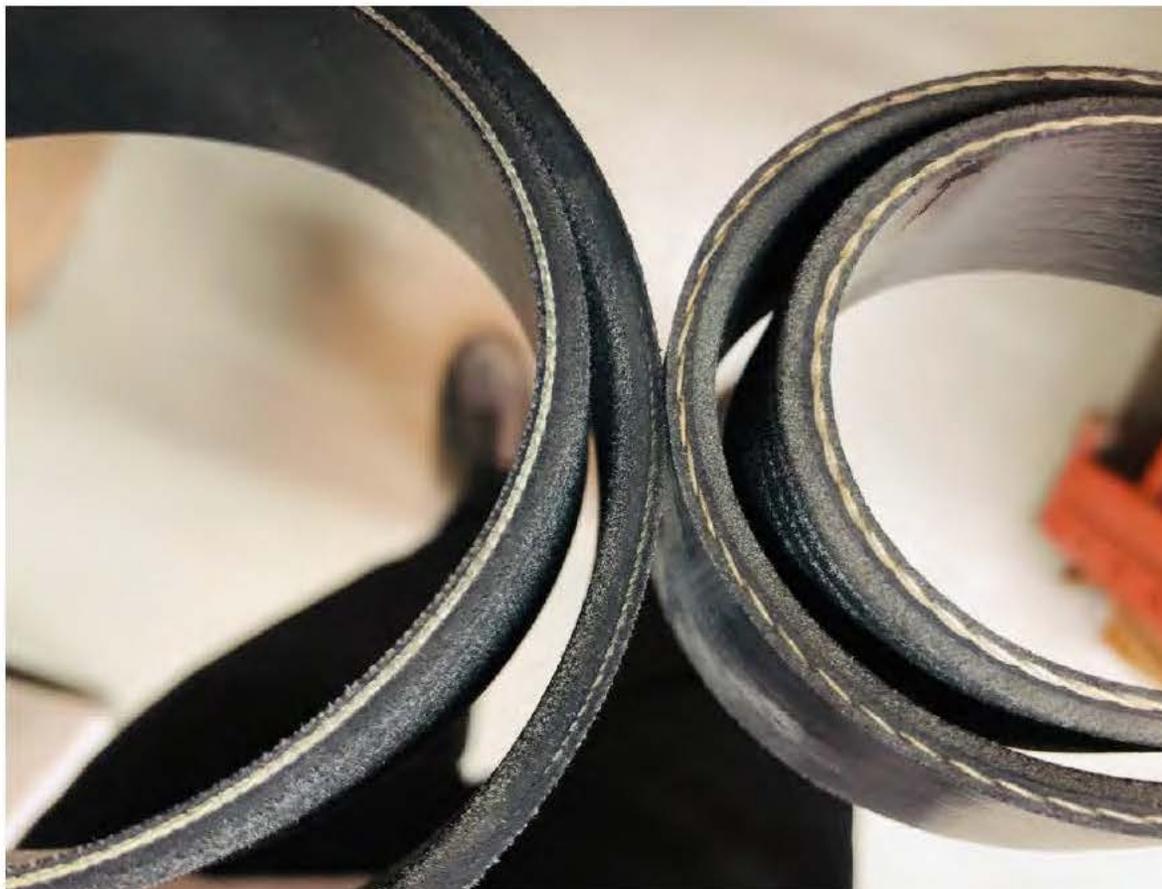
**Aramid reinforced cord belt (left) vs new polyester cord belt (right).**

7. Inspect the alternator belt(s) (refer to the picture above).
  - If the belts are polyester reinforced reinstall them.
  - If the belts are reinforced with aramid cords, complete the inspection and replace them with new polyester belts (see interchange table).
8. Reverse the procedure to reinstall the other belts on the vehicle.

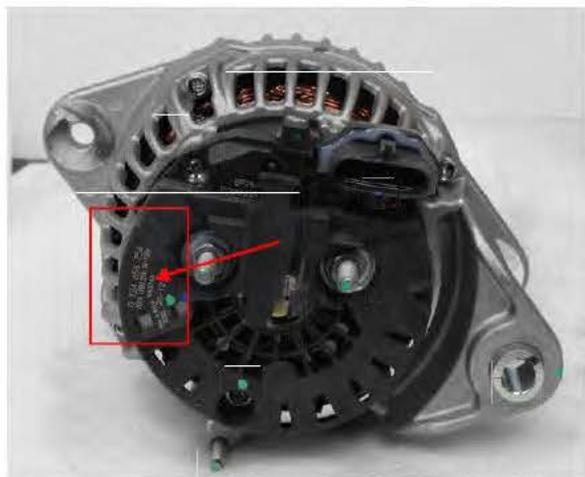
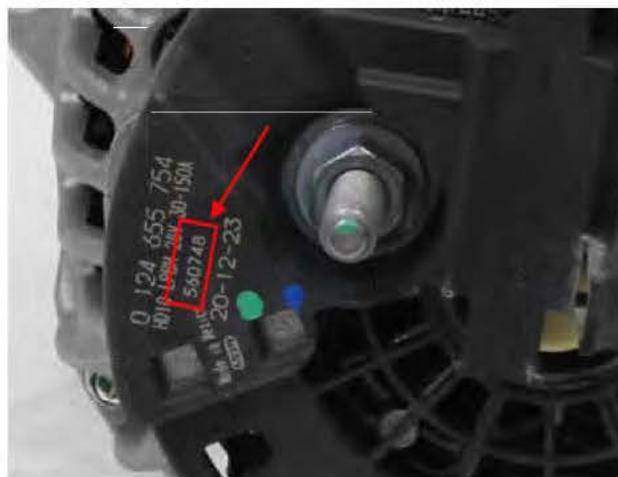
##### BOSCH HD10

- **BOSCH HD10 OEM alternator will have a Prevest part number stamped on the back cover (as well as Bosch part numbers).**

- These identification marks (numbers) can either be printed in white or stamped/molded in the plastic cover (150amp HD10 with white marking shown).

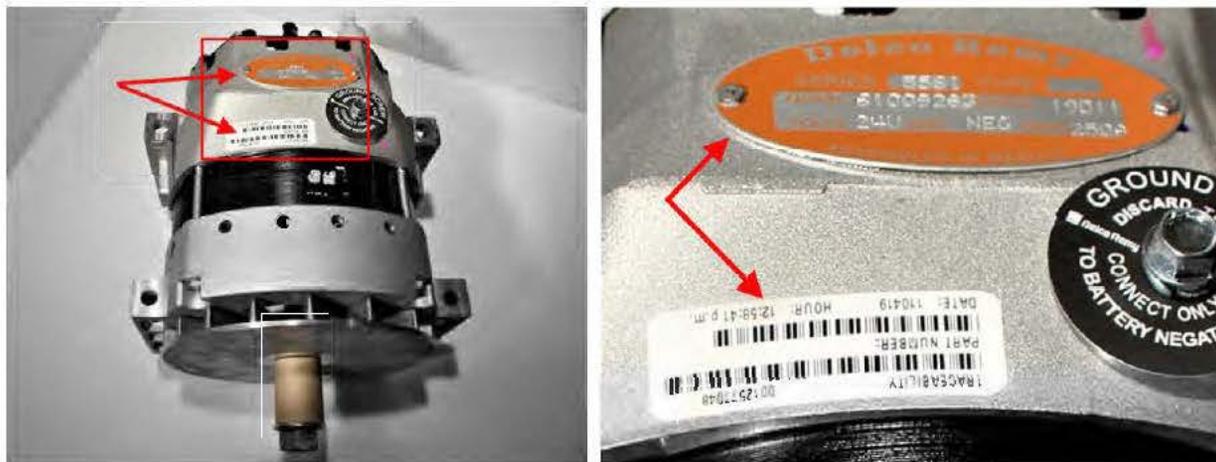
### REMY 55S

- REMY 55S Alternator will have a Delco-Remy identification plate riveted to the body as well as a bar code sticker next to the ground stud as shown.
