# Product Safety Recall

## N212356050 Driver Seat Improper Weld

**Release Date:** June 2022 **Revision:** 01  
**Revision Description:** The customer letter has been added to this bulletin. Please discard all previous copies of bulletin N212356050.

<b>Condition</b>	General Motors has decided that a defect, which relates to motor vehicle safety, exists in certain 2021 model year Chevrolet Malibu and 2022 model year Chevrolet Blazer, Equinox, and Cadillac XT4 vehicles. The driver's seat cushion frames in these vehicles may have an improper weld in the power tilt-adjustment mechanism. These improper welds may degrade management of occupant loads in certain crashes, which may increase the risk of injury for some occupants seated in the affected driver's seats.
<b>Correction</b>	Dealers will inspect the driver's seat and replace the cushion frame as necessary.

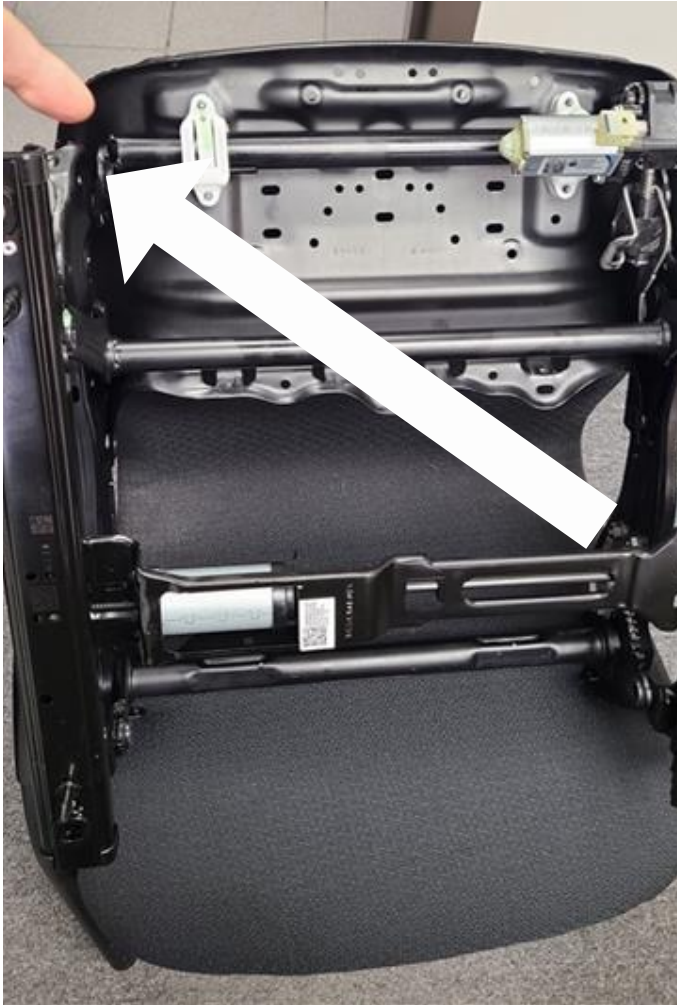
6081071

1. Remove the four seat attachment bolts. Refer to *Front Seat Removal and Installation* in SI.
2. Lay the seat back in the vehicle allowing access to the inboard (center of vehicle) side of the front seat cushion frame.

3. Locate the inboard (center of vehicle) end of the seat tilt tube where it meets the welded-on bracket (the tilt tube is mounted to the seat pan with white or black nylon pivots).

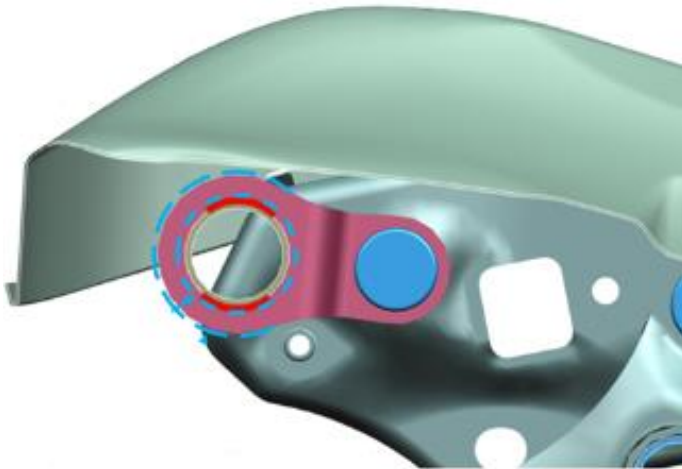
6081072

**Good Tilt Tube Example 1**

4. Inspect the area where the tilt tube goes through the bracket and ensure it is fully inserted, flush (or slightly proud) of the bracket and appears to be correctly assembled.

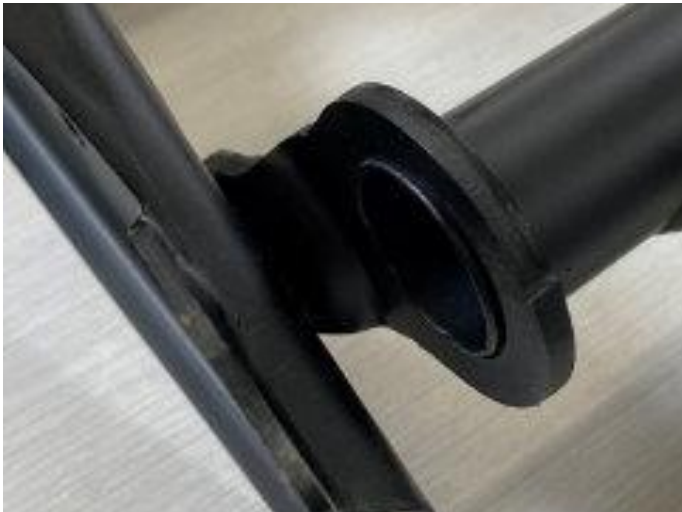
6081073

**Good Tilt Tube Example 2**

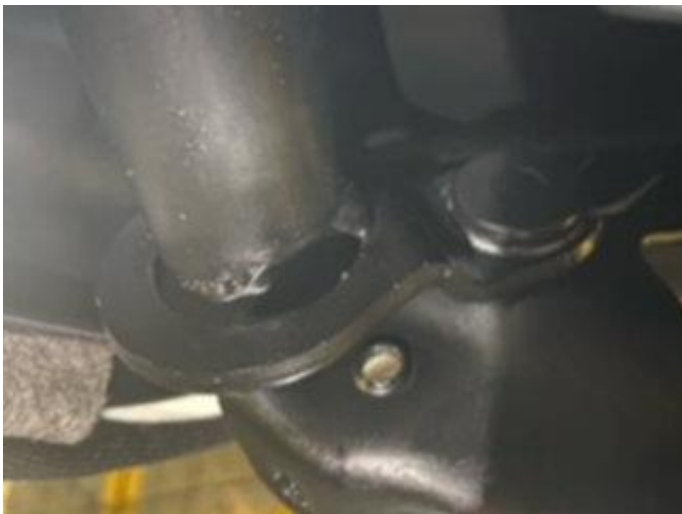
6081074

**Not Acceptable Tilt Tube Example 1**

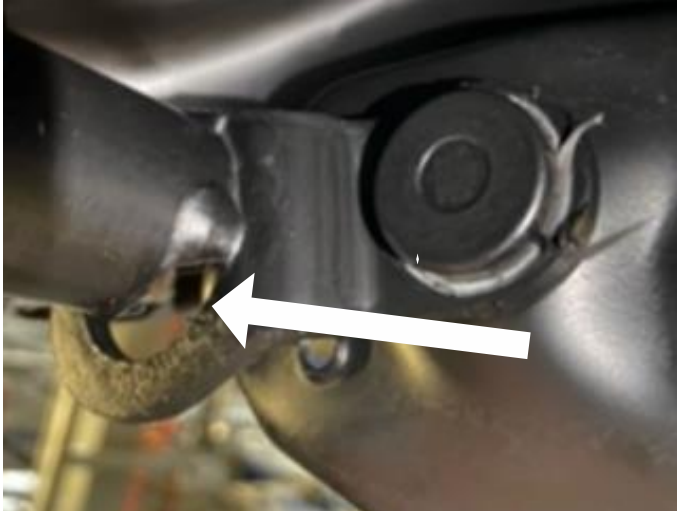
6081075

**Not Acceptable Tilt Tube Example 2**

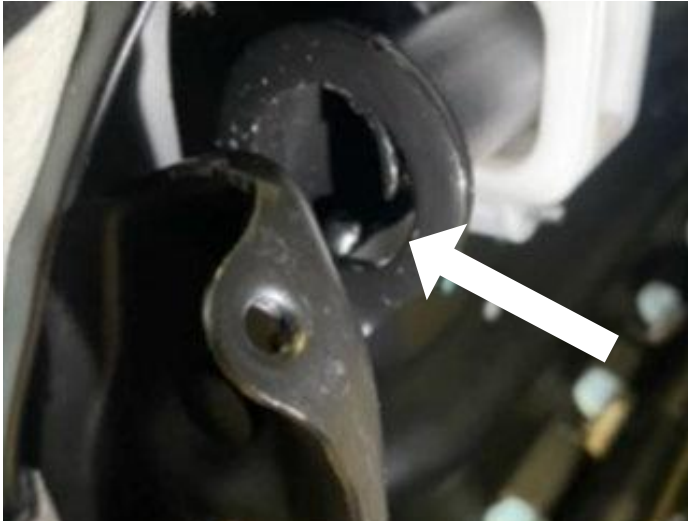
6081076

**Not Acceptable Tilt Tube Example 3**

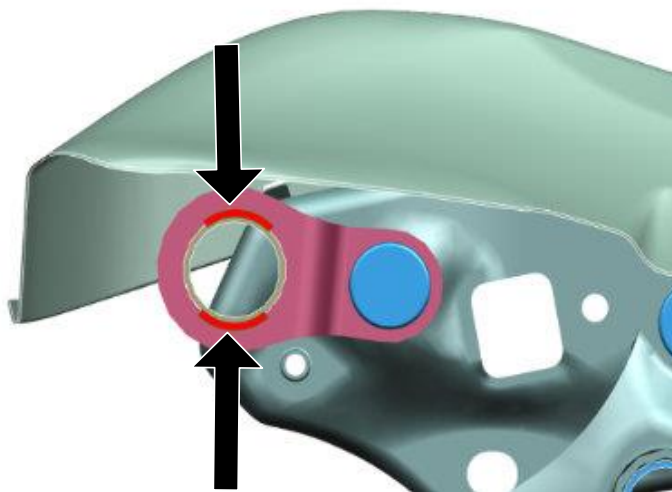
6081077

Good Weld Example 1, red area represents correct length for both welds.

5. Inspect the two semi-circular welds that secure the tilt tube to the bracket and ensure they are complete, sound and that there is no “burn through” causing a void or hole in the tilt tube or bracket.
6. If the welds and tilt tube assembly are correct, no further action is required, reinstall the seat. Refer to *Front Seat Removal and Installation* in SI.
7. If the seat tilt tube or bracket show any weld defects, missing welds or the seat tilt tube is not correctly assembled to the bracket, replace the front seat cushion frame assembly. Refer to *Front Seat Cushion Frame Replacement* in SI.

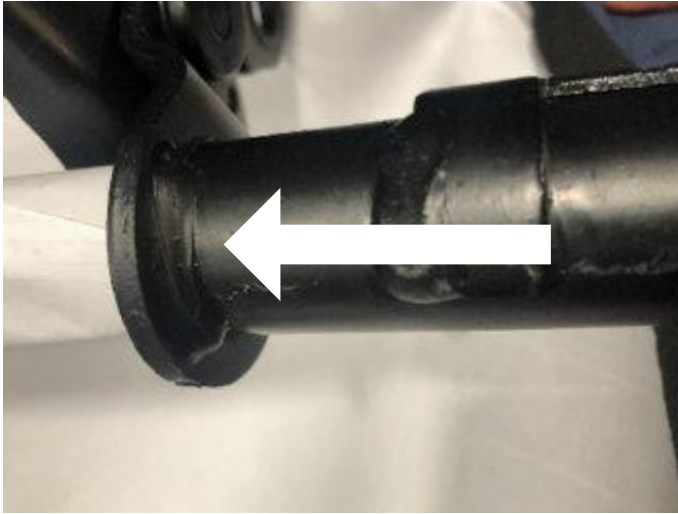
6081078

Good Weld Example 2

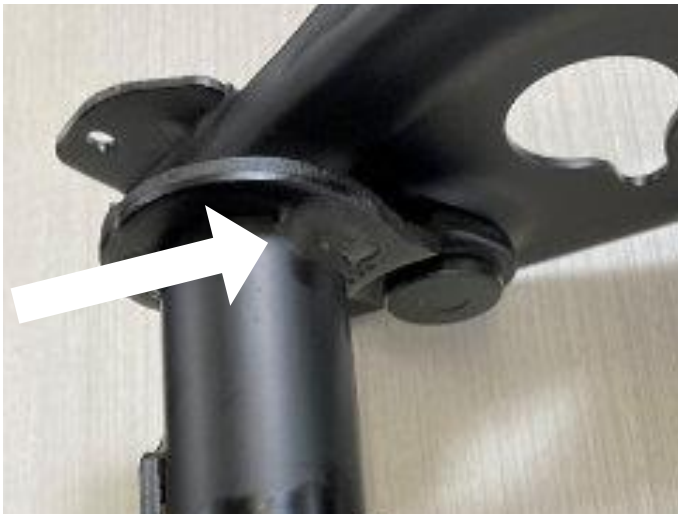
6081079

Good Weld Example 3

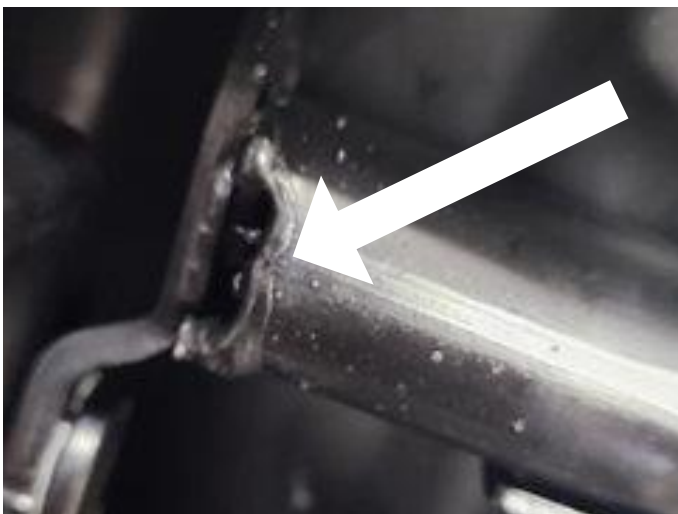
6081081

Bad Weld Example 1, burn through.

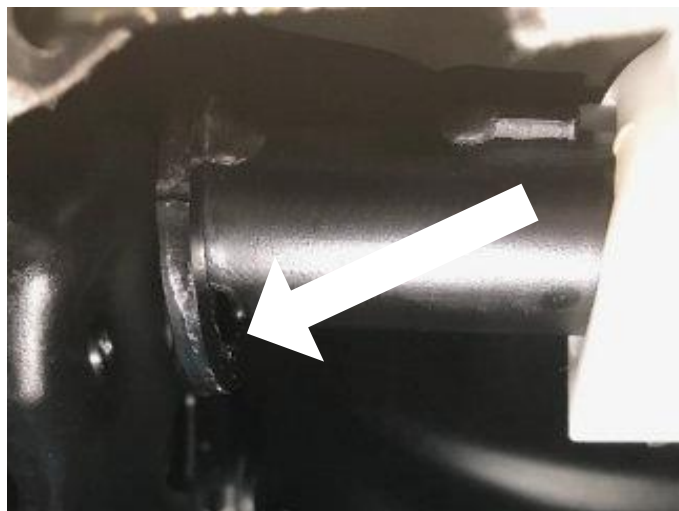
6081082

#### **Bad Weld 2, missing/incomplete weld.**
