## IMPORTANT SAFETY RECALL

This notice applies to your upper vehicle seat covers models [T62213BLK](#) and [T62131BLK](#)  
NHTSA Recall No. [\[YY-000\]](#)/[\[MFR Recall No\]](#) [\[000\]](#)

## T62131 / T62213 SHORT TERM REPAIR INSTRUCTIONS

## T62131 / T62213 SEAT BACK COVER REMOVAL INSTRUCTIONS

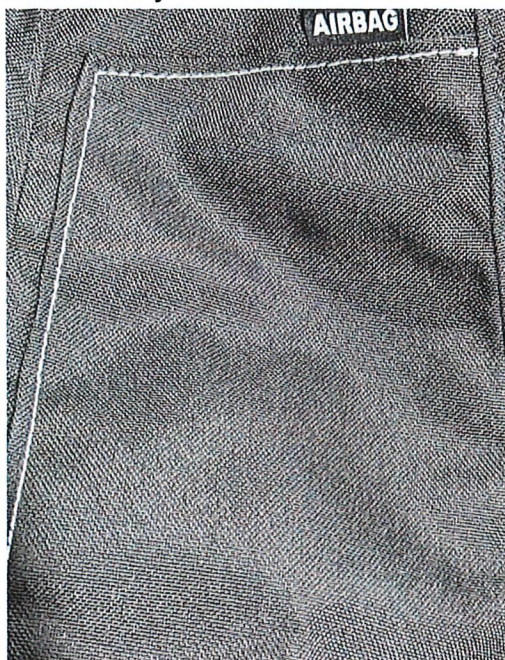
This is a noncompliant side flap. The stitches are compact, close together and have a very short stitch length.

This thread is more dense and has a higher tensile strength than the correct thread.

TigerTough is providing a free replacement seat back cover to replace the one that you purchased. The product will look identical when received and it should take less than 10 minutes to install the replacement seat cover. If you purchased this seat cover as a large batch for a commercial customer, TigerTough will send you the number of seat covers in your original order. **Because of the safety nature of this recall, you must notify all vehicle owners who had this seat cover installed.**

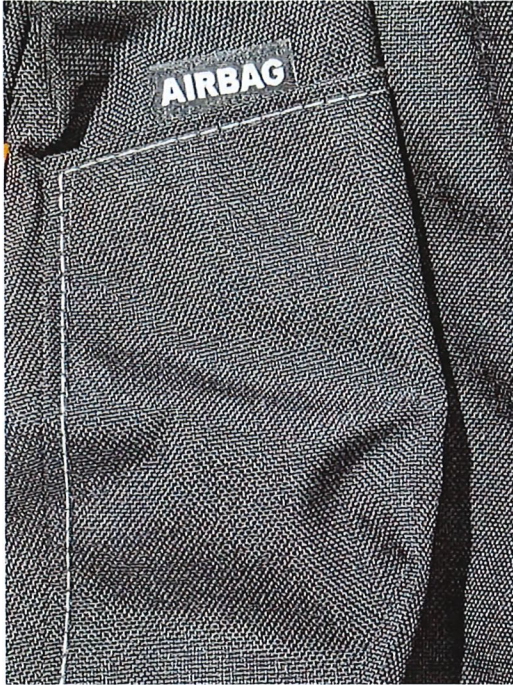
This is a compliant side flap. The stitch length is much longer, less compact and less tension. This thread is less dense than the noncompliant thread.

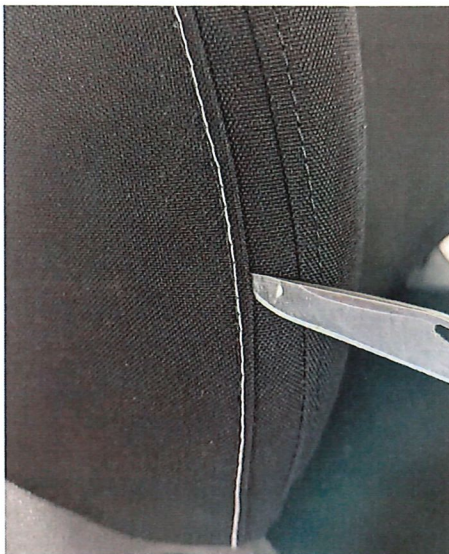
Insert a knife or scissors between the airbag tearway and the seat cover.

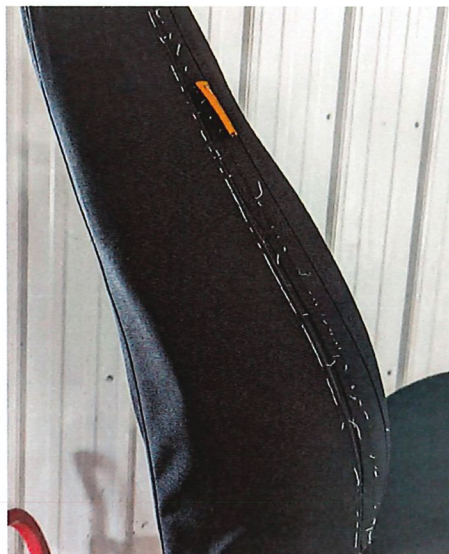
Cut all of the white thread so that the seam is allowed to come open.

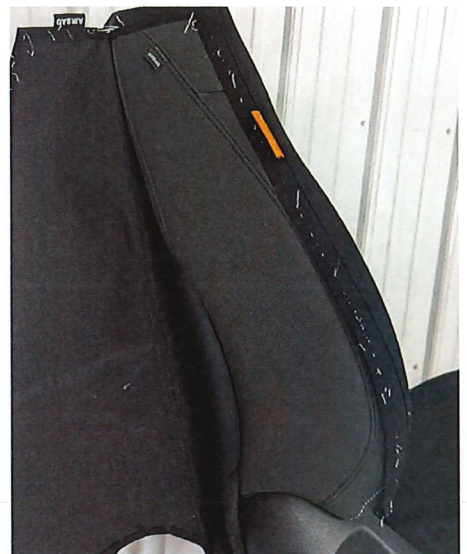
With the seam cut open, the airbag won't be impeded in any way.

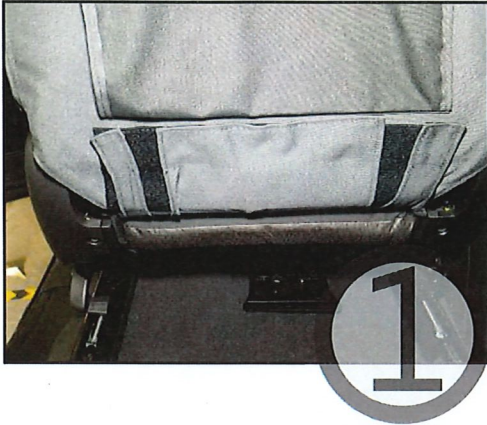
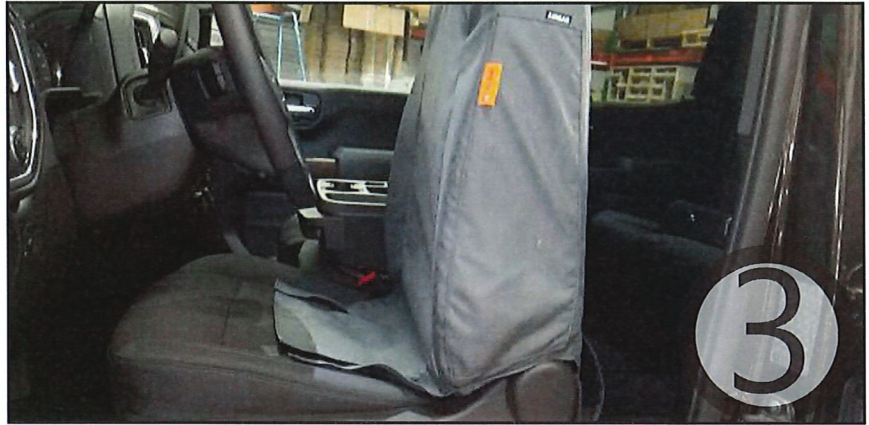
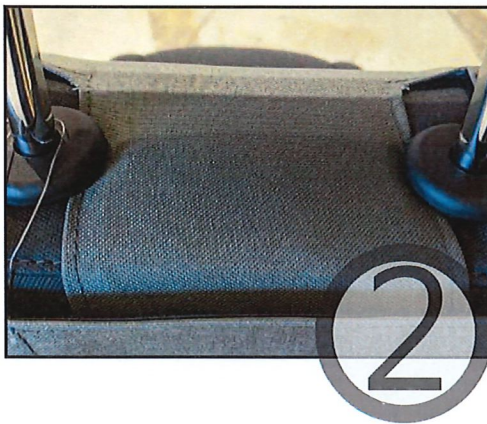
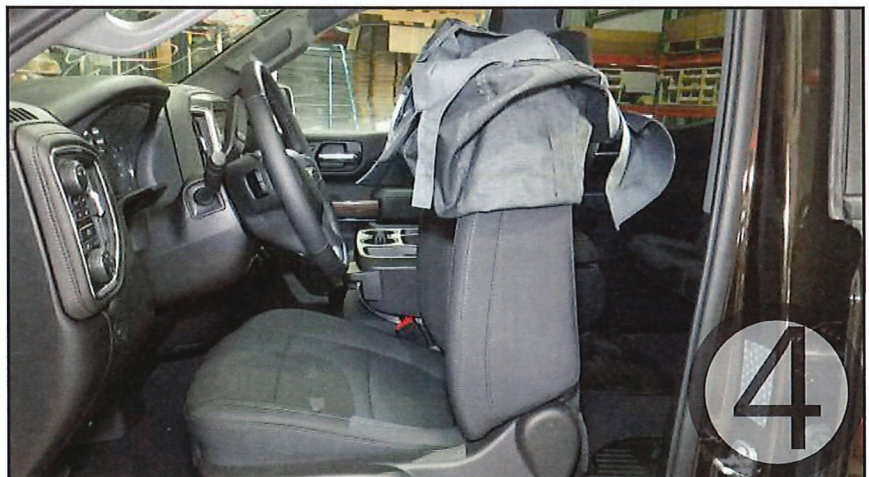
1. Undo the Hook & Loop fasteners on the back of the seat back cover.
2. Undo the Hook & Loop fasteners on the top of the seat back cover.
3. Pull the front of the seat cover to pull the flaps out from between the seat back and seat bottom.
4. Pull the cover up off the seat back and over the headrest.
