Subject: Freightliner & Western Star Short Wheelbase Tire Conformance

Models Affected: Specific model years 2020-2024 Freightliner Cascadia, Classic Cascadia, Business Class M2, and Western Star 4700 vehicles, manufactured November 8, 2019, through February 6, 2023.

June 2023 FL971 A-B NHTSA #23V-299

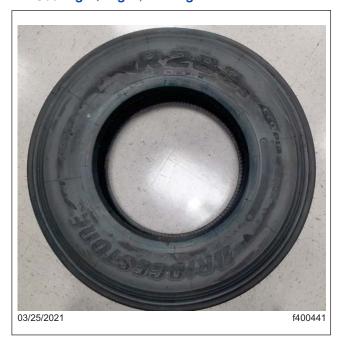
Fig. 1, Bridgestone® R283s Tire

1. Locate the department of transportation (DOT) tire identification number (TIN) on each tire. See Fig.1, Fig.2, and Fig. 3.

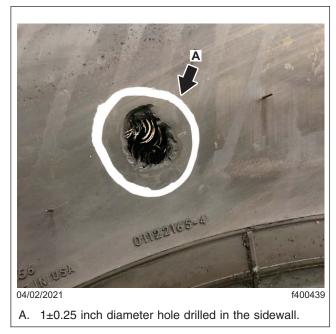
Fig. 4, Hole Drilled

- 2. Drill a 1±0.25 inch diameter hole in the sidewall of the tire, as shown in Fig. 4.
- 3. Drill another hole of the same diameter, 180 degrees away from the first hole, on the same side of the tire. See Fig. 5.

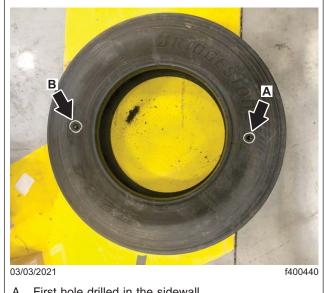
Fig. 5, Both Holes Drilled

- A. First hole drilled in the sidewall.
- Second hole drilled 180 degrees away from the first hole, on the same side.
