SAFETY RECALL 23TA12 (Remedy Notice)

Certain 2020 – 2023 Model Year Highlander and Highlander HV
Front Lower Bumper Cover Assembly May Detach While Driving
NHTSA Recall No. 23V-720

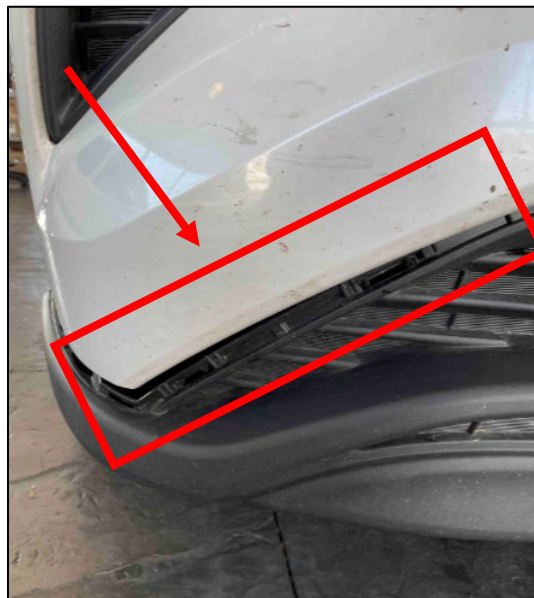
A1a: Yes, if some of the mounting tabs have detached, customers may notice the lower bumper cover hanging loose from the upper bumper cover. This can be seen by looking at the bottom of the front bumper.

A2: Toyota dealers will inspect the upper to lower front bumper cover mounting tabs and slots for damage. If no damage is found, dealers will install retention hardware with an improved design. If damage is found, dealers will replace the upper and/or lower front bumper cover and install retention hardware with an improved design **FREE OF CHARGE**.
