TO: Mercedes-Benz Dealer Principals, General Managers, Sales Managers, Service Managers, Parts Managers	FROM: Gregory Gunther, Senior Manager, Vehicle Compliance and Analysis, Engineering Services
RE: Recall Campaign - Launch Notification Replace Rear Axle Differential Housing – Wave 2 MY22-23 AMG G63 4x4 squared (463 platform)	DATE: June 14, 2024

Campaign No. 2024040012, June 2024

SUBJECT: **Model G-Class (463 platform)**
Model Year 2022 – 2023

Replace Rear Axle Differential Housing – Wave 2

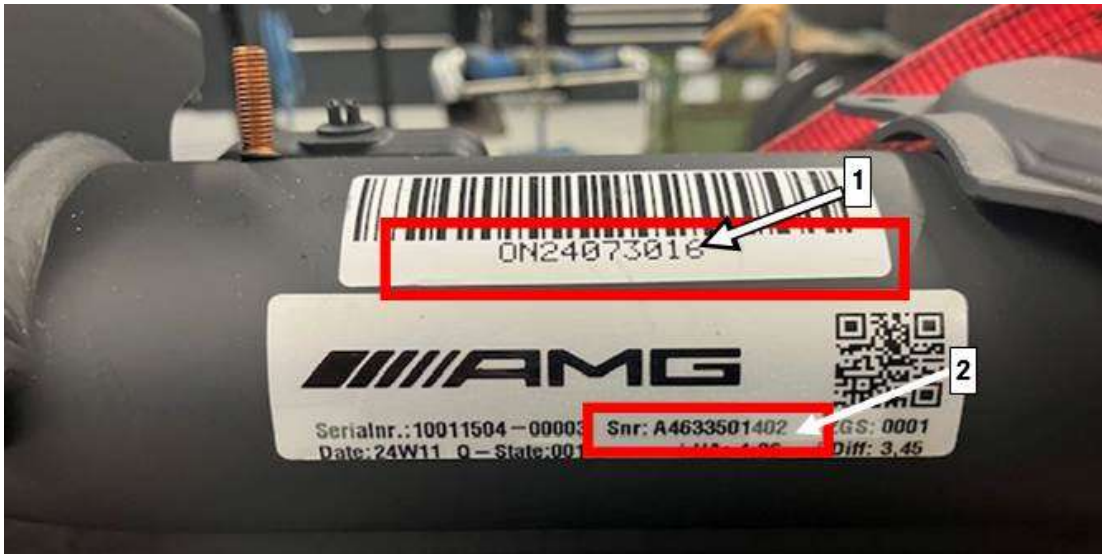
Figure 1

i Serial number (**Figure 1, 1**) and item number (**Figure 1, 2**).

i After the **rear axle centerpiece** has been replaced, the new **serial number** and **item number** must be documented in **VeDoc**. This can be done by opening a “**Vehicle Data/VeDoc**” XSF ticket and providing a picture of the new serial number and item number.

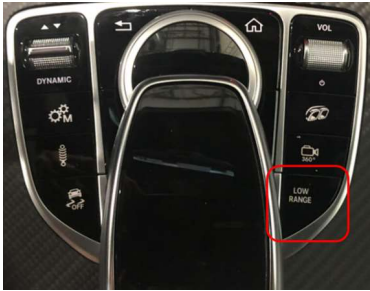
Figure 3

- When the vehicle wheels are **lifted** off the ground, engage the rear axle differential lock actuator and then disconnect the electrical plug on the rear axle lock actuator while the lock is engaged.
i **The rear axle must be removed with the lock actuator set to lock position.**
i **To do this:** Start the engine – Release the parking brake – Engage Neutral position (N) – Engage Low Range (**Figure 3**) – Engage Drive position (D) – Engage Center Differential Lock (**Figure 4, 1**) – While wheels are rotating slowly, Engage Rear Axle Differential Lock (**Figure 4, 2**) – Ensure red confirmation light is illuminated for Center and Rear Differential Lock (**Figure 4**) – Switch 'OFF' Ignition – Disconnect electrical plug on Lock Actuator of rear axle and leave disconnected (**Figure 5**).

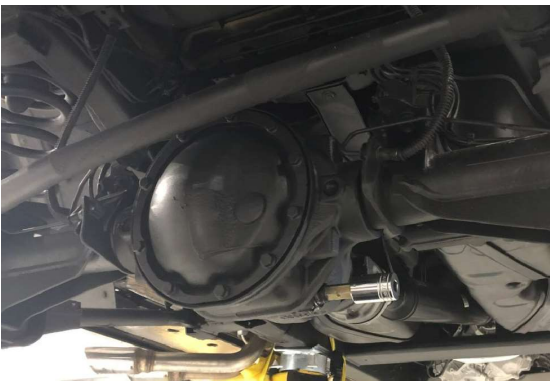
Figure 8

7. Drain rear axle oil (**Figure 8**).

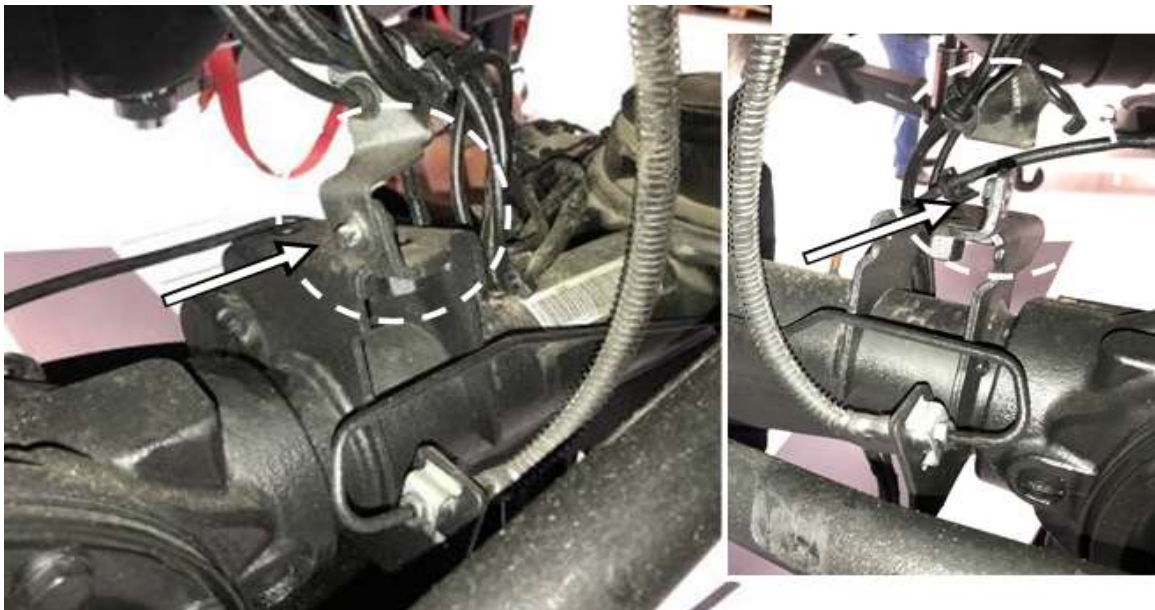
Figure 10

9. Unscrew the two holders for electrical wiring harness from the rear axle tube. (**Figure 10**).

Remove the complete rear axle wiring harness with holders and cable ties/clips from the rear axle and working area.

i Only replace defective cable ties/clips when installing the wiring harness onto the new axle bridge to ensure that the positioning of the wiring harness remains identical.

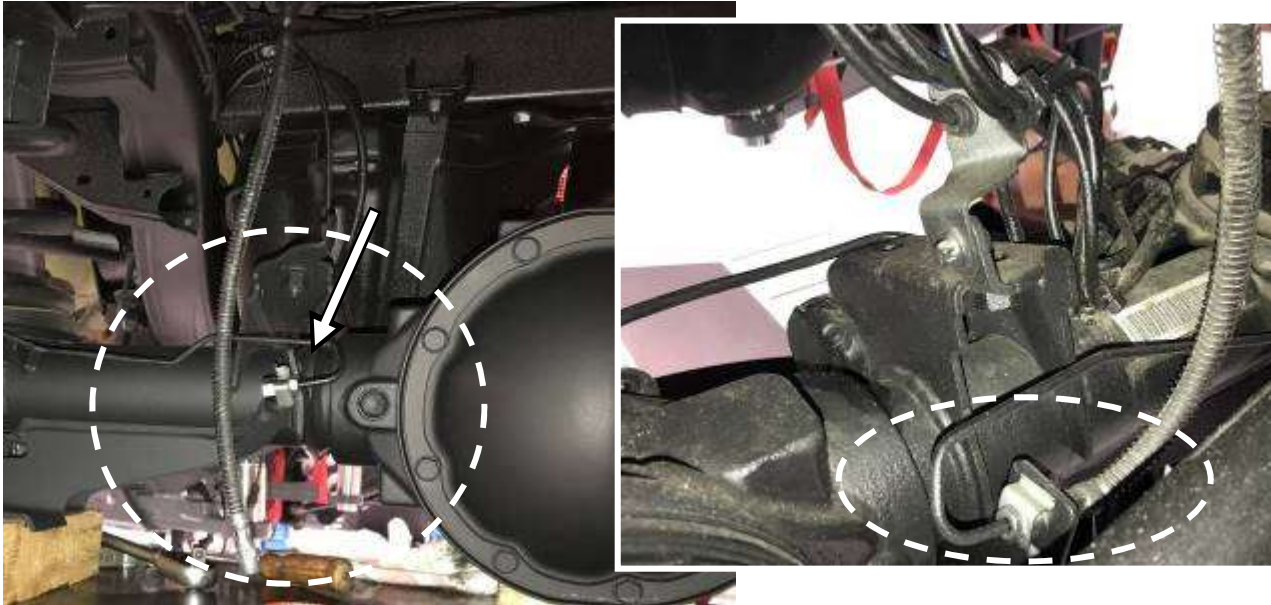
Figure 13

12. Unscrew brake hoses from brake lines on inside of axle (**Figure 13**) and seal open brake lines with suitable stop plugs (e.g. W129 589 00 91 10).

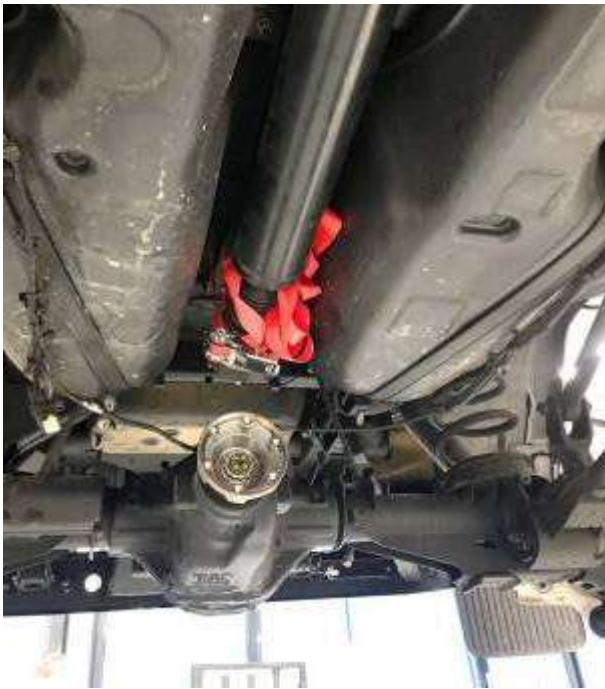
Figure 14

13. Unscrew propeller shaft at rear axle differential, and secure from falling by tying to the top (**Figure 14**).

Nm Propeller shaft screws at rear axle differential: **Stage 1: 40 Nm**
Stage 2: 90°

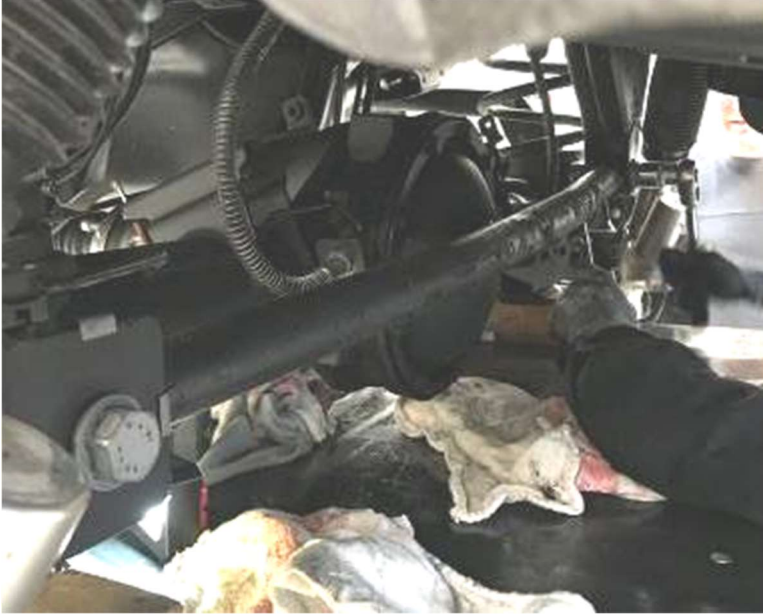
Figure 17

16. Remove transverse control arm of rear axle (**Figure 17**).

Nm Transverse control arm screw to rear axle: **Stage 1: 150 Nm**
Stage 2: 90°

Nm Transverse control arm screw to frame: **Stage 1: 150 Nm**
Stage 2: 90°

i During installation, the transverse control arm at the rear axle **must be fit into the bearing using a shim**.

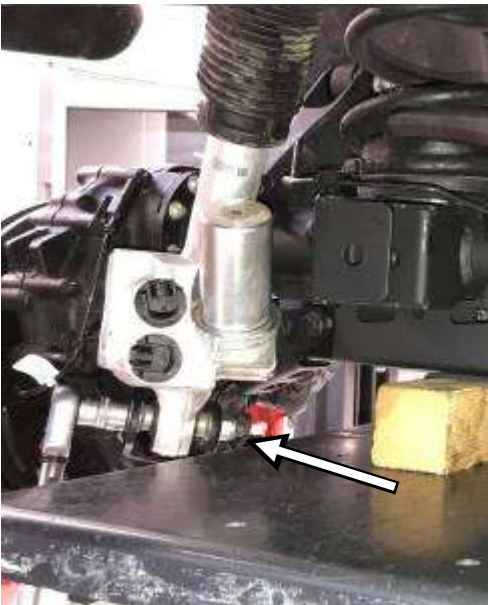
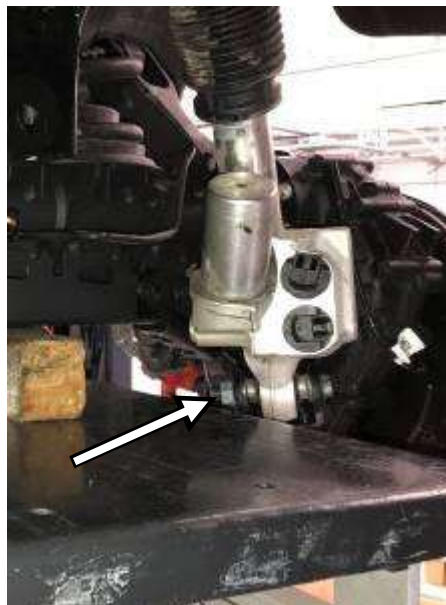
Figure 18

17. Unscrew left and right shock absorbers at bottom axle (**Figure 18**).

i The shock absorbers remain on the vehicle and need not be removed completely.

Nm Shock absorber screw to holder (axle tube): **Stage 1: 100 Nm**
Stage 2: 90°

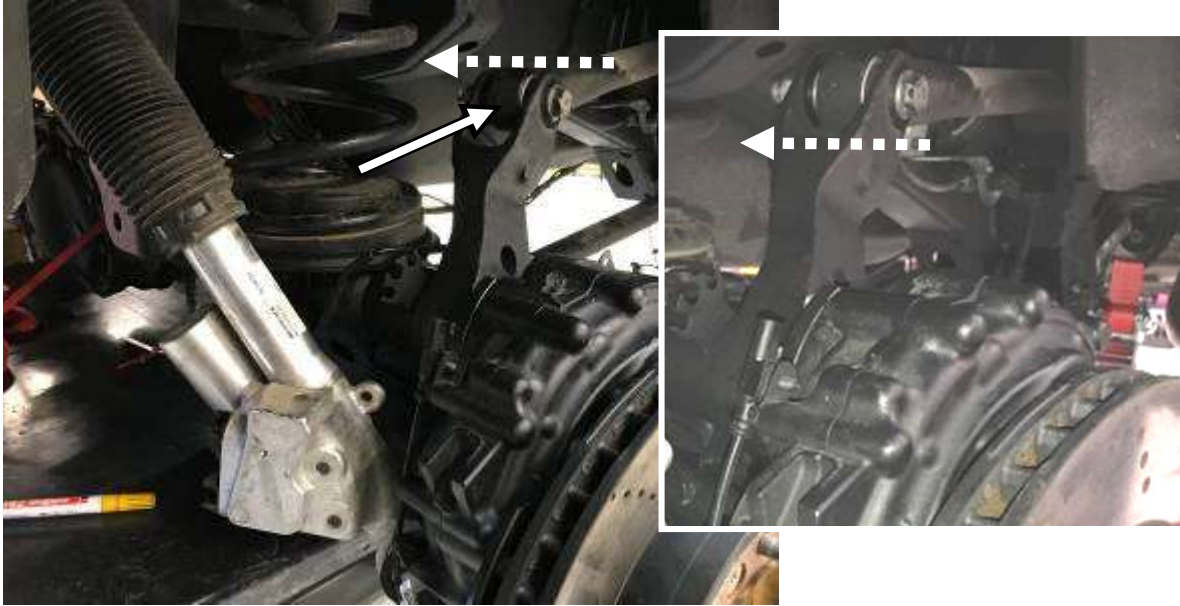
Figure 19

18. Release screw connection of top left and right trailing arms at rear axle (**Figure 19 and 20**).

Nm Upper trailing arm screw to rear axle: **Stage 1: 100 Nm**
Stage 2: 90°

i **Important!** The **new** screw on rear axle to the upper trailing arm is inserted inwards, from wheel side towards the rear axle spring (**Figure 19**).

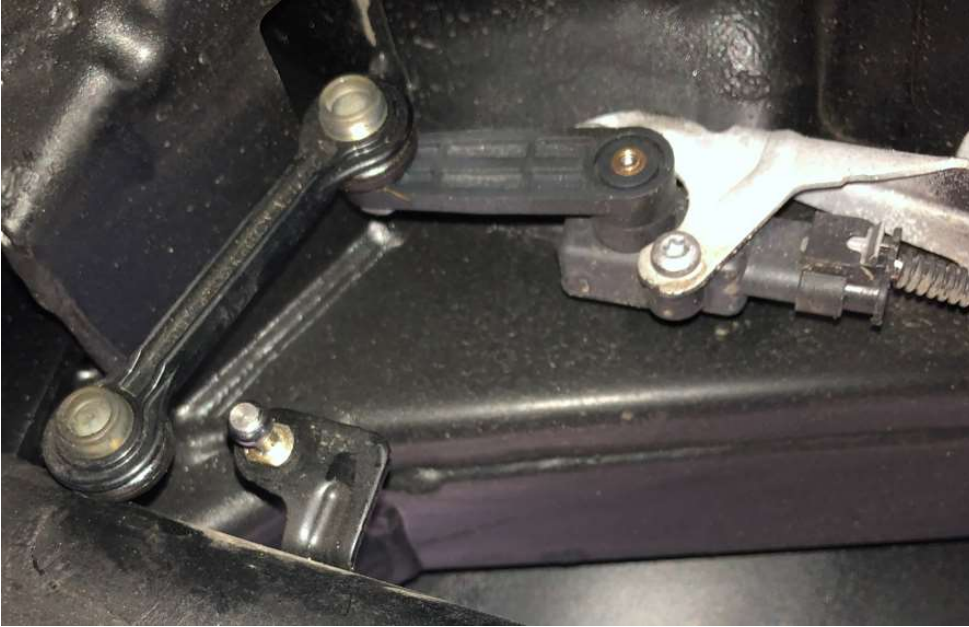
Figure 21

19. Mark adjusting plates for adjusting the drive line angle, disconnect level sensors on trailing arms (**Figure 21**) and unscrew connection of the rear axle at left and right lower trailing arms (**Figure 22**).

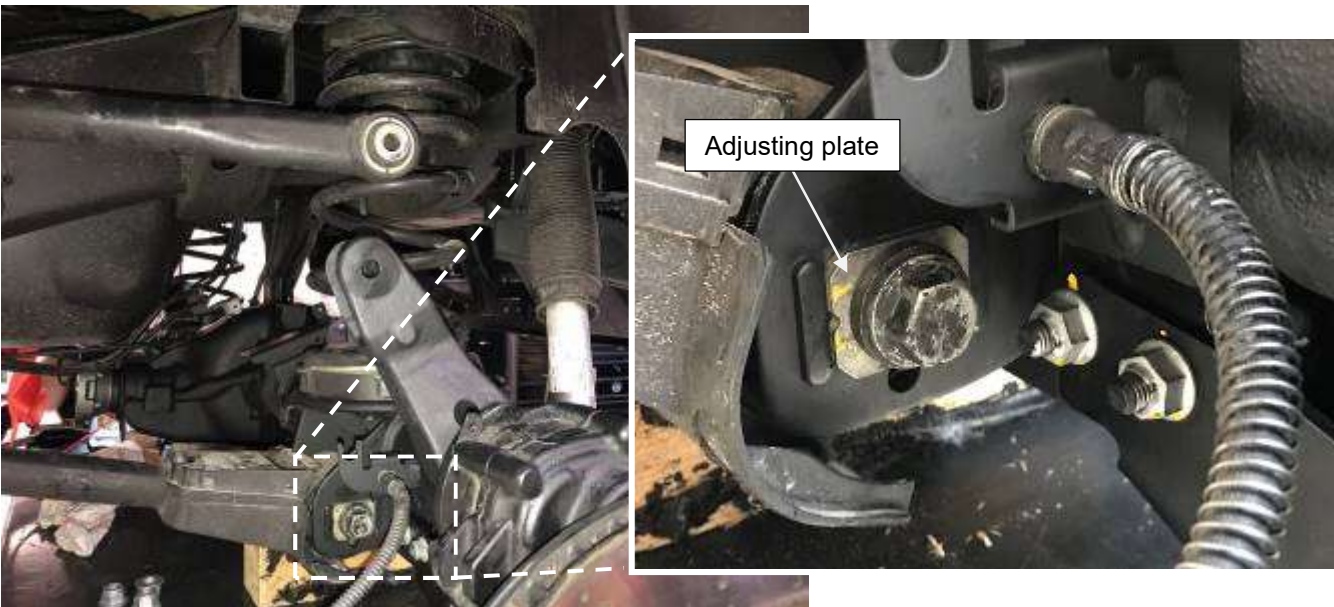
Figure 22

Nm Lower trailing arm screw to rear axle: **Stage 1: 100 Nm**
Stage 2: 180°

i **Important!** Mark adjusting plates and install in the same location and same installation position on the new axle.

i **Installation:** Install adjusting plates with opening pointing downward.

i **Installation:** The notch on the adjusting plate should point in the direction of travel.

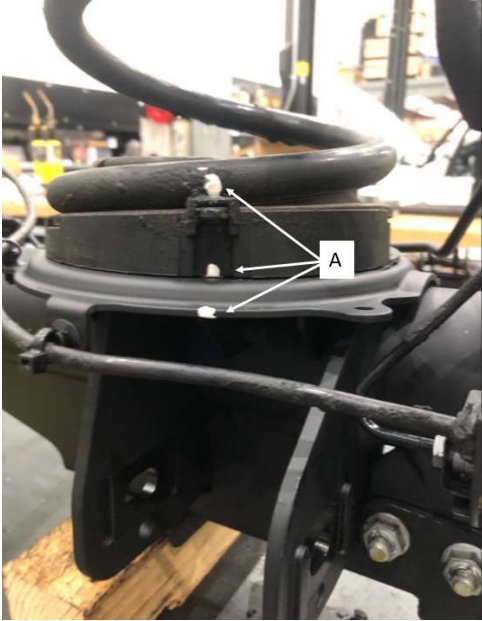
Figure 23

21. Mark the springs, as well as the upper and lower spring retainer, then remove the springs completely (**Figure 23, A**).

i **Installation:** Align installation position (**Figure 23, A**).

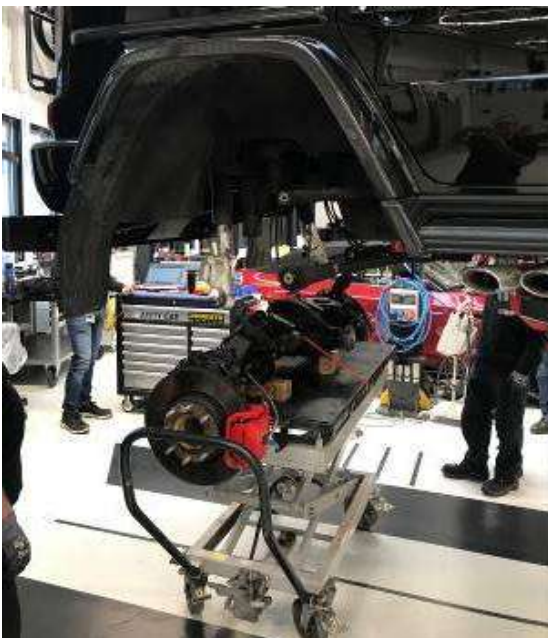
Figure 24

22. Fully lower rear axle and remove from underneath vehicle (**Figure 24**).

i Pay attention to surrounding component parts when lowering and lifting the rear axle.

i Unthread lower trailing arms while lowering.

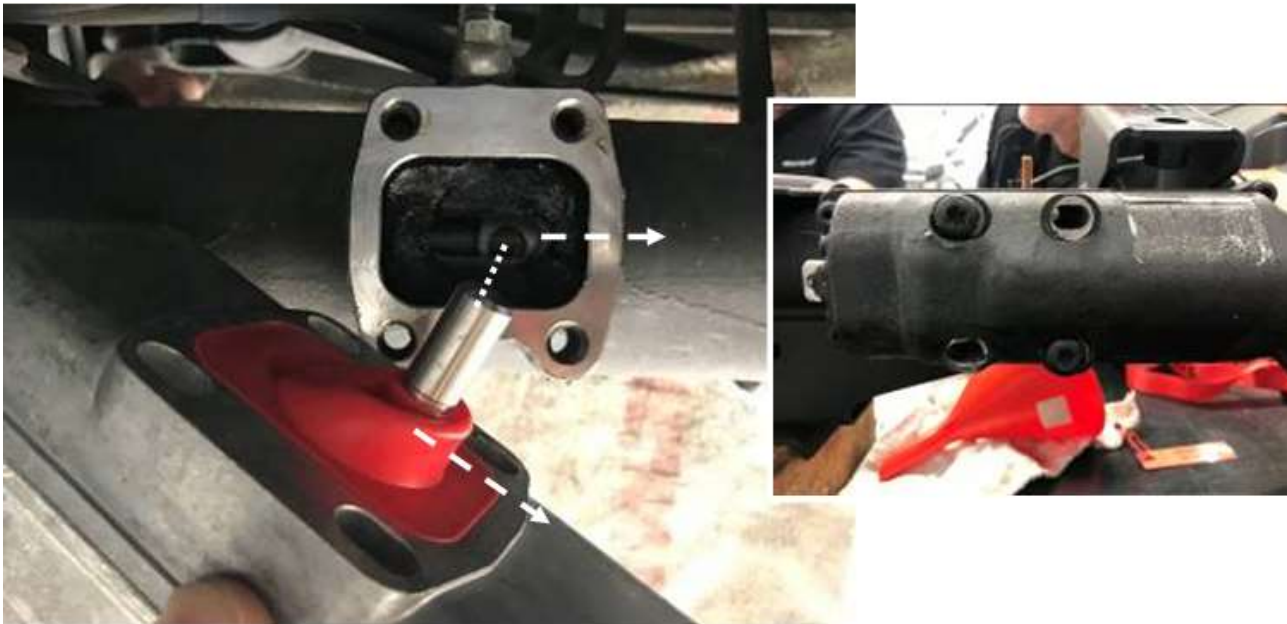
Figure 25

25. Remove rear axle actuator (**Figure 25**).

i Rear axle actuator is in **lock engaged position**.

i **Installation:** The slide in the axle tube for actuating the lock must be slid in the direction of the axle centerpiece. One of the wheel flanges must be turned at the same time.

Nm Locking Actuator screw to axle tube **Stage 1: 10 Nm**
Stage 2: 20 Nm
Stage 3: 60°

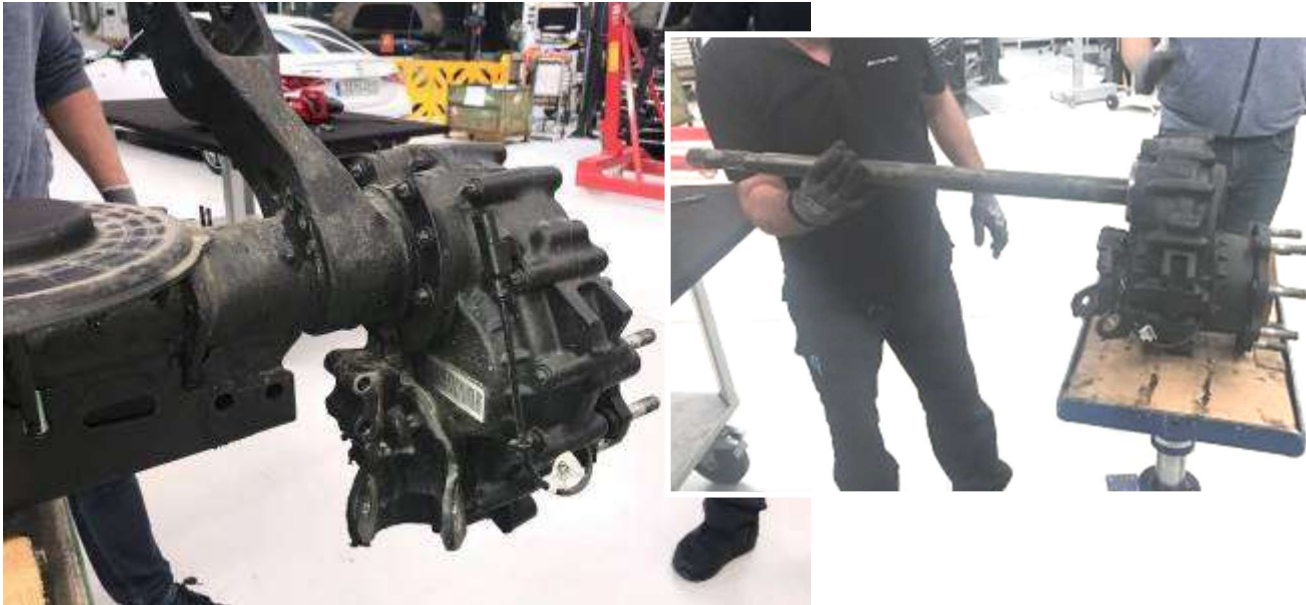
Figure 27

27. Remove left and right hub reduction gears (**Figure 27**).

Nm Hub reduction gear screw to axle tube: **Stage 1: 40 Nm**
Stage 2: 45°

i **Installation:** Carefully slide hub reduction gear with axle shaft into rear axle differential while turning at the same time so that the gearing engages.

i **Installation:** Exercise particular caution when inserting the right (passenger side) portal axle to ensure the slide for the lock actuation is not damaged.

i **Installation:** To install the right-side portal axle, **position the lock actuator temporarily** so that the lock tube has better guidance into the new axle centerpiece.

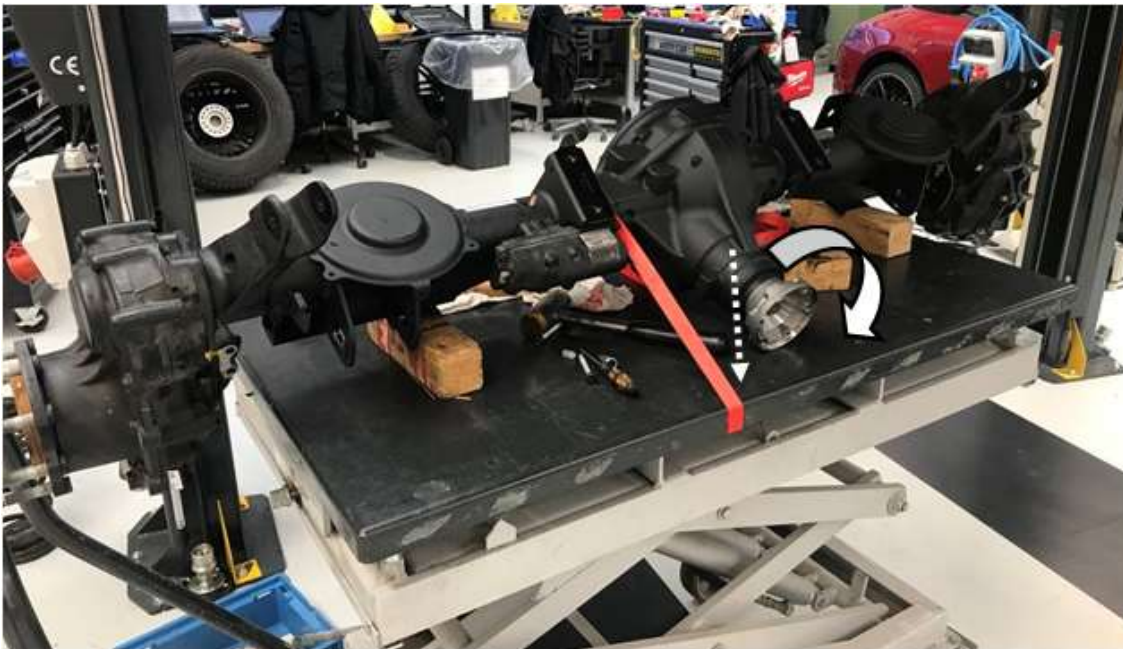
Figure 33

32. Fill rear axle centerpiece with 1.5 liters of oil and rotate the differential drive pinion multiple times for **at least 30 seconds** with the drive pinion tilted downward by **at least 5–10°** (**Figure 33**).

i **Attention, very important:** This ensures the bearing of the drive pinion is sufficiently lubricated prior to initial use.

i **After the rear axle has been installed, the oil level must be checked and in a ready-to-drive condition.**

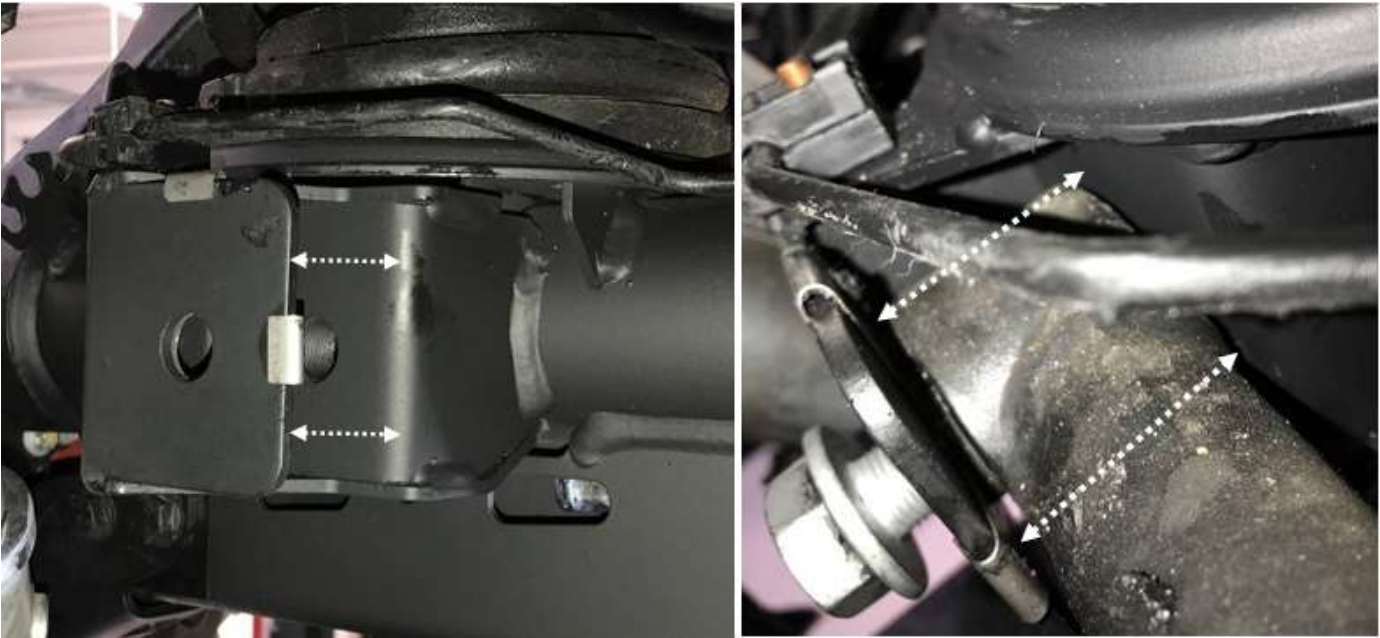
Figure 34

33. Install adjusting plate (if necessary) for transverse control arm on new axle bridge (**Figure 34, 35**).

i The left bearing of the transverse control arm must be installed with suction and with almost zero clearance, into the retaining tab of the axle bridge.

i The fit for the transverse control arm can be adjusted as required, either **without** an adjusting plate, **with a 0.5 mm** adjusting plate, or **with a 0.8 mm** adjusting plate.

i A **maximum of one adjusting plate** may be installed.

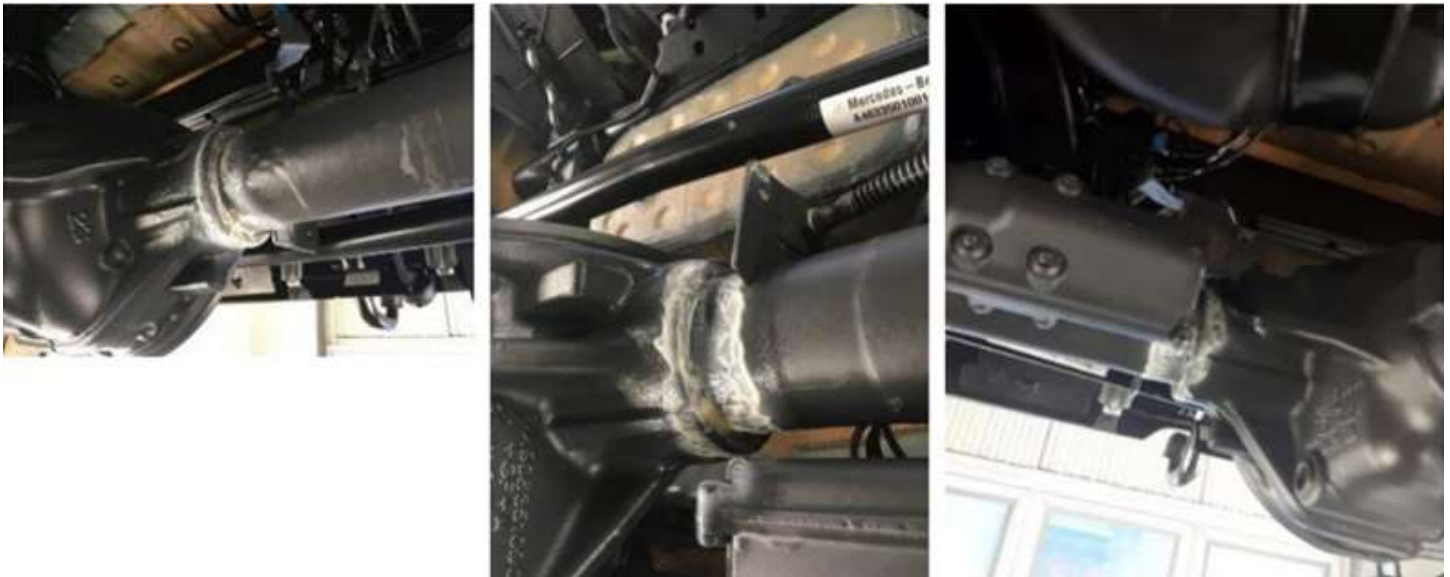
Figure 36

39. Apply wax **A 000 986 32 01 09** to rear axle in area between axle tube and differential (**Figure 36**).
