URGENT RECALL CAMPAIGN UPDATE

23P3591005
23P3591006Replace Rear Axle Differential
Housing – Wave 8

Recall Campaign Bulletin

Replace Rear Axle Differential Housing – Wave 8

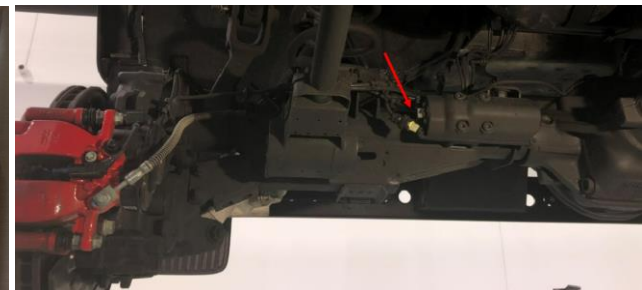
Figure 5

- The rear axle must be removed with the lock actuator set to lock position.**
 - To do this:** Start the engine – Release the parking brake – Engage Neutral position (N) – Engage Low Range (**Figure 3**) – Engage Drive position (D) – Engage Center Differential Lock (**Figure 4, 1**) – While wheels are rotating slowly, Engage Rear Axle Differential Lock (**Figure 4, 2**) – Ensure red confirmation light is illuminated for Center and Rear Differential Lock (**Figure 4**) – Switch 'OFF' Ignition – Disconnect electrical plug on Lock Actuator of rear axle and leave disconnected (**Figure 5**).

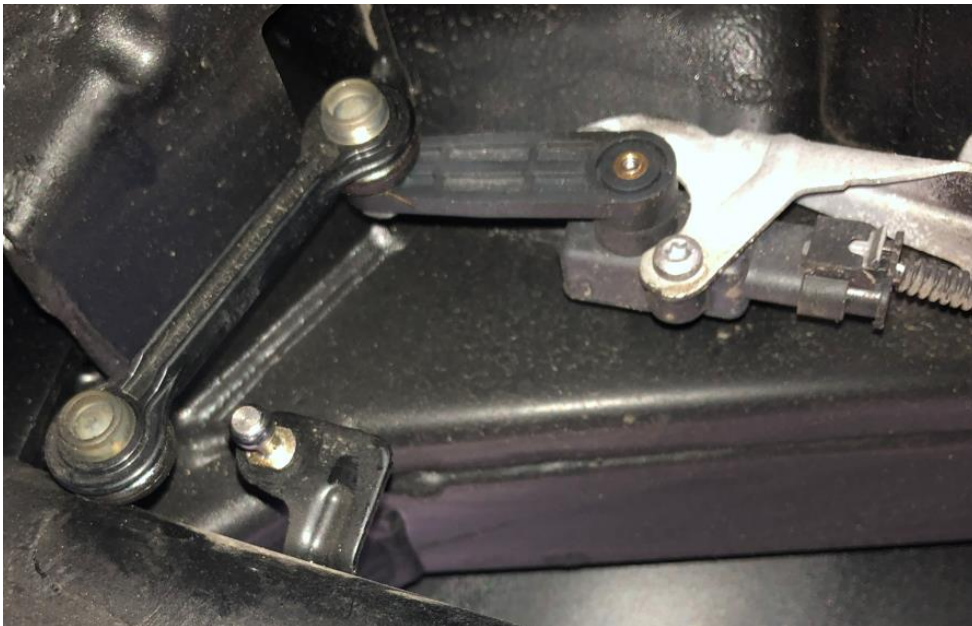
Figure 21

19. Mark adjusting plates for adjusting the drive line angle, disconnect level sensors on trailing arms (Figure 21) and unscrew connection of the rear axle at left and right lower trailing arms (Figure 22).

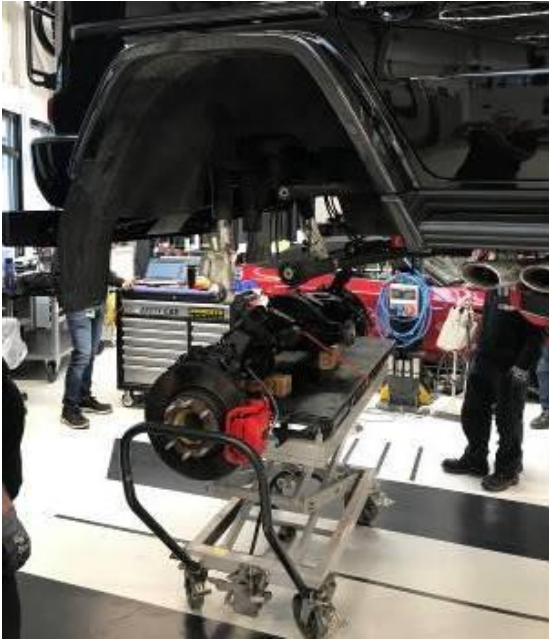
Figure 24

22. Fully lower rear axle and remove from underneath vehicle (**Figure 24**).

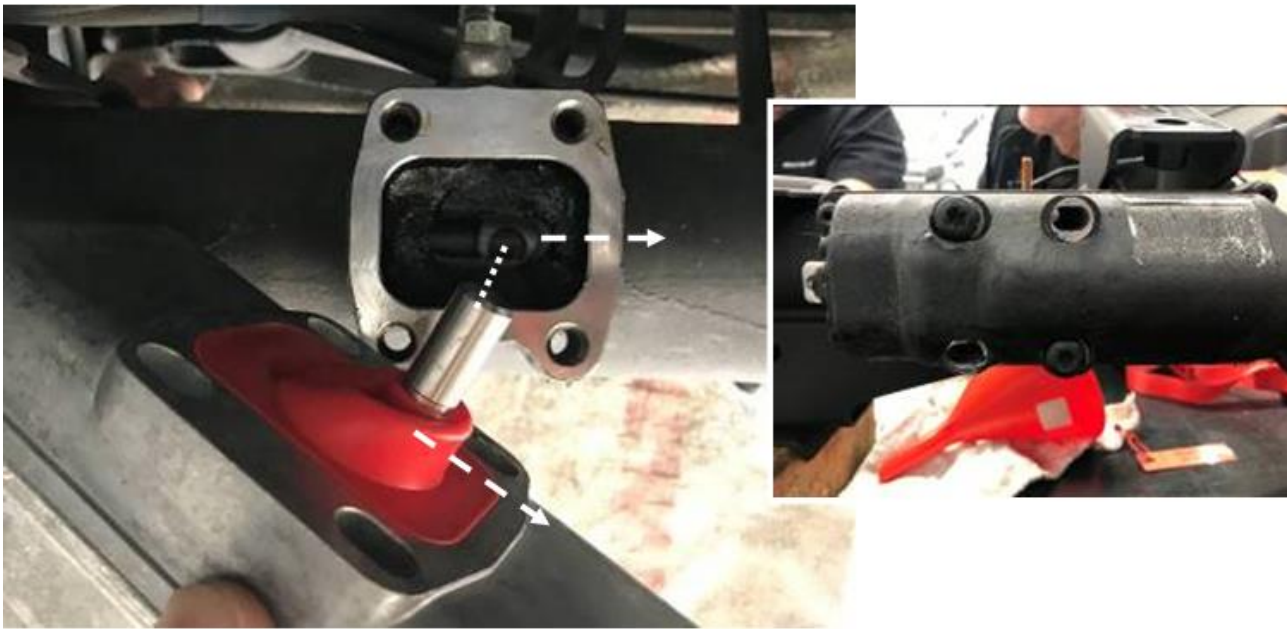
Figure 25

25. Remove rear axle actuator (**Figure 25**).

Rear axle actuator is in **lock engaged position**.
-

**Installation:** The slide in the axle tube for actuating the lock must be slid in the direction of the axle centerpiece. One of the wheel flanges must be turned at the same time.
-

Locking Actuator screw to axle tube **Stage 1: 10 Nm**
Stage 2: 20 Nm
Stage 3: 60°

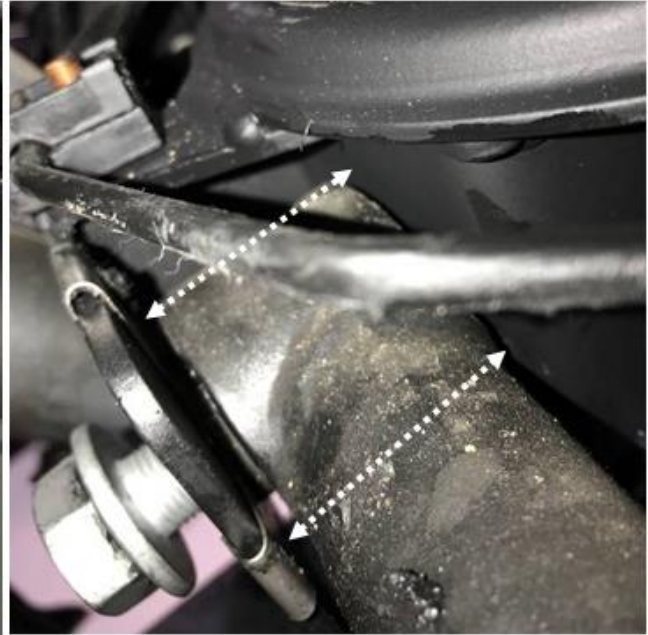
Figure 34

33. Install adjusting plate (if necessary) for transverse control arm on new axle bridge (**Figure 34, 35**).

i The left bearing of the transverse control arm must be installed with suction and with almost zero clearance, into the retaining tab of the axle bridge.

i The fit for the transverse control arm can be adjusted as required, either **without** an adjusting plate, **with a 0.5 mm** adjusting plate, or **with a 0.8 mm** adjusting plate.

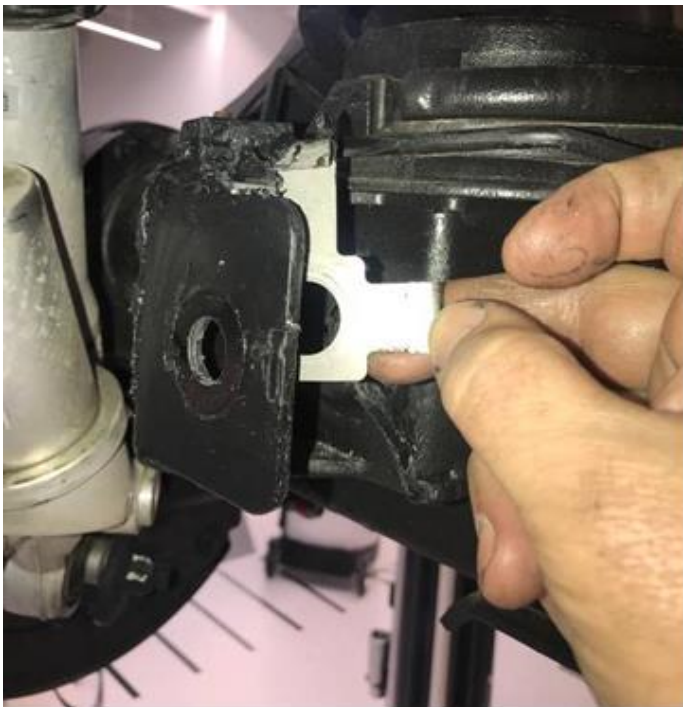
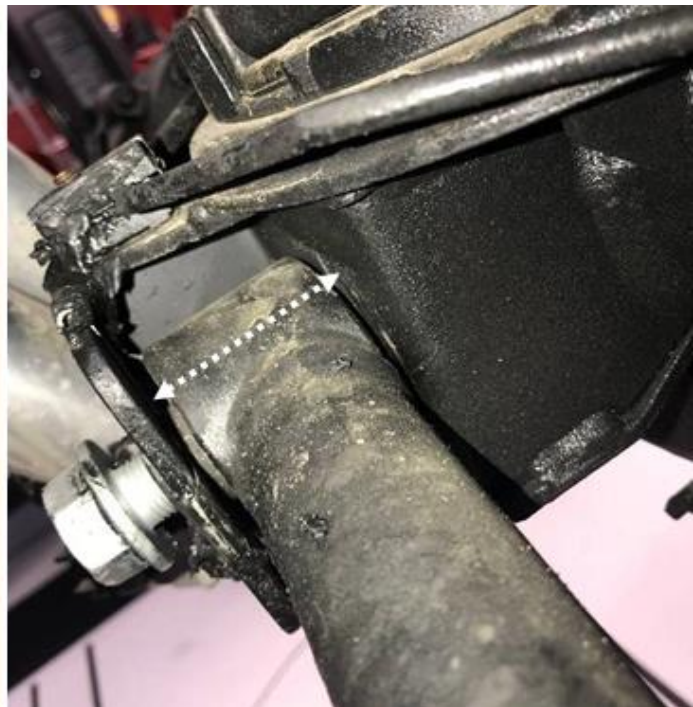
Figure 35

i A maximum of one adjusting plate may be installed.

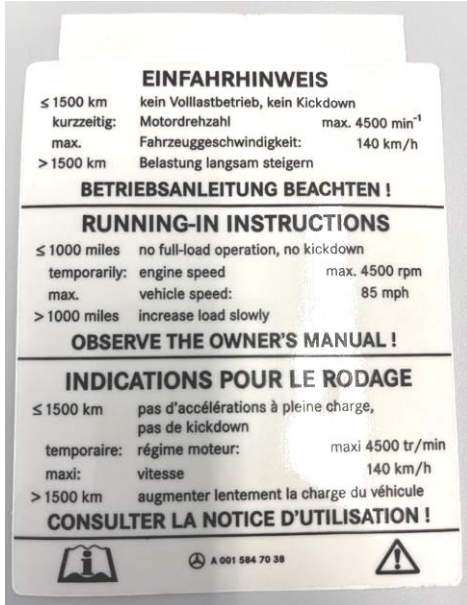
Figure 37

42. Install adhesive label for running-in (break-in period) instructions (**Figure 37**) in top left-hand corner on inside of windshield.

- Install adhesive label for running-in (break-in period) instructions (**Page 20, Figure 37**) in top left-hand corner on inside of windshield.
 - Print out information about running-in (break-in period) instructions (**Page 23**) and provide to customer.
- NOTE:** Running-in instructions are the maximum guidelines for the rear axle operation break-in period.
