Recall Campaign Launch Notification

Replace Rear Axle Differential Housing – Wave 8

Recall Campaign Bulletin

Replace Rear Axle Differential Housing – Wave 8 – 463 4x4²

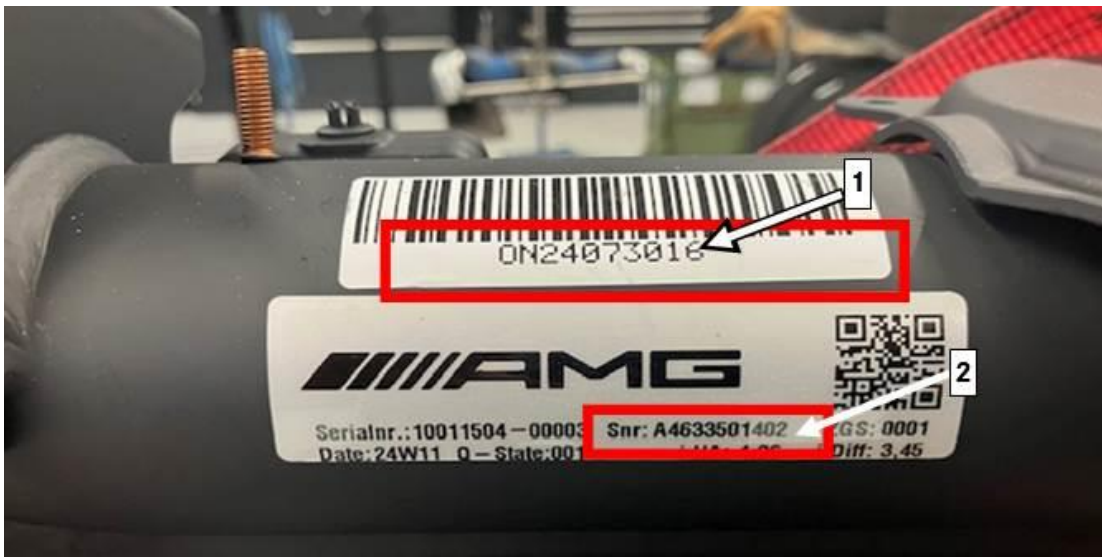
Figure 1

i Serial number (**Figure 1, 1**) and item number (**Figure 1, 2**).

i The new serial number (**Figure 1, 1**) and item number (**Figure 1, 2**) are documented in the VeDoc system in the tab “**VPD & SerienNr. (VPD & Serial no.) (Figure 2, 3)**” – “**Seriennummern (Serial numbers) (Figure 2, 4)**” – “**Hinterachse 1 Fremdhersteller -VPD-Ident (Rear axle 1 other manufacturer -VPD identification) (Figure 2, 5)**”.

i After the **rear axle centerpiece** has been replaced, the new **serial number** and **item number** must be documented in **VeDoc**. This can be done by opening a “**Vehicle Data/VeDoc**” XSF ticket and providing a picture of the new serial number and item number.

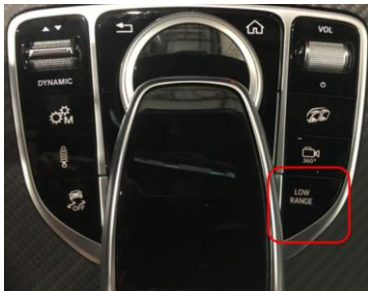
Figure 3

To do this: Start the engine – Release the parking brake – Engage Neutral position (N) – Engage Low Range (**Figure 3**) – Engage Drive position (D) – Engage Center Differential Lock (**Figure 4, 1**) – While wheels are rotating slowly, Engage Rear Axle Differential Lock (**Figure 4, 2**) – Ensure red confirmation light is illuminated for Center and Rear Differential Lock (**Figure 4**) – Switch 'OFF' Ignition – Disconnect electrical plug on Lock Actuator of rear axle and leave disconnected (**Figure 5**).

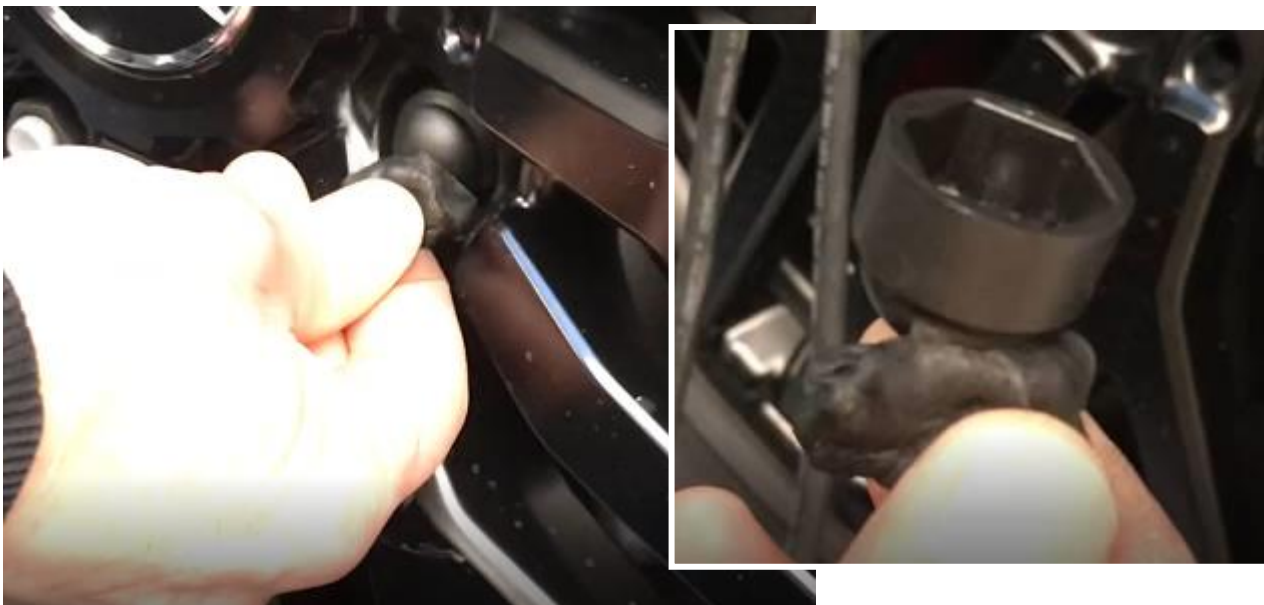
Figure 7

i For basic data, see **AR54.10-P-0003XG**.
5. Remove cover caps of wheel nuts on all four wheels (**Figure 7**).

i To do this, clean cover caps then press Butyl Tape firmly against the cover cap and pull off the cap.

i Damaged cover caps must be replaced.

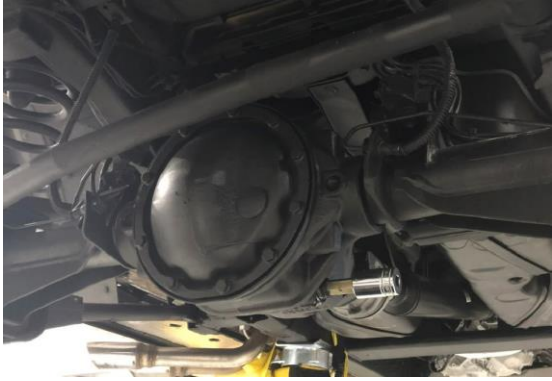
Figure 8

7. Drain rear axle oil (**Figure 8**).

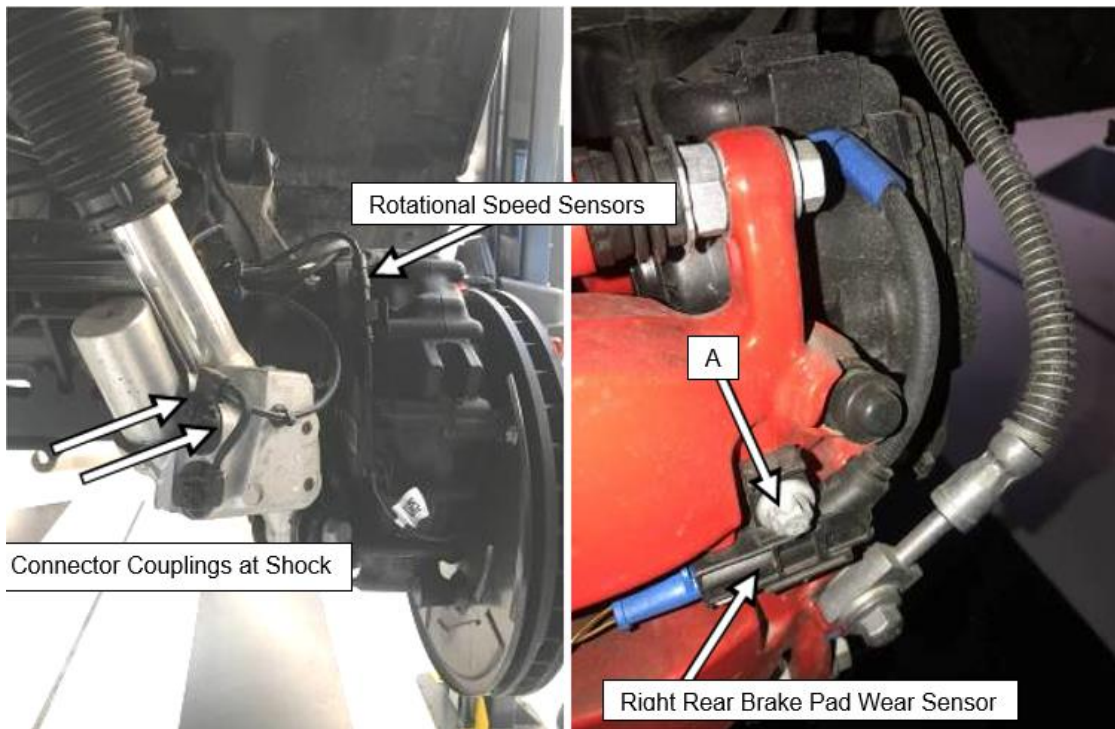
Figure 9

8. Disconnect electrical connectors of rear axle wiring harness on rear axle components (**Figure 9**).

Brake sensor screw (**Figure 9, A**): **8 Nm**

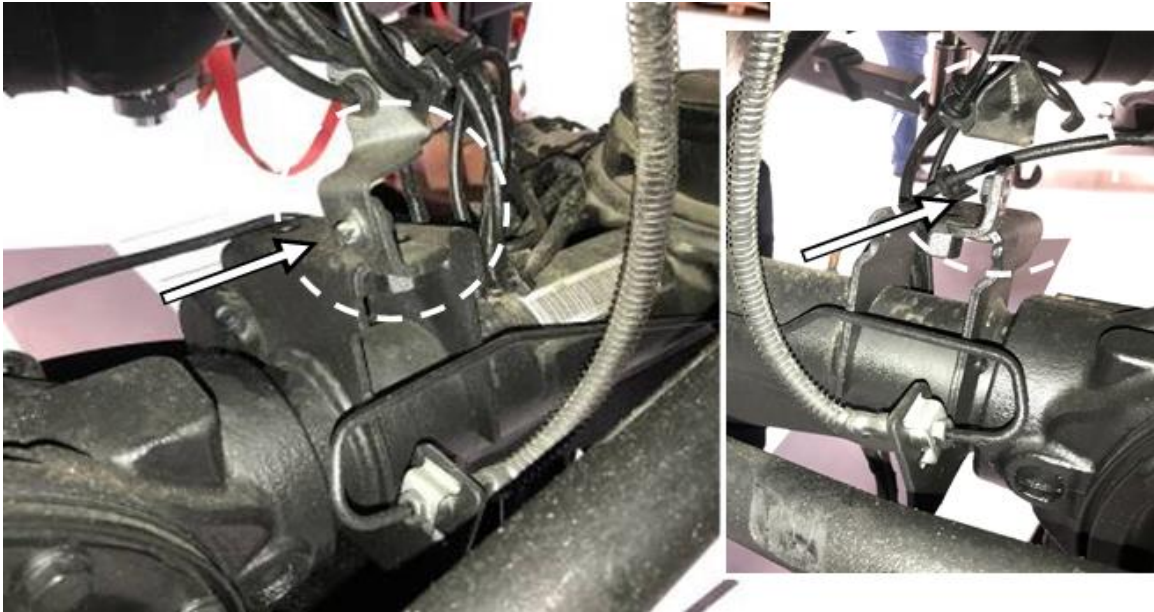
Figure 10

9. Unscrew the two holders for electrical wiring harness from the rear axle tube. (**Figure 10**).

Remove the complete rear axle wiring harness with holders and cable ties/clips from the rear axle and working area.

Only replace defective cable ties/clips when installing the wiring harness onto the new axle bridge to ensure that the positioning of the wiring harness remains identical.

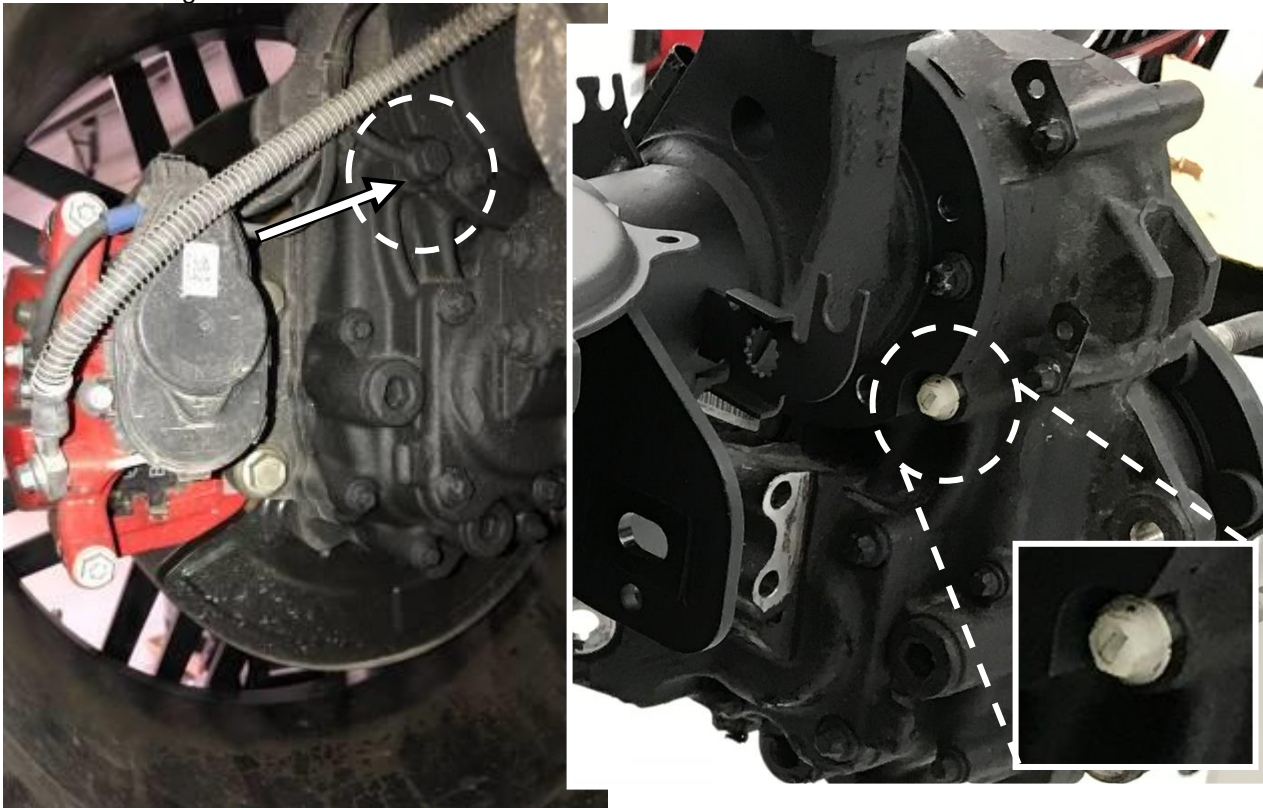
Figure 11

10. Unscrew banjo bolts for bleed lines at left and right rear axle hub reduction gears (**Figure 11**).

Nm M10 bleed line banjo bolt to rear axle hub reduction gear: **15 Nm**.

i **Seal thread openings** on rear axle hub reduction gears with suitable stop plug/screw **immediately** to prevent oil from leaking out.

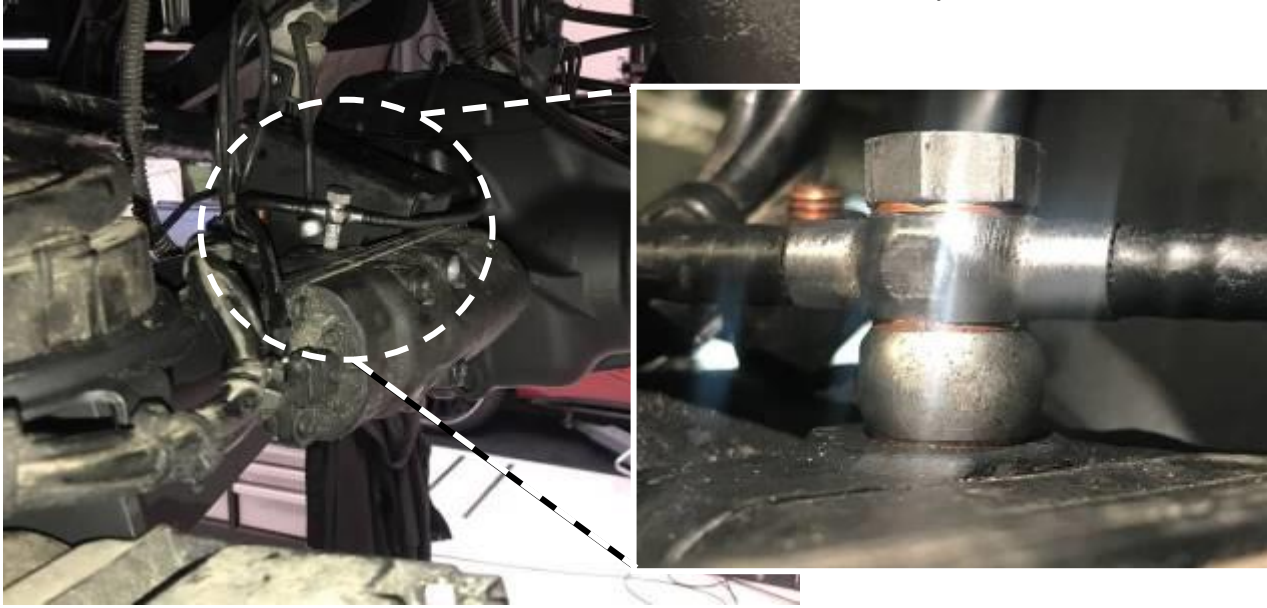
Figure 12

11. Unscrew banjo bolt of bleed lines at axle bridge above lock actuator (**Figure 12**).

Nm M8 bleed line banjo bolt to axle bridge: **8 Nm**

i **Seal thread openings** at axle bridge with suitable stop plug/screw **immediately**.

⚠ Important! A total of **three (3) copper sealing rings** are installed with banjo bolt of bleed lines above lock actuator.

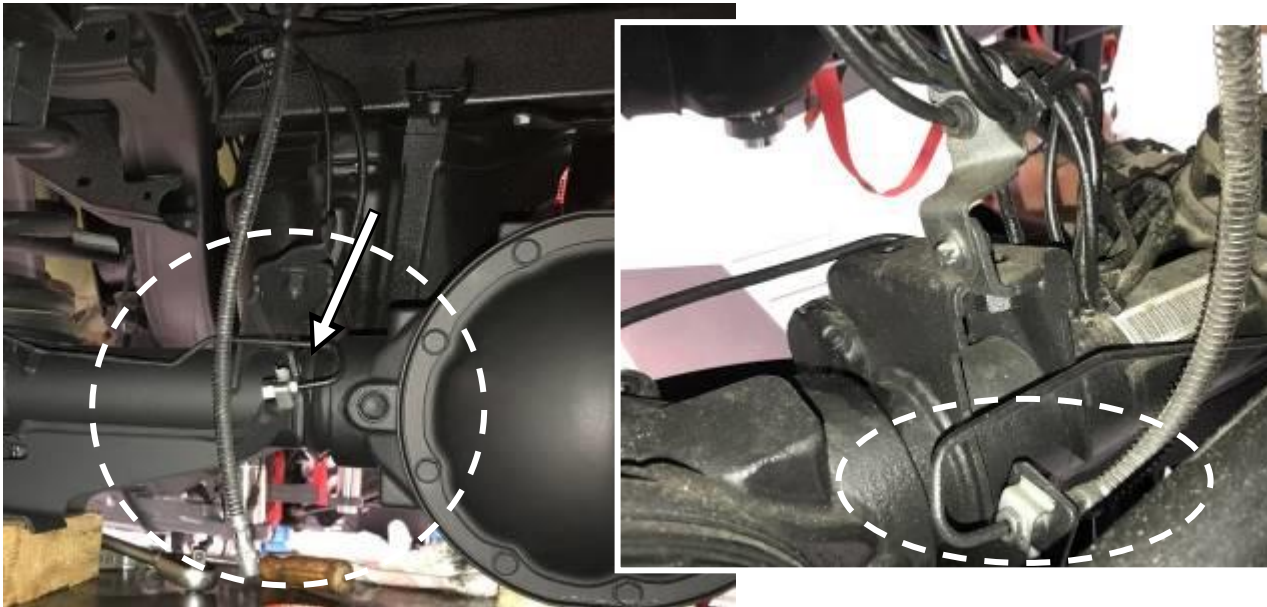
Figure 13

12. Unscrew brake hoses from brake lines on inside of axle (**Figure 13**) and seal open brake lines with suitable stop plugs (e.g. W129 589 00 91 10).

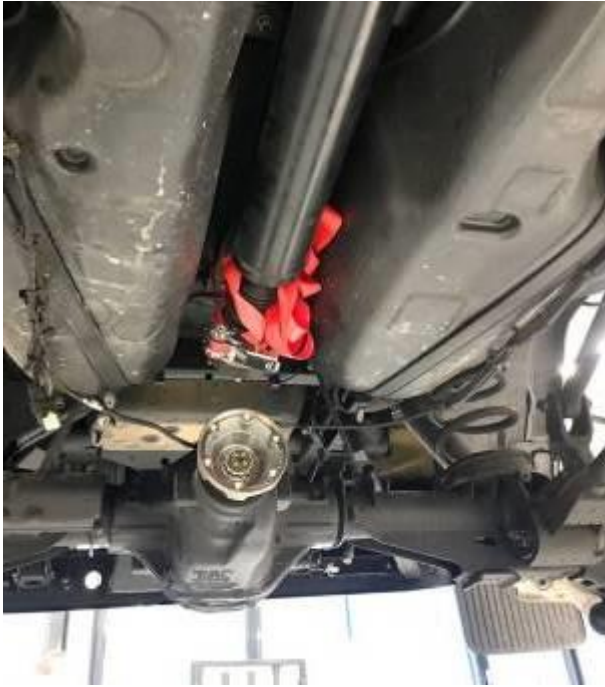
Figure 14

13. Unscrew propeller shaft at rear axle differential, and secure from falling by tying to the top (**Figure 14**).

Propeller shaft screws at rear axle differential: **Stage 1: 40 Nm**
Stage 2: 90°

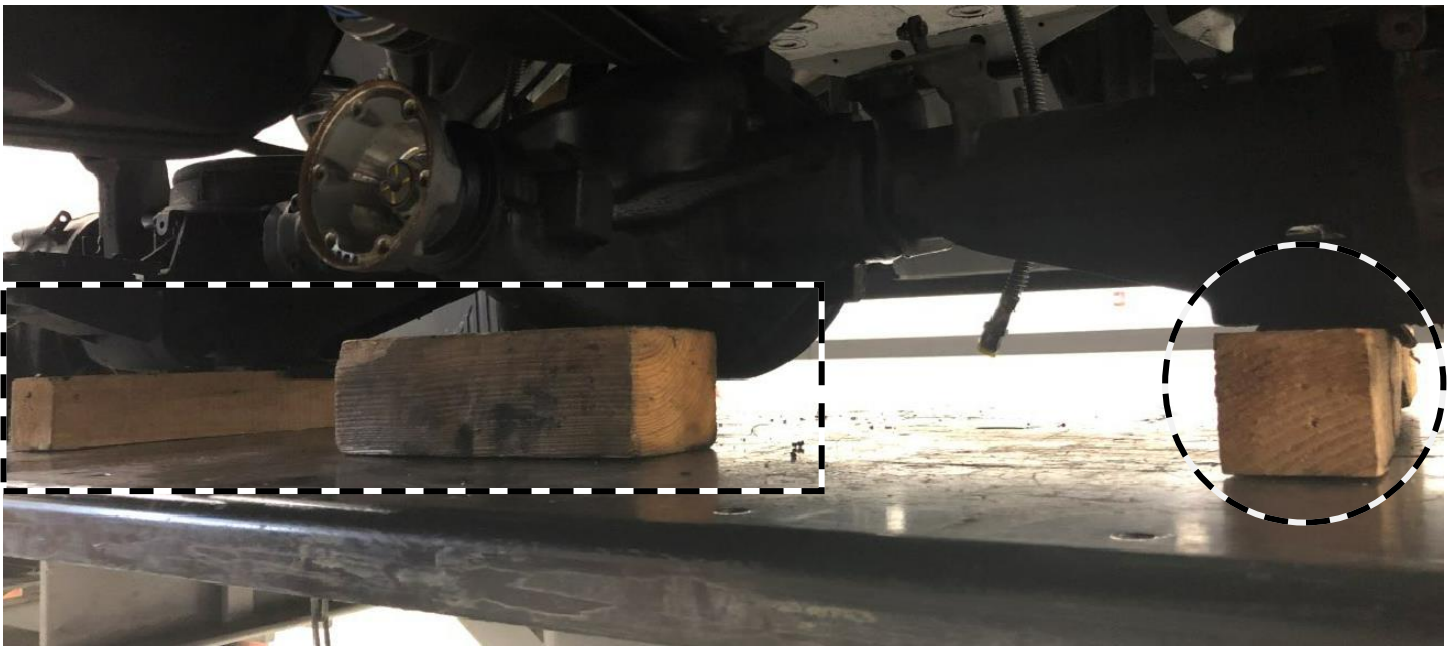
Figure 15

Place a support block with a width of approx. 5.5 cm (e.g. a hardwood block), under the axle at the left and right and under the center front section of the differential to ensure that the rear axle is evenly supported (**Figure 15**).

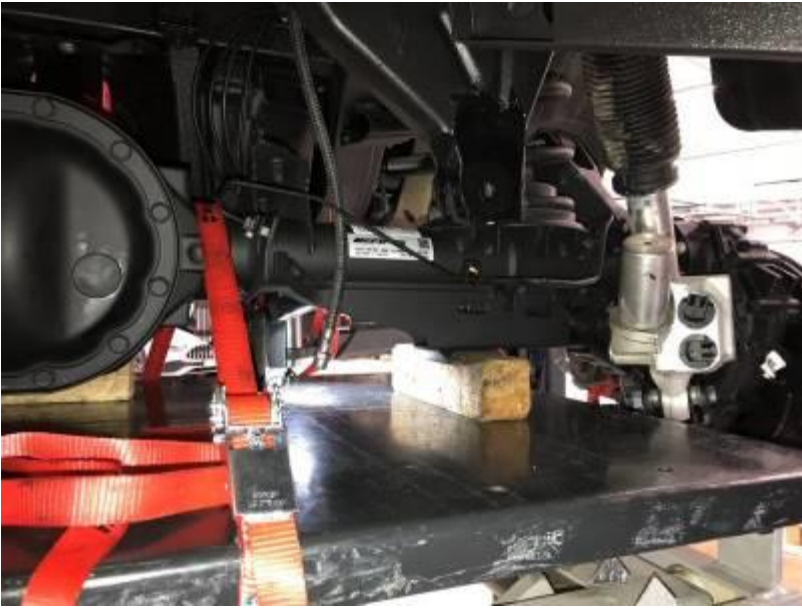
Figure 16

14. Position Lift table (W 000 588 03 62 00) under rear axle and use tension belt (**Figure 16**) to secure against falling.

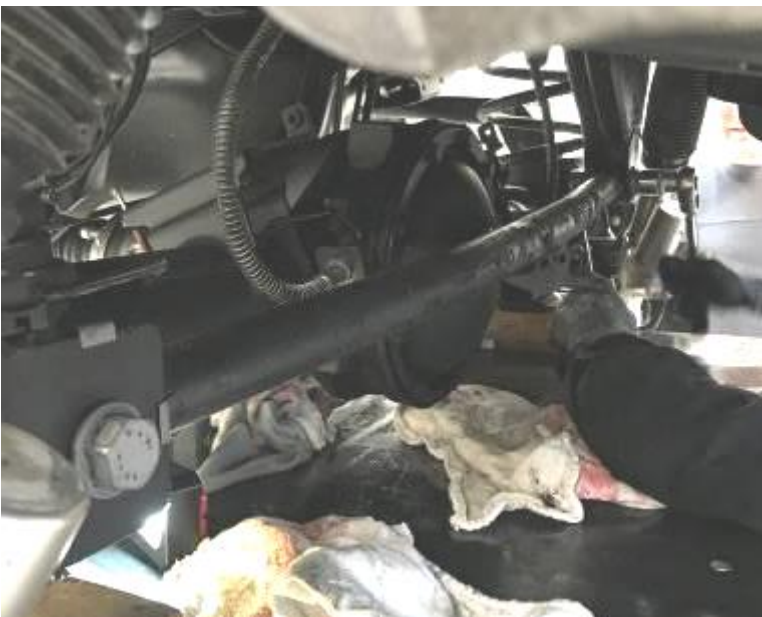
Figure 17

16. Remove transverse control arm of rear axle (Figure 17).

Nm Transverse control arm screw to rear axle: **Stage 1: 150 Nm**
Stage 2: 90°

Nm Transverse control arm screw to frame: **Stage 1: 150 Nm**
Stage 2: 90°

i During installation, the transverse control arm at the rear axle **must be fit into the bearing using a shim**.

i The previously installed original adjusting plate shim can be reused.

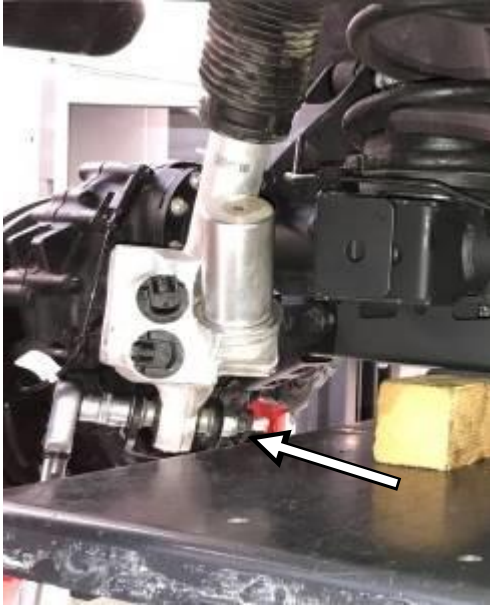
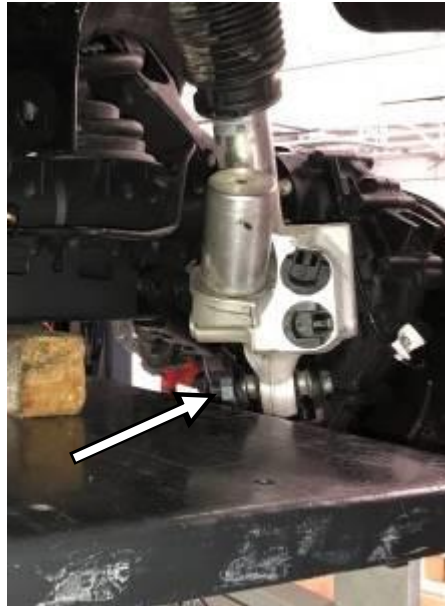
Figure 18

17. Unscrew left and right shock absorbers at bottom axle (**Figure 18**).

i The shock absorbers remain on the vehicle and need not be removed completely.

Nm Shock absorber screw to holder (axle tube): **Stage 1: 100 Nm**
Stage 2: 90°

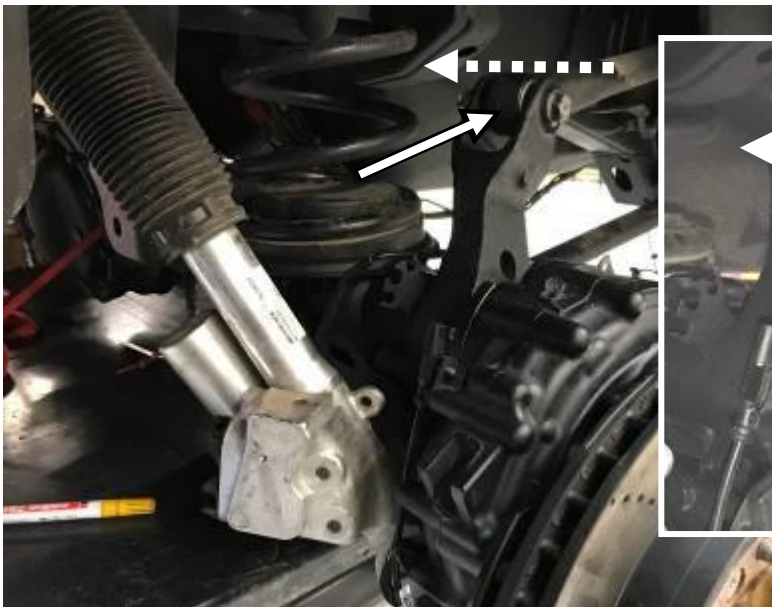
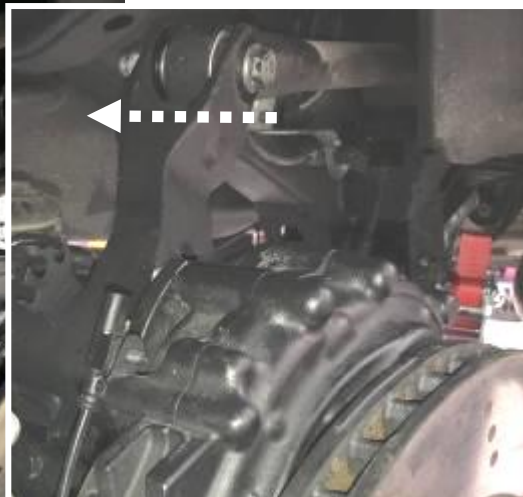
Figure 19

18. Release screw connection of top left and right trailing arms at rear axle (**Figure 19 and 20**).

Nm Upper trailing arm screw to rear axle: **Stage 1: 100 Nm**
Stage 2: 90°

i **Important!** The **new** screw on rear axle to the upper trailing arm is inserted inwards, from wheel side towards the rear axle spring (**Figure 19**).

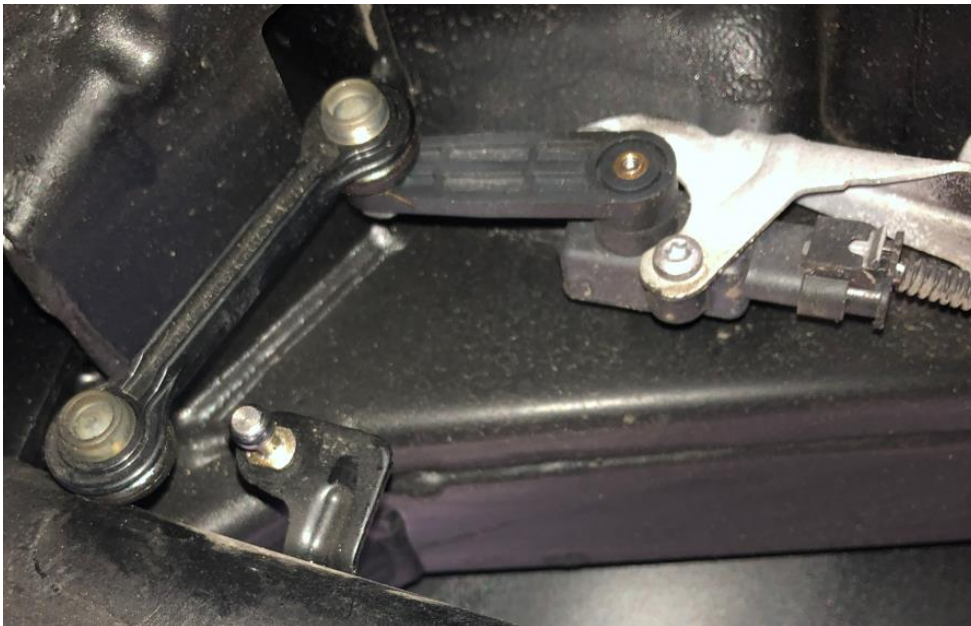
Figure 21

19. Mark adjusting plates for adjusting the drive line angle, disconnect level sensors on trailing arms (Figure 21) and unscrew connection of the rear axle at left and right lower trailing arms (Figure 22).

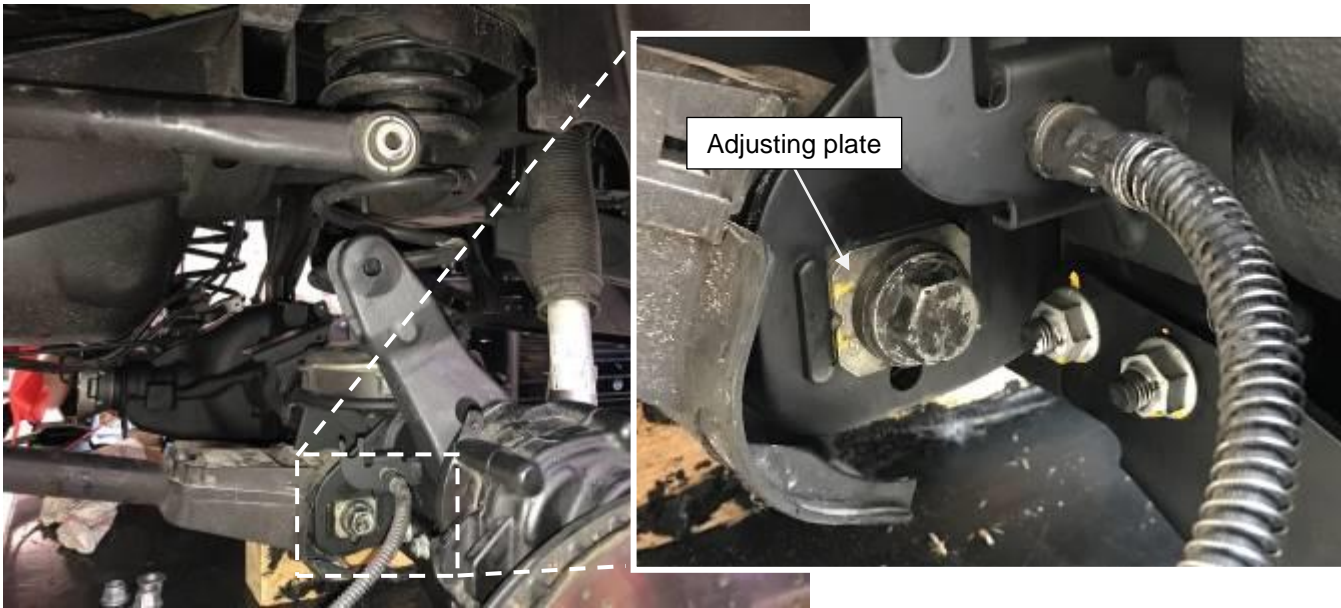
Figure 22

Nm Lower trailing arm screw to rear axle: **Stage 1: 100 Nm**
Stage 2: 180°

i Important! Mark adjusting plates and install in the same location and same installation position on the new axle.

i Installation: Install adjusting plates with opening pointing downward.

i Installation: The notch on the adjusting plate should point in the direction of travel.

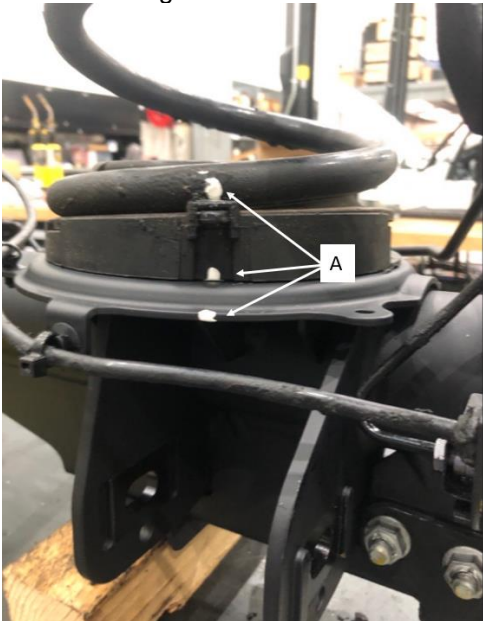
Figure 23

21. Mark the springs, as well as the upper and lower spring retainer, then remove the springs completely (**Figure 23, A**).

i **Installation:** Align installation position (**Figure 23, A**).

i A tensioning device is not needed.

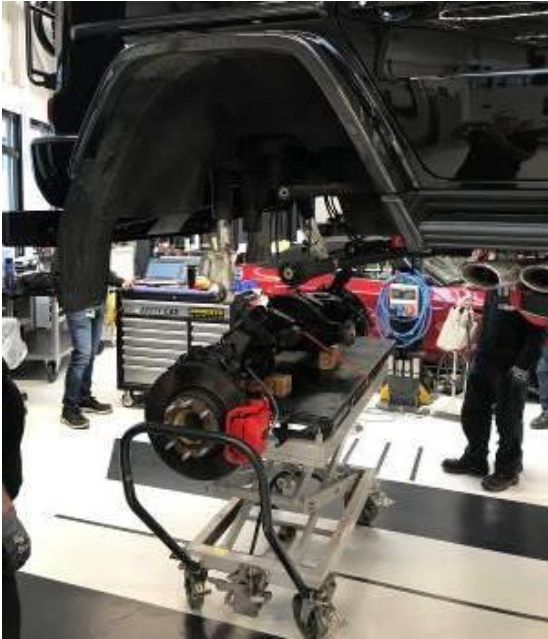
Figure 24

22. Fully lower rear axle and remove from underneath vehicle (**Figure 24**).

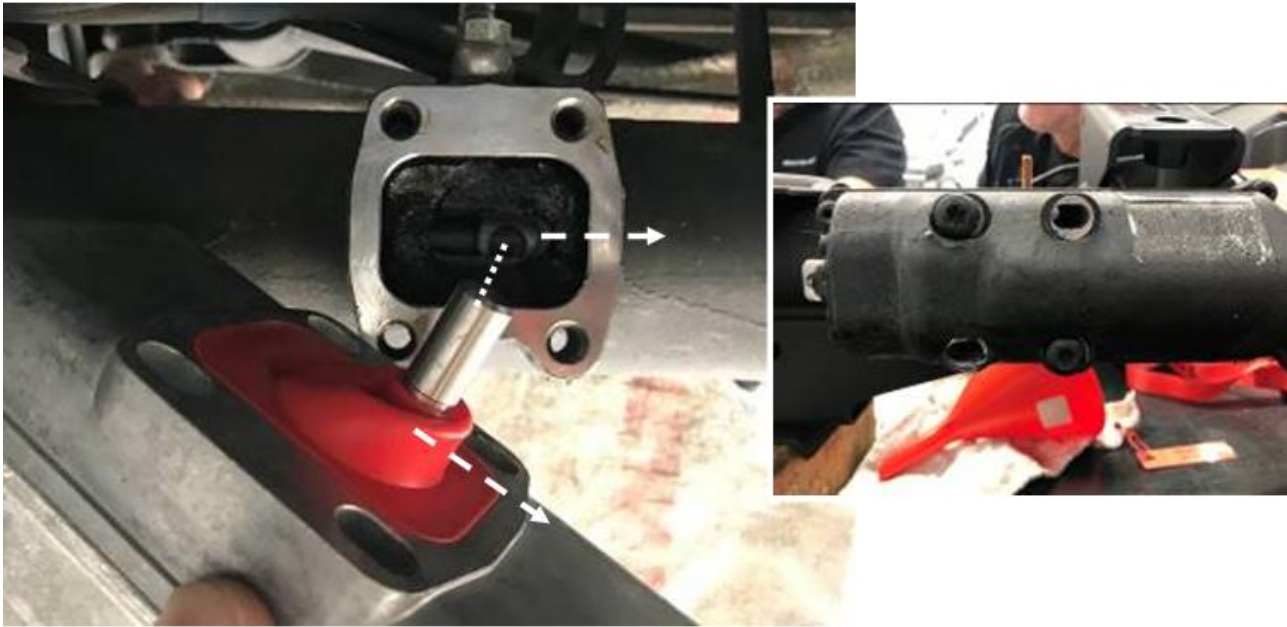
Figure 25

25. Remove rear axle actuator (**Figure 25**).

Rear axle actuator is in **lock engaged position**.
-

**Installation:** The slide in the axle tube for actuating the lock must be slid in the direction of the axle centerpiece. One of the wheel flanges must be turned at the same time.
-

Locking Actuator screw to axle tube **Stage 1: 10 Nm**
Stage 2: 20 Nm
Stage 3: 60°

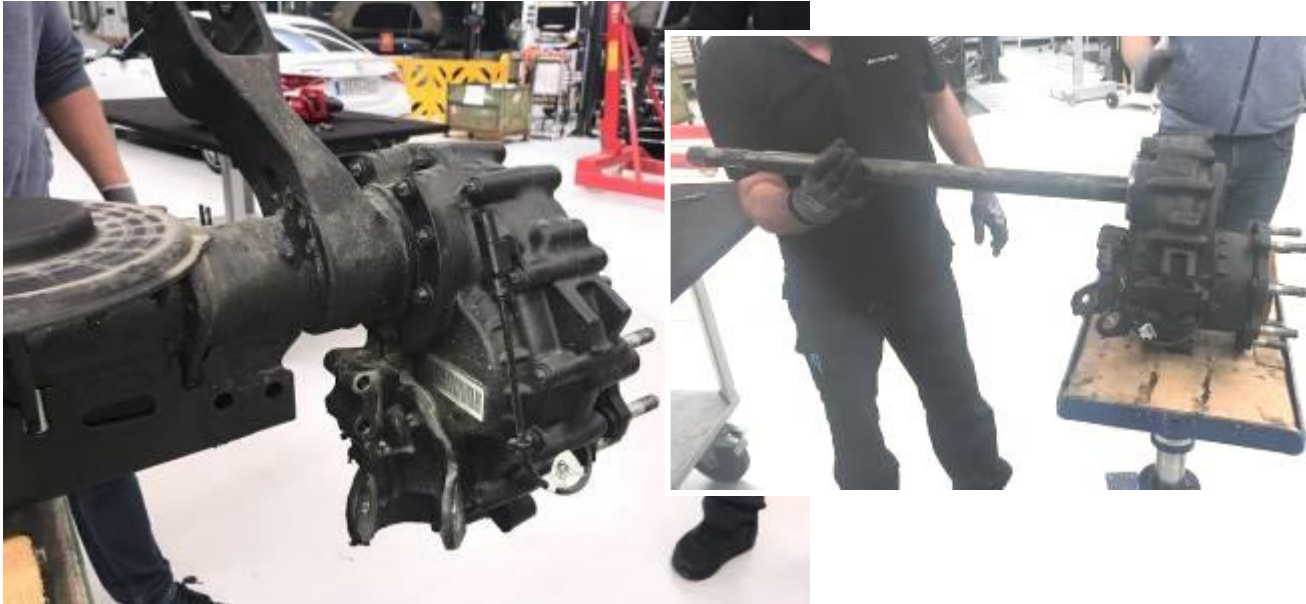
Figure 27

27. Remove left and right hub reduction gears (**Figure 27**).

Nm Hub reduction gear screw to axle tube: **Stage 1: 40 Nm**
Stage 2: 45°

i **Installation:** Carefully slide hub reduction gear with axle shaft into rear axle differential while turning at the same time so that the gearing engages.

i **Installation:** Exercise particular caution when inserting the right (passenger side) portal axle to ensure the slide for the lock actuation is not damaged.

i **Installation:** To install the right-side portal axle, **position the lock actuator temporarily** so that the lock tube has better guidance into the new axle centerpiece.

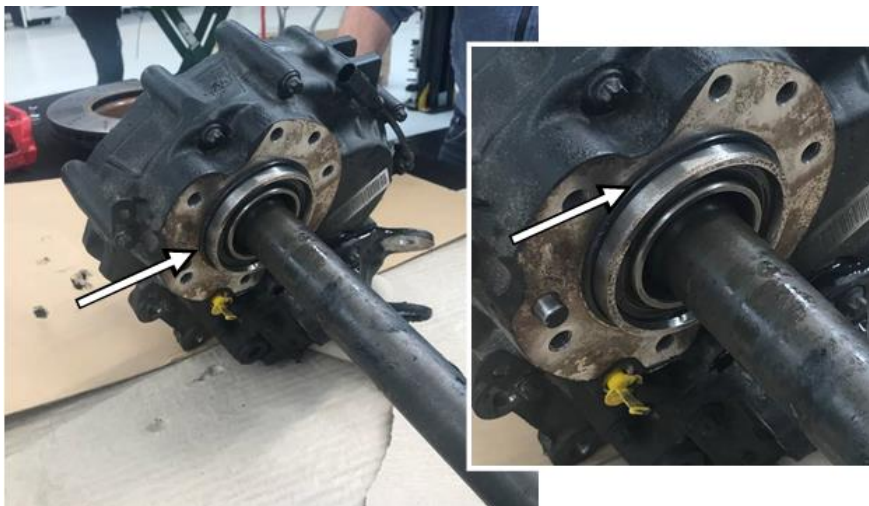
Figure 28

28. Replace sealing rings on hub reduction gears and install axle hubs (**Figure 28**).

i New sealing rings are included in the delivery package of the new axle centerpiece.

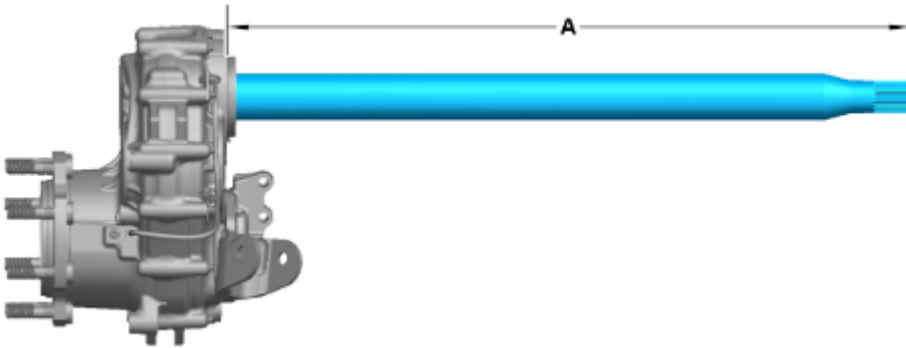
i Installed dimension of left rear axle drive shaft **727.2mm \pm 1.5mm (Figure 29, A)**.

Figure 29: Left hub reduction gear, A installed dimension: 727.2 mm \pm 1.5 mm

30. Check installed dimension of drive shafts (**Figure 29 & 30**) in hub reduction gears prior to installing into new axle centerpiece.

i If the drive shaft has moved out of the hub reduction gear, it must be removed completely and reinstalled with a new snap ring.

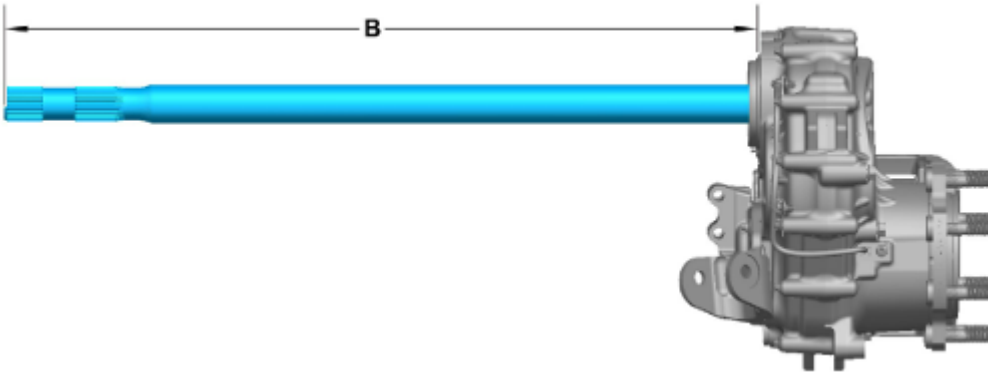
i Installed dimension of right rear axle drive shaft **743.3mm \pm 1.5mm (Figure 30, B)**.

Figure 30: Right hub reduction gear, B installed dimension: 743.3 mm \pm 1.5 mm

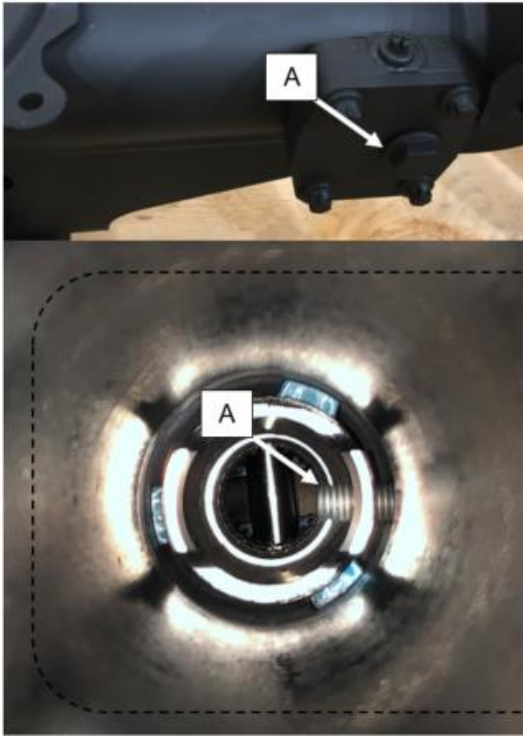
- i** For the installation of the right hub reduction gear, it is required to back out the bolt (**Figure 31, A**) on the new axle until there are no threads protruding into the axle shaft housing (**Figure 32, B**).

Figure 31 (delivery condition of bolt)

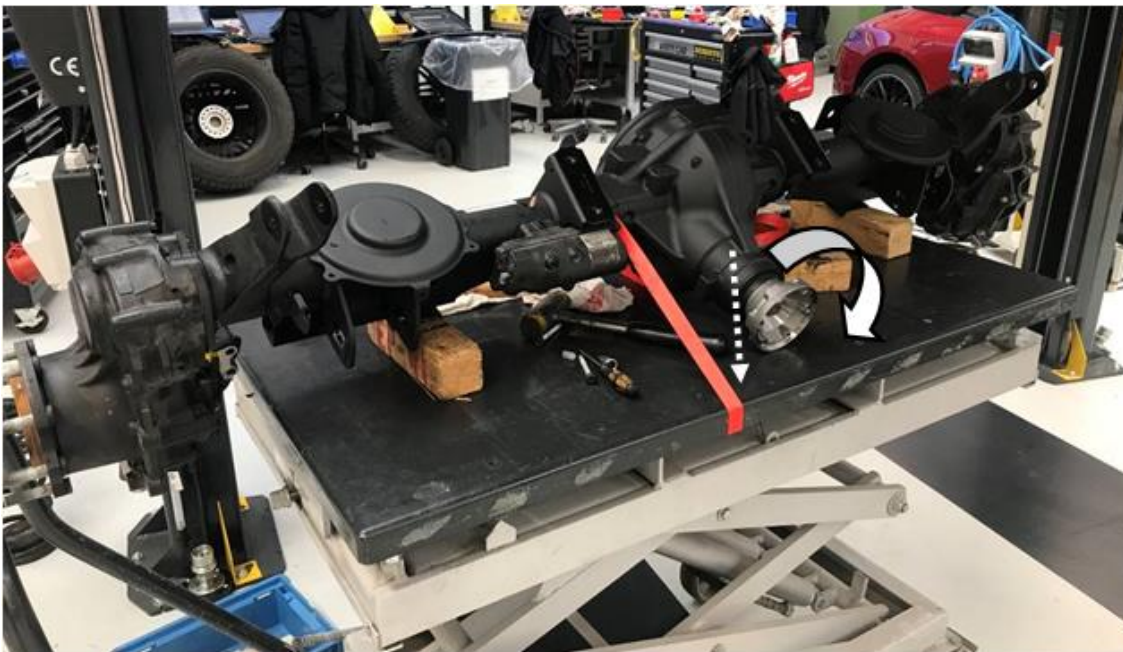
Figure 33

32. Fill rear axle centerpiece with 1.5 liters of oil and rotate the differential drive pinion multiple times for **at least 30 seconds** with the drive pinion tilted downward by **at least 5–10°** (**Figure 33**).

- i** **Attention, very important:** This ensures the bearing of the drive pinion is sufficiently lubricated prior to initial use.

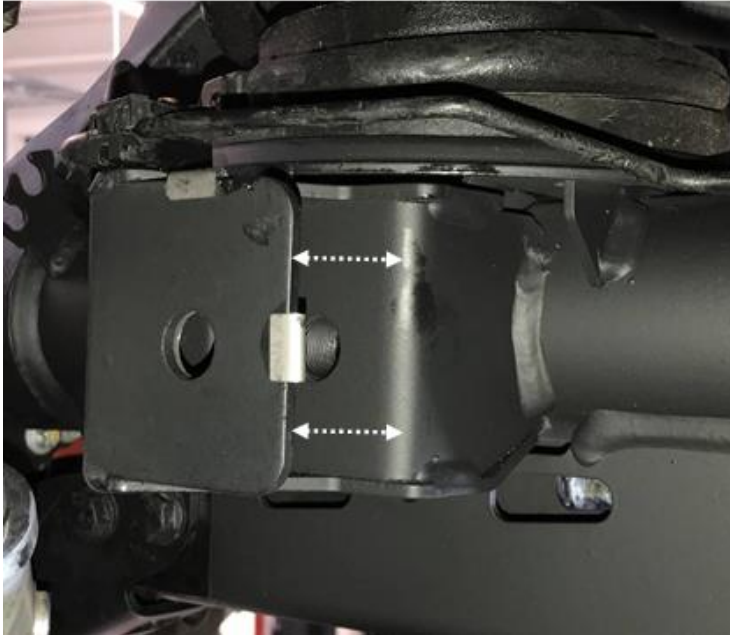
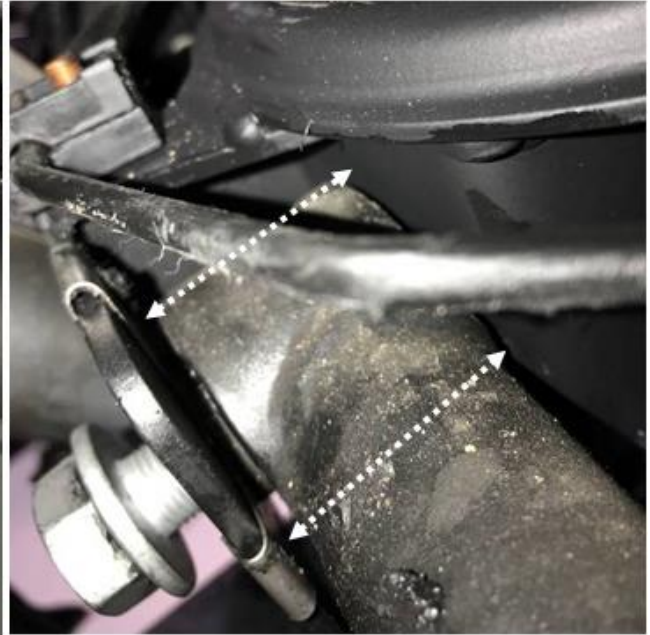
Figure 34

33. Install adjusting plate (if necessary) for transverse control arm on new axle bridge (**Figure 34, 35**).

i The left bearing of the transverse control arm must be installed with suction and with almost zero clearance, into the retaining tab of the axle bridge.

i The fit for the transverse control arm can be adjusted as required, either **without** an adjusting plate, **with a 0.5 mm** adjusting plate, or **with a 0.8 mm** adjusting plate.

i A maximum of one adjusting plate may be installed.

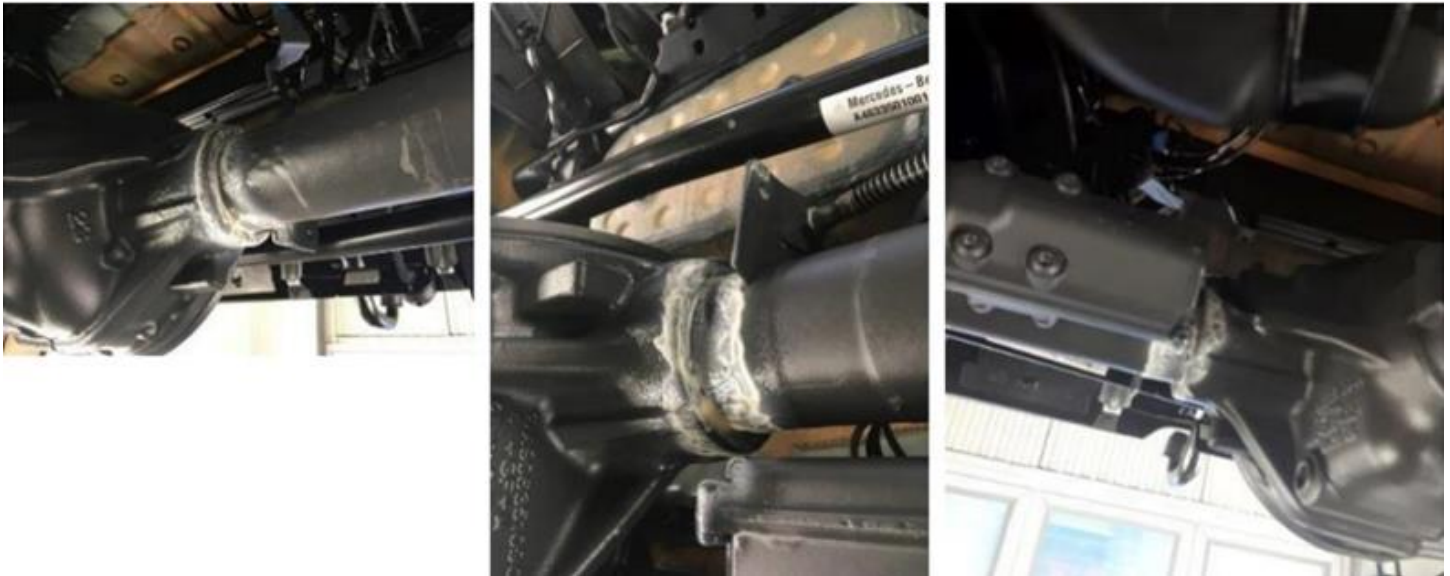
Figure 36

39. Apply wax **A 000 986 32 01 09** to rear axle in area between axle tube and differential (**Figure 36**).

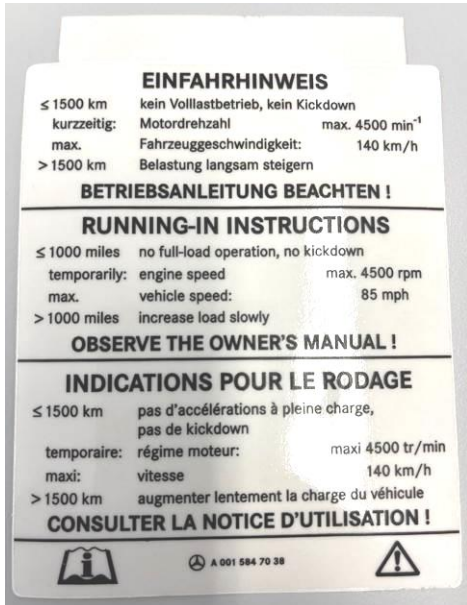
Figure 37

42. Install adhesive label for running-in (break-in period) instructions (**Figure 37**) in top left-hand corner on inside of windshield.

RUNNING-IN INSTRUCTIONS

≤ 1000 miles	no full-load operation, no kickdown	
temporarily:	engine speed	max. 4500 rpm
max.	vehicle speed:	85 mph
>1000 mi	increase load slowly

- Install adhesive label for running-in (break-in period) instructions (**Page 20, Figure 37**) in top left-hand corner on inside of windshield.
- Print out information about running-in (break-in period) instructions (**Page 23**) and provide to customer.
NOTE: Running-in instructions are the maximum guidelines for the rear axle operation break-in period.
