TO: Mercedes-Benz Dealer Principals, General Managers, Sales Managers, Service Managers, Parts Managers	FROM: Gregory Gunther, Senior Manager, Vehicle Compliance and Analysis, Engineering Services
RE: Recall Campaign - Launch Notification Replace Rear Axle Differential Housing – Wave 2 MY22-23 AMG G63 4x4 squared (463 platform)	DATE: June 14, 2024

Campaign No. 2024050005, June 2024

SUBJECT: **Model G-Class (463 platform)**
Model Year 2022 – 2023

Replace Rear Axle Differential Housing – Wave 2

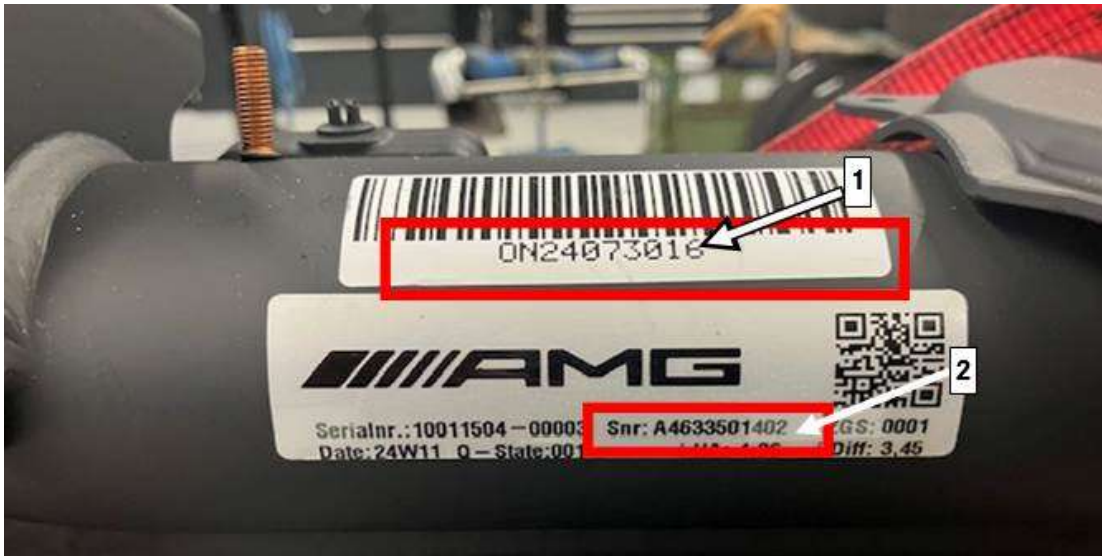
Figure 1

i Serial number (**Figure 1, 1**) and item number (**Figure 1, 2**).

i After the **rear axle centerpiece** has been replaced, the new **serial number** and **item number** must be documented in **VeDoc**. This can be done by opening a “**Vehicle Data/VeDoc**” XSF ticket and providing a picture of the new serial number and item number.

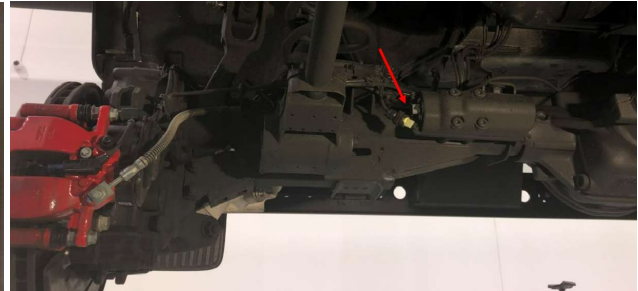
Figure 5

2. When the vehicle wheels are **lifted** off the ground, engage the rear axle differential lock actuator and then disconnect the electrical plug on the rear axle lock actuator while the lock is engaged.
i **The rear axle must be removed with the lock actuator set to lock position.**
i **To do this:** Start the engine – Release the parking brake – Engage Neutral position (N) – Engage Low Range (**Figure 3**) – Engage Drive position (D) – Engage Center Differential Lock (**Figure 4, 1**) – While wheels are rotating slowly, Engage Rear Axle Differential Lock (**Figure 4, 2**) – Ensure red confirmation light is illuminated for Center and Rear Differential Lock (**Figure 4**) – Switch 'OFF' Ignition – Disconnect electrical plug on Lock Actuator of rear axle and leave disconnected (**Figure 5**).

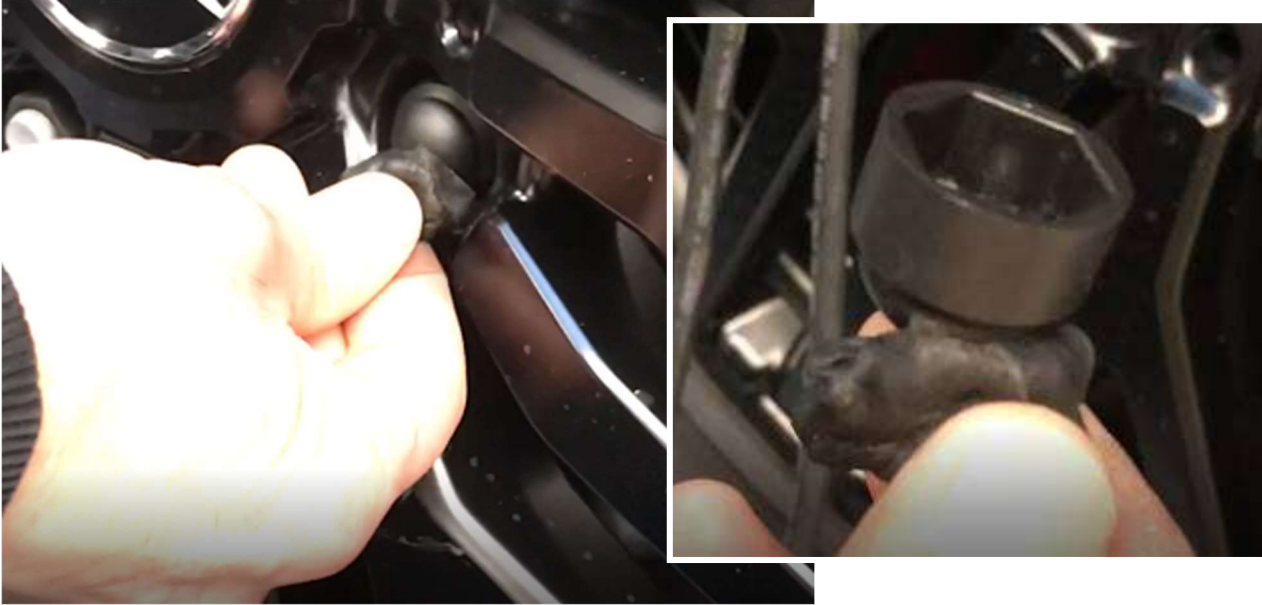
Figure 7

5. Remove cover caps of wheel nuts on all four wheels (**Figure 7**).

i To do this, clean cover caps then press Butyl Tape firmly against the cover cap and pull off the cap.

i Damaged cover caps must be replaced.

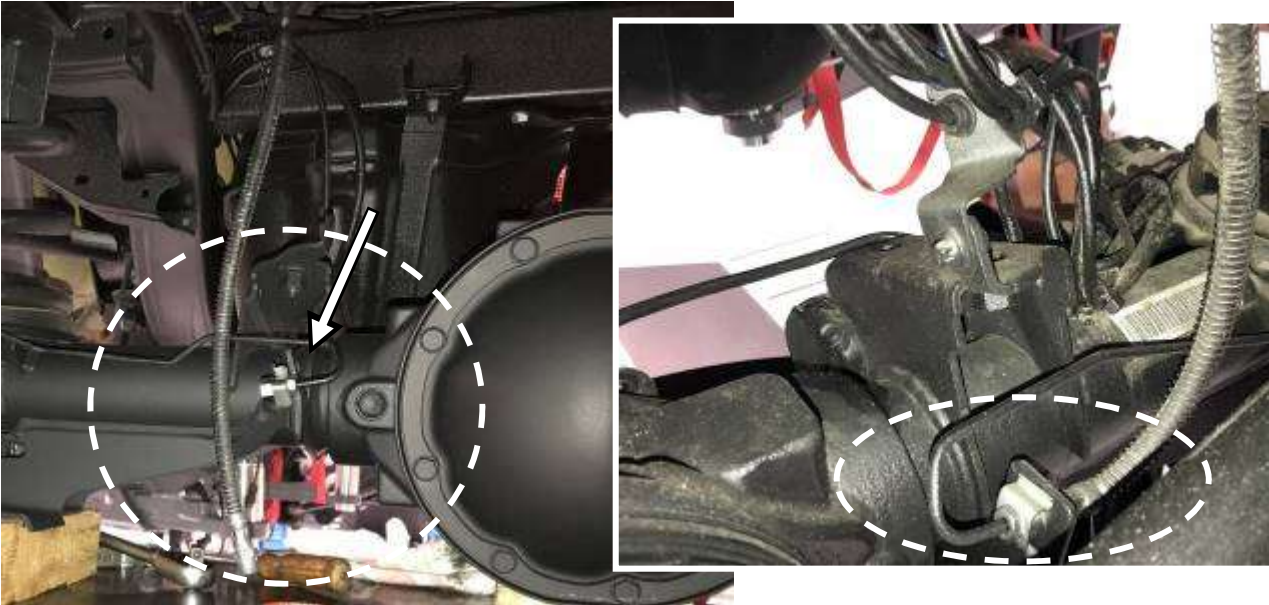
Figure 13

12. Unscrew brake hoses from brake lines on inside of axle (**Figure 13**) and seal open brake lines with suitable stop plugs (e.g. W129 589 00 91 10).

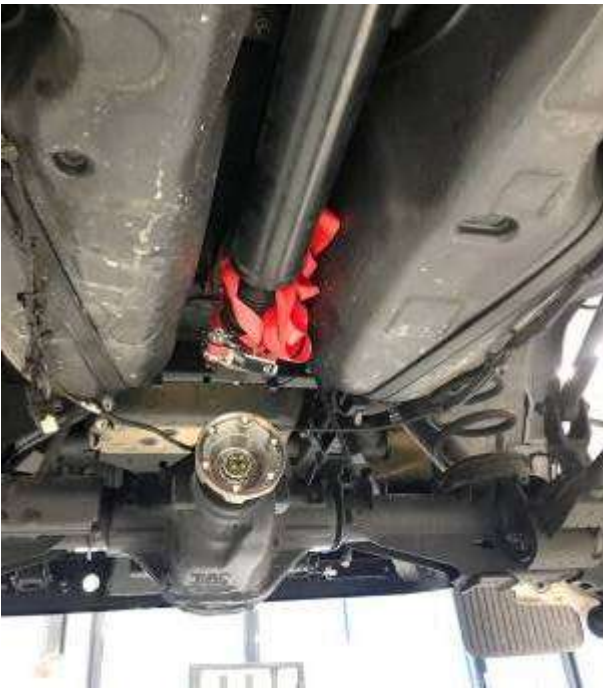
Figure 14

13. Unscrew propeller shaft at rear axle differential, and secure from falling by tying to the top (**Figure 14**).

Nm Propeller shaft screws at rear axle differential: **Stage 1: 40 Nm**
Stage 2: 90°

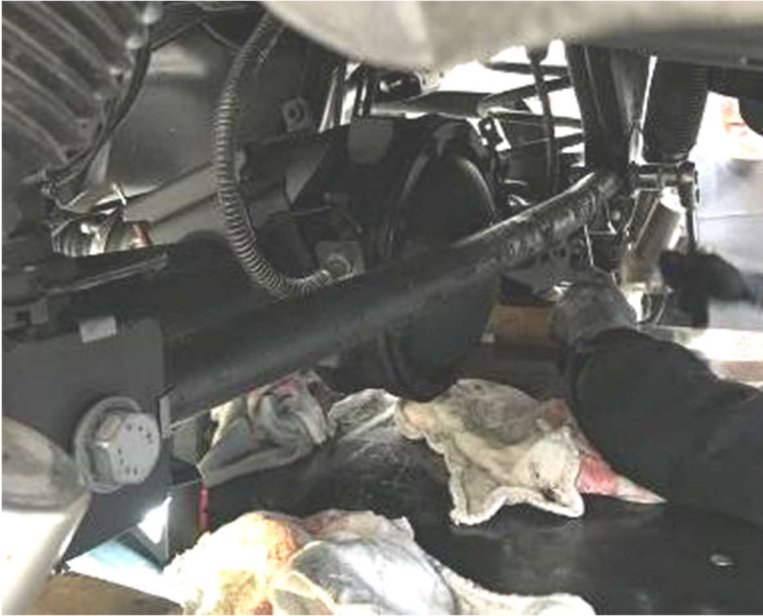
Figure 17

16. Remove transverse control arm of rear axle (**Figure 17**).

Nm Transverse control arm screw to rear axle: **Stage 1: 150 Nm**
Stage 2: 90°

Nm Transverse control arm screw to frame: **Stage 1: 150 Nm**
Stage 2: 90°

i During installation, the transverse control arm at the rear axle **must be fit into the bearing using a shim**.

i The previously installed original adjusting plate shim can be reused.

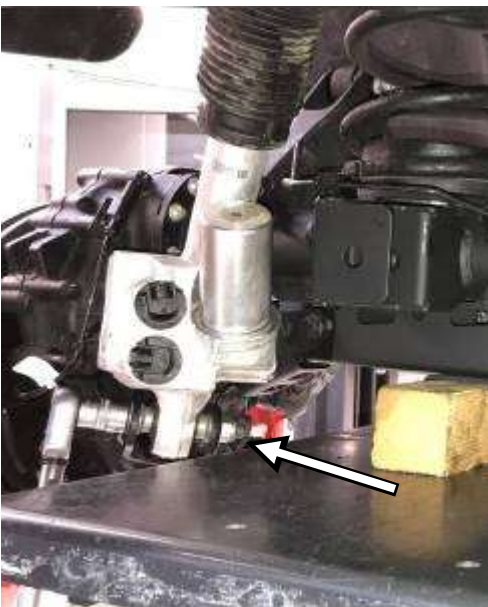
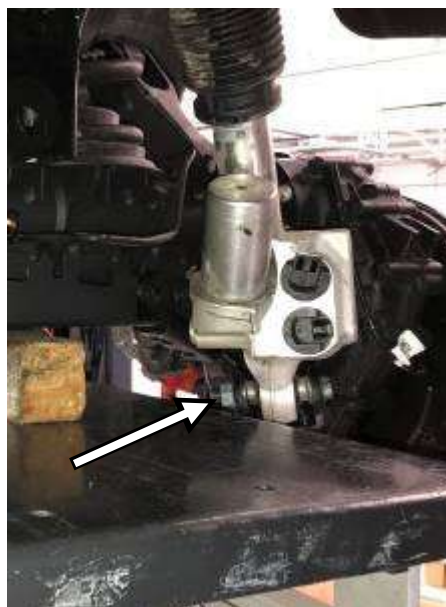
Figure 18

17. Unscrew left and right shock absorbers at bottom axle (**Figure 18**).

i The shock absorbers remain on the vehicle and need not be removed completely.

Nm Shock absorber screw to holder (axle tube): **Stage 1: 100 Nm**
Stage 2: 90°

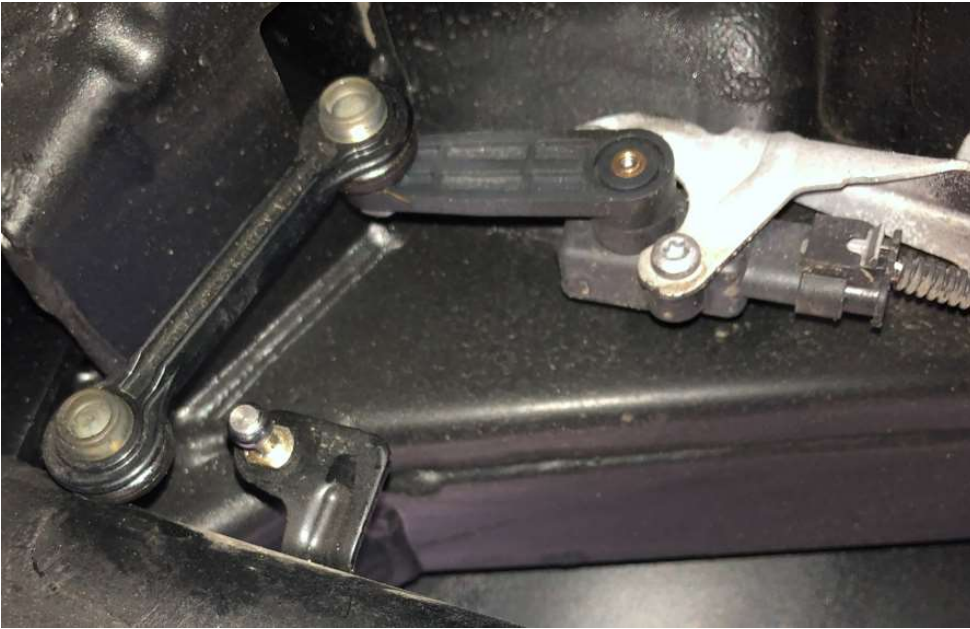
Figure 21

19. Mark adjusting plates for adjusting the drive line angle, disconnect level sensors on trailing arms (**Figure 21**) and unscrew connection of the rear axle at left and right lower trailing arms (**Figure 22**).

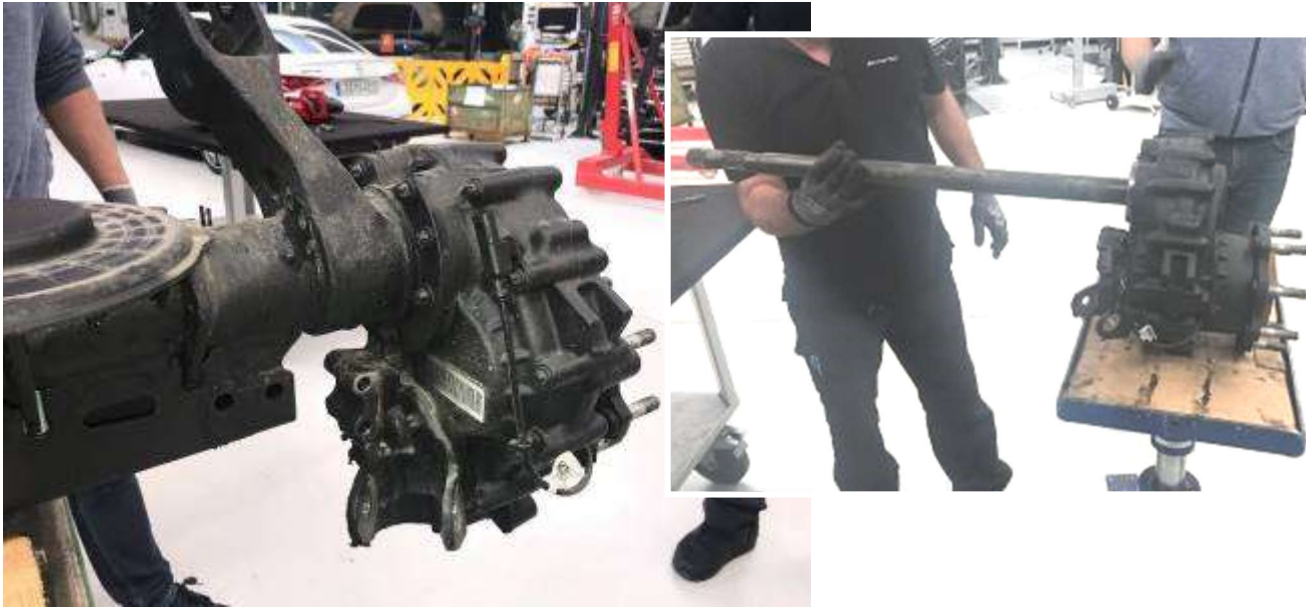
Figure 27

27. Remove left and right hub reduction gears (**Figure 27**).

Nm Hub reduction gear screw to axle tube: **Stage 1: 40 Nm**
Stage 2: 45°

i **Installation:** Carefully slide hub reduction gear with axle shaft into rear axle differential while turning at the same time so that the gearing engages.

i **Installation:** Exercise particular caution when inserting the right (passenger side) portal axle to ensure the slide for the lock actuation is not damaged.

i **Installation:** To install the right-side portal axle, **position the lock actuator temporarily** so that the lock tube has better guidance into the new axle centerpiece.

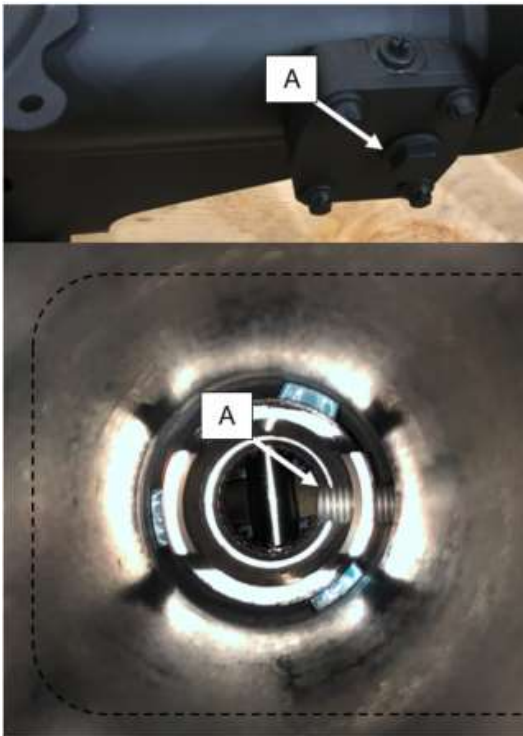
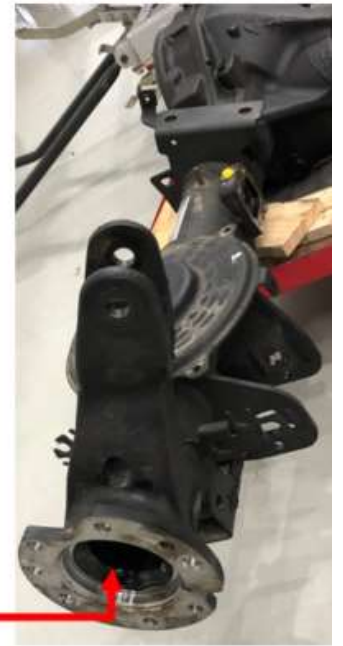
i For the installation of the right hub reduction gear, it is required to back out the bolt (**Figure 31, A**) on the new axle until there are no threads protruding into the axle shaft housing (**Figure 32, B**).

Figure 31 (delivery condition of bolt)

Figure 32 (backed out bolt for mounting position)

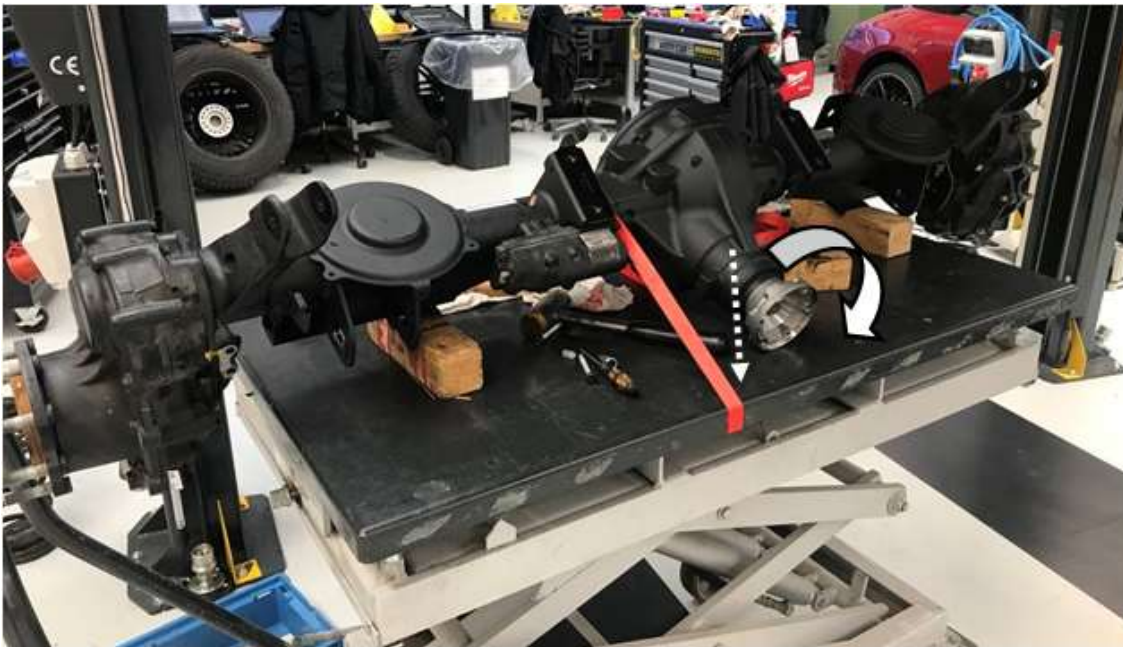
Figure 33

32. Fill rear axle centerpiece with 1.5 liters of oil and rotate the differential drive pinion multiple times for **at least 30 seconds** with the drive pinion tilted downward by **at least 5–10°** (**Figure 33**).

i **Attention, very important:** This ensures the bearing of the drive pinion is sufficiently lubricated prior to initial use.

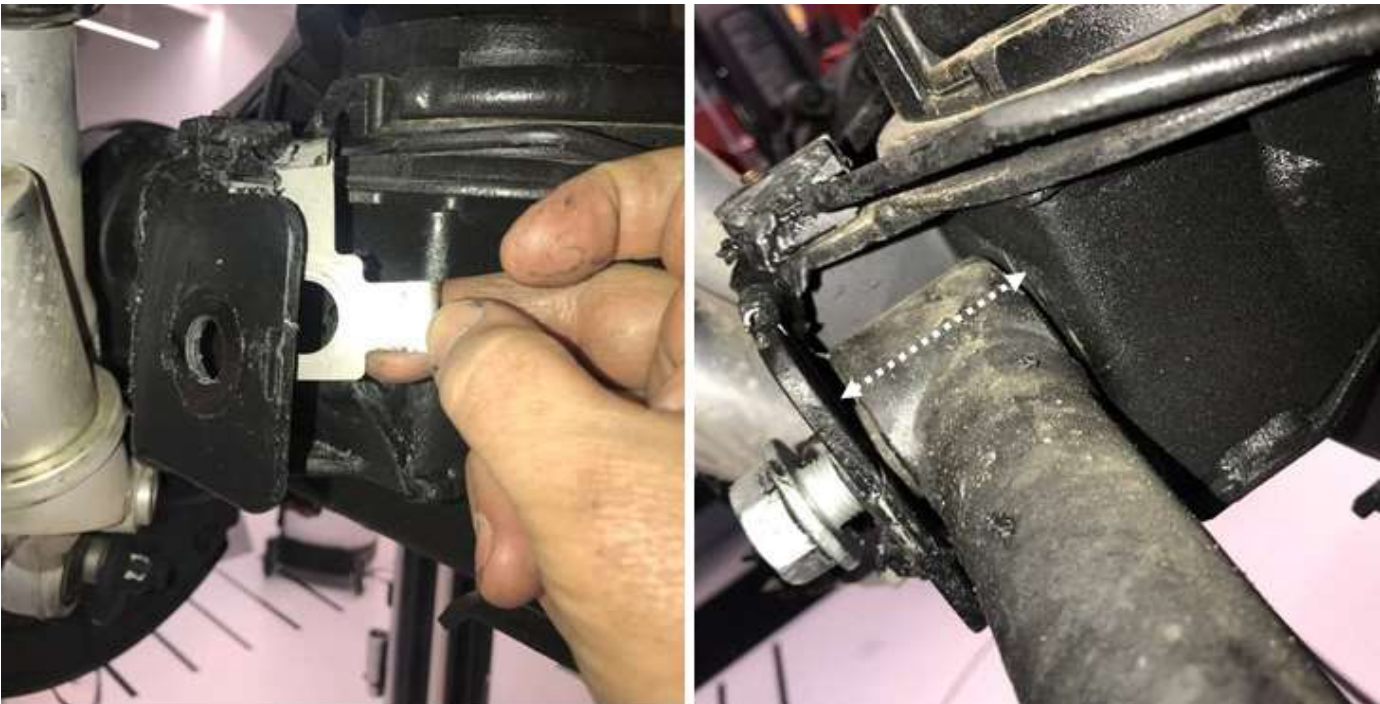
Figure 35

33. Install adjusting plate (if necessary) for transverse control arm on new axle bridge (**Figure 34, 35**).

i A maximum of one adjusting plate may be installed.
