TO: Mercedes-Benz Dealer Principals, General Managers, Sales Managers, Service Managers, Parts Managers	FROM: Gregory Gunther, Senior Manager, Vehicle Compliance and Analysis, Engineering Services
RE: <b>Recall Campaign - Launch Notification</b> <b>Replace Rear Axle Differential Housing – Wave 5</b> <b>MY22-23 AMG G63 4x4 squared (463 platform)</b>	DATE: September 6, 2024

Campaign No. 2024040012, June 2024

SUBJECT: **Model G-Class (463 platform)**  
**Model Year 2022 – 2023**

## **Replace Rear Axle Differential Housing – Wave 5**

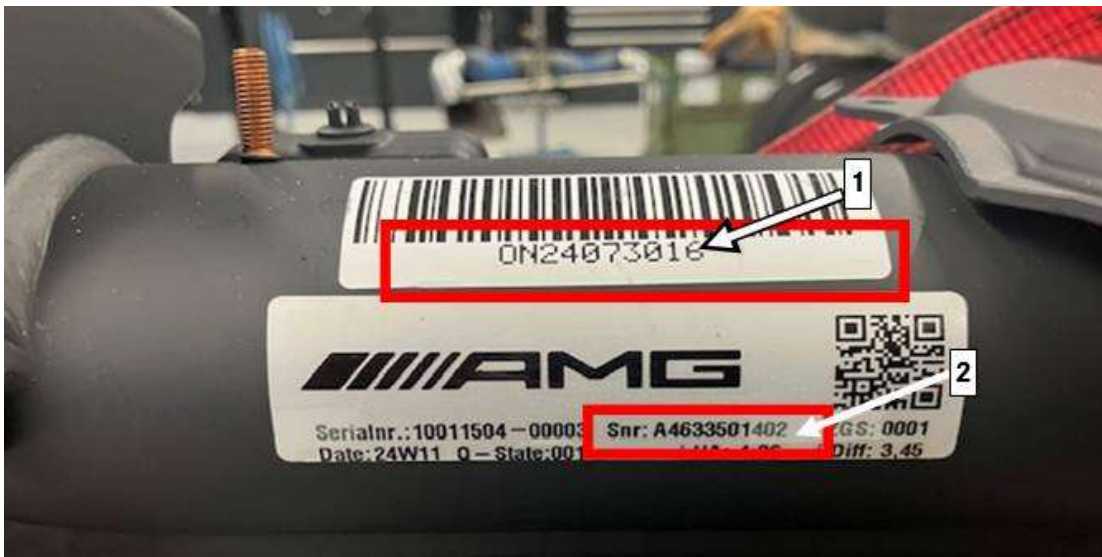
Figure 1

**i** Serial number (**Figure 1, 1**) and item number (**Figure 1, 2**).

**i** The new serial number (**Figure 1, 1**) and item number (**Figure 1, 2**) are documented in the VeDoc system in the tab “**VPD & SerienNr. (VPD & Serial no.) (Figure 2, 3)**” – “**Seriennummern (Serial numbers) (Figure 2, 4)**” – “**Hinterachse 1 Fremdhersteller -VPD-Ident (Rear axle 1 other manufacturer -VPD identification) (Figure 2, 5)**”.

**i** After the **rear axle centerpiece** has been replaced, the new **serial number** and **item number** must be documented in **VeDoc**. This can be done by opening a “**Vehicle Data/VeDoc**” **XSF ticket** and providing a picture of the new serial number and item number.

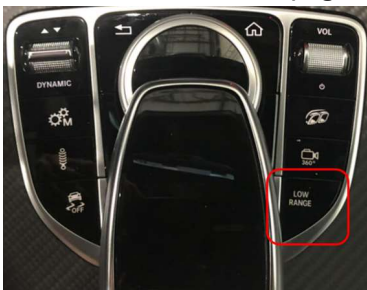
Figure 3

**i** **The rear axle must be removed with the lock actuator set to lock position.**  
**i** **To do this:** Start the engine – Release the parking brake – Engage Neutral position (N) – Engage Low Range (**Figure 3**) – Engage Drive position (D) – Engage Center Differential Lock (**Figure 4, 1**) – While wheels are rotating slowly, Engage Rear Axle Differential Lock (**Figure 4, 2**) – Ensure red confirmation light is illuminated for Center and Rear Differential Lock (**Figure 4**) – Switch 'OFF' Ignition – Disconnect electrical plug on Lock Actuator of rear axle and leave disconnected (**Figure 5**).

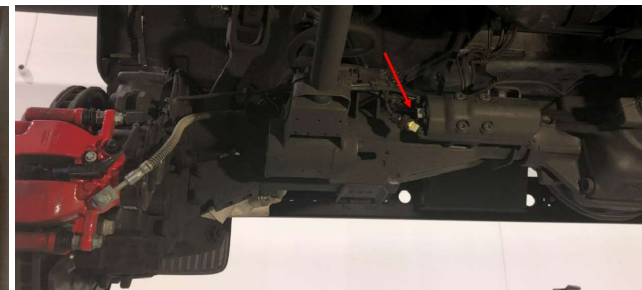
Figure 5

2. When the vehicle wheels are **lifted** off the ground, engage the rear axle differential lock actuator and then disconnect the electrical plug on the rear axle lock actuator while the lock is engaged.

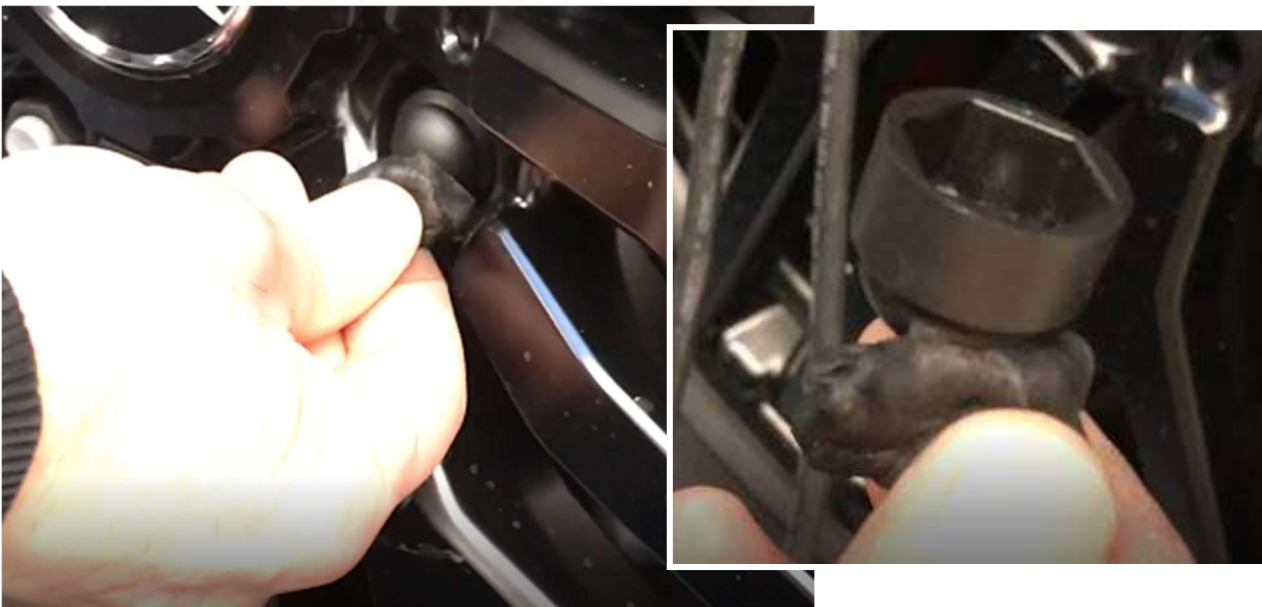
Figure 7

**i** For basic data, see **AR54.10-P-0003XG**.
5. Remove cover caps of wheel nuts on all four wheels (**Figure 7**).

**i** To do this, clean cover caps then press Butyl Tape firmly against the cover cap and pull off the cap.

**i** Damaged cover caps must be replaced.

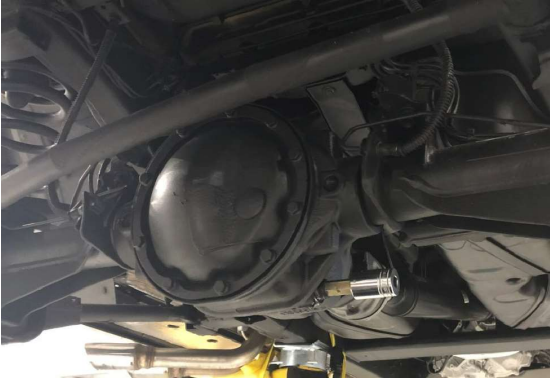
**Figure 8**

7. Drain rear axle oil (**Figure 8**).

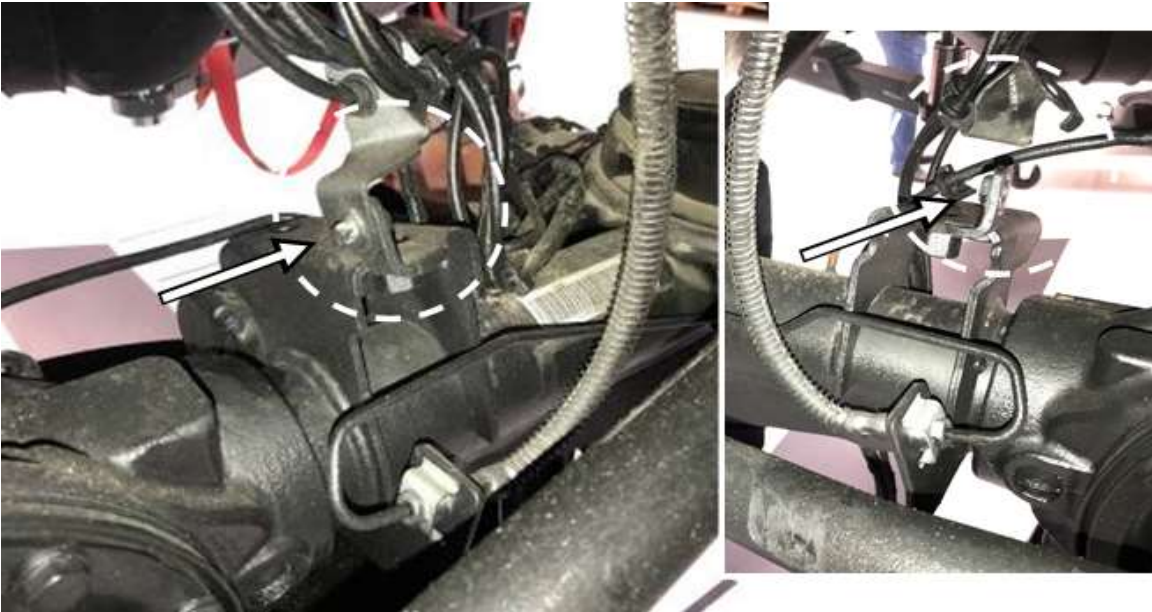
Figure 10

9. Unscrew the two holders for electrical wiring harness from the rear axle tube. (**Figure 10**).

Remove the complete rear axle wiring harness with holders and cable ties/clips from the rear axle and working area.

**i** Only replace defective cable ties/clips when installing the wiring harness onto the new axle bridge to ensure that the positioning of the wiring harness remains identical.

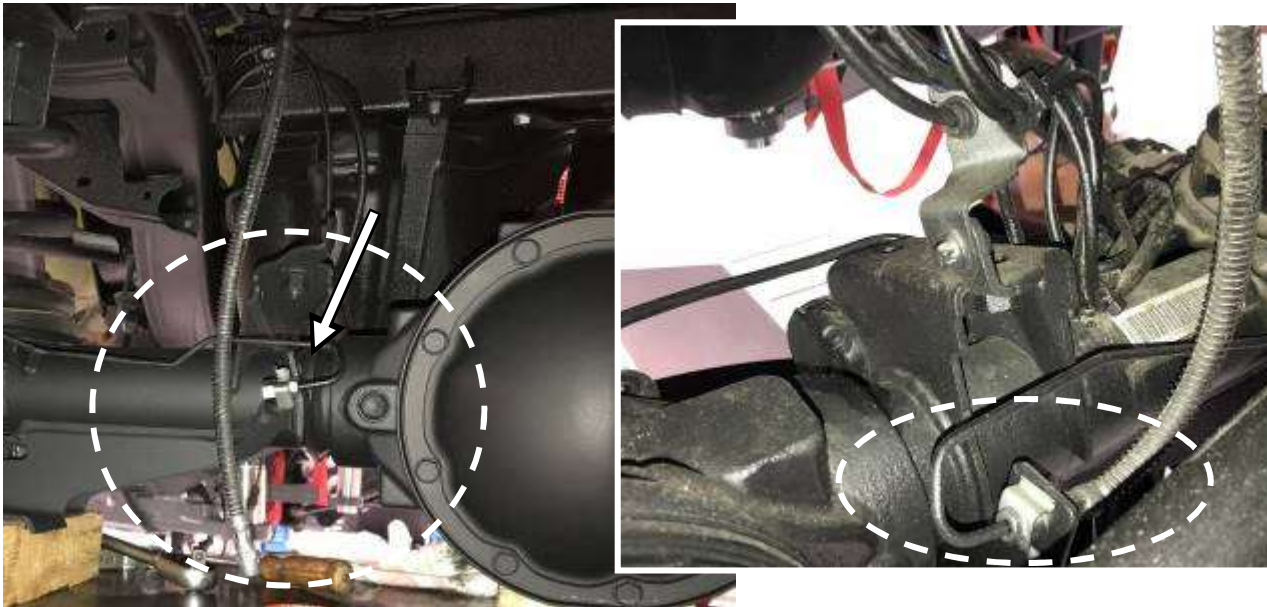
Figure 13

12. Unscrew brake hoses from brake lines on inside of axle (**Figure 13**) and seal open brake lines with suitable stop plugs (e.g. W129 589 00 91 10).

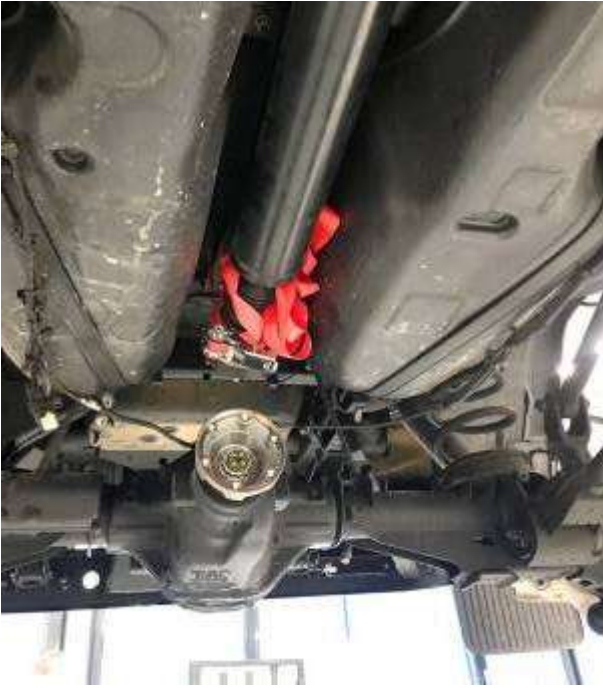
Figure 14

13. Unscrew propeller shaft at rear axle differential, and secure from falling by tying to the top (**Figure 14**).

**Hm** Propeller shaft screws at rear axle differential: **Stage 1: 40 Nm**  
**Stage 2: 90°**

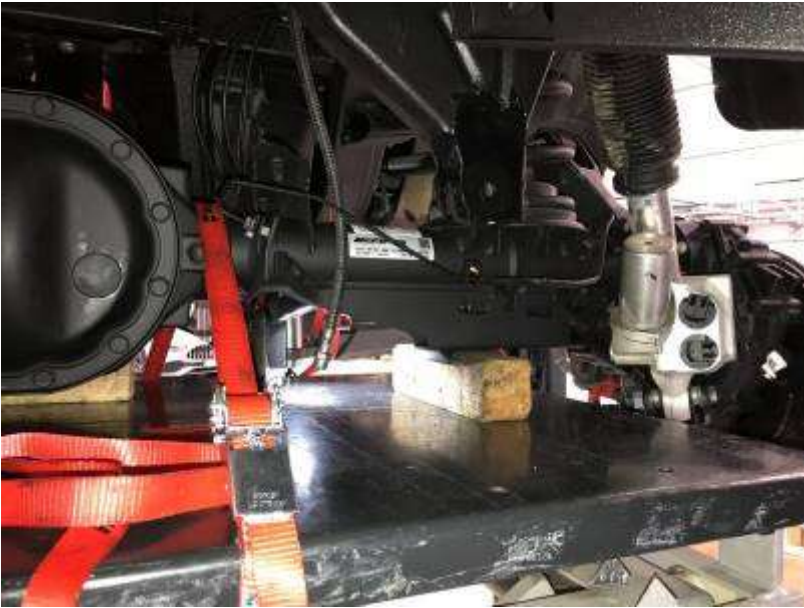
Figure 16

14. Position Lift table (W 000 588 03 62 00) under rear axle and use tension belt (**Figure 16**) to secure against falling.

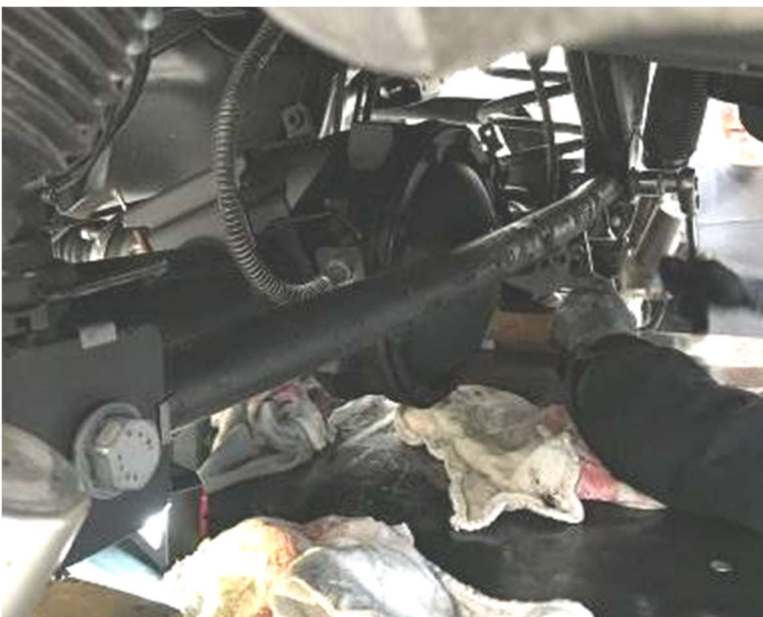
Figure 17

15. Lift major assembly lifting platform approx. 10 cm and bring rear axle to level of suspension.  
*i* This way, the screw connections can be released and tightened again without distortions.
16. Remove transverse control arm of rear axle (Figure 17).  
*i* For basic data, see **AR35.20-P-0140XG**.  
**Nm** Transverse control arm screw to rear axle: **Stage 1: 150 Nm**  
**Stage 2: 90°**  
**Nm** Transverse control arm screw to frame: **Stage 1: 150 Nm**  
**Stage 2: 90°**  
*i* During installation, the transverse control arm at the rear axle **must be fit into the bearing using a shim**.  
*i* **The previously installed original adjusting plate shim can be reused.**

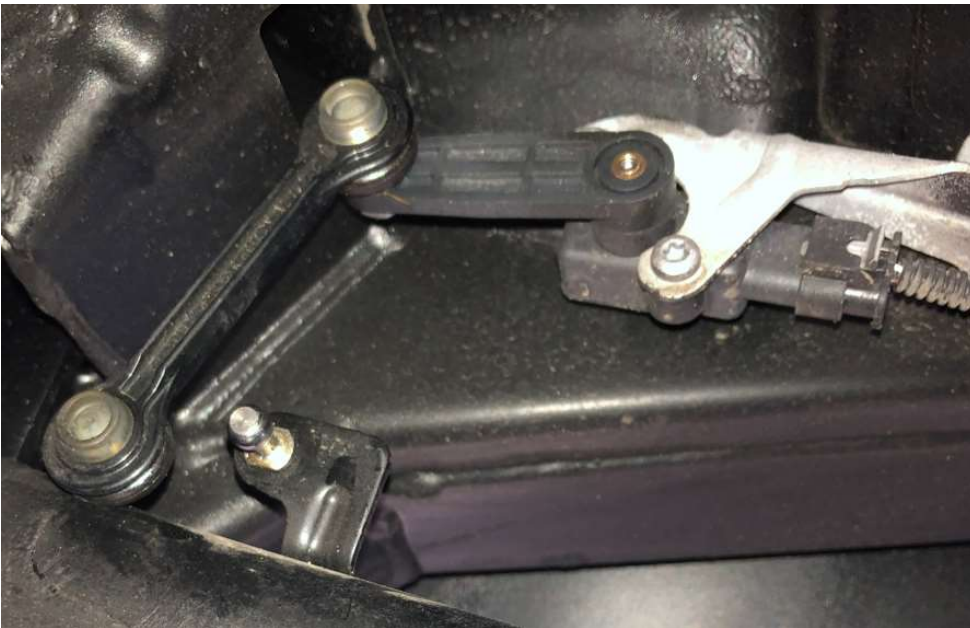
Figure 21

19. Mark adjusting plates for adjusting the drive line angle, disconnect level sensors on trailing arms (Figure 21) and unscrew connection of the rear axle at left and right lower trailing arms (Figure 22).

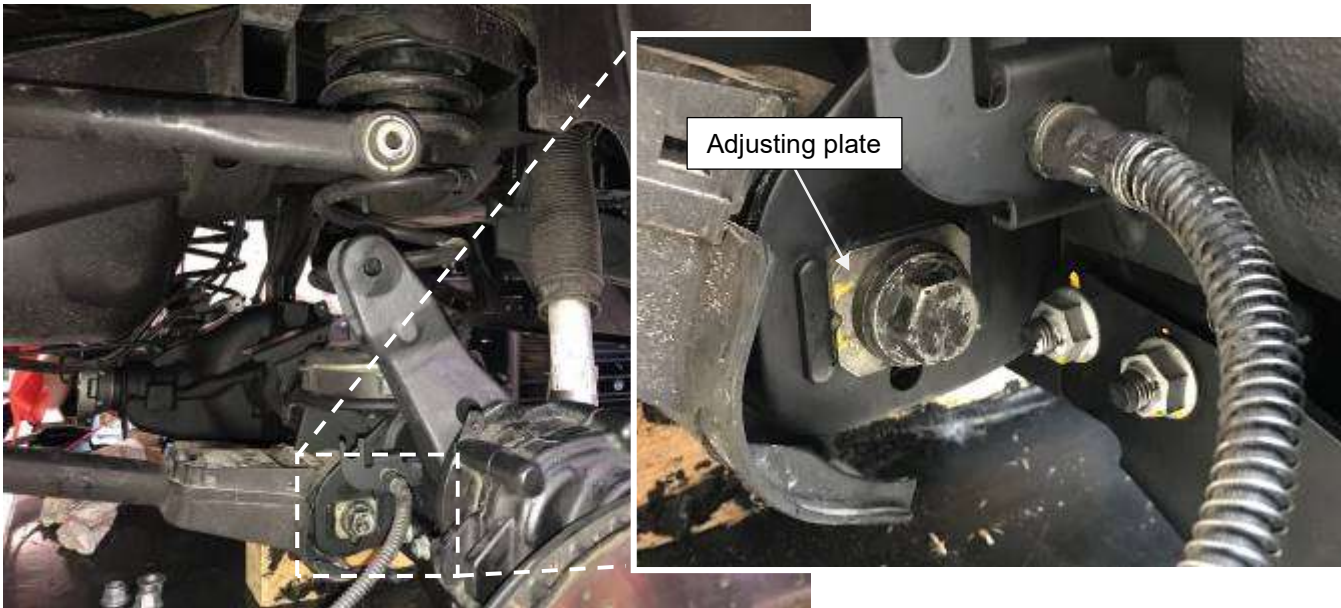
Figure 22

**Nm** Lower trailing arm screw to rear axle: **Stage 1: 100 Nm**  
**Stage 2: 180°**

**i Important!** Mark adjusting plates and install in the same location and same installation position on the new axle.

**i Installation:** Install adjusting plates with opening pointing downward.

**i Installation:** The notch on the adjusting plate should point in the direction of travel.

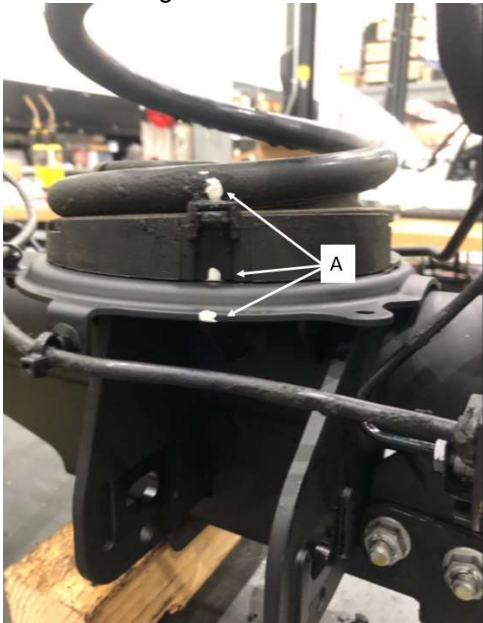
Figure 23

21. Mark the springs, as well as the upper and lower spring retainer, then remove the springs completely (**Figure 23, A**).

**i** **Installation:** Align installation position (**Figure 23, A**).

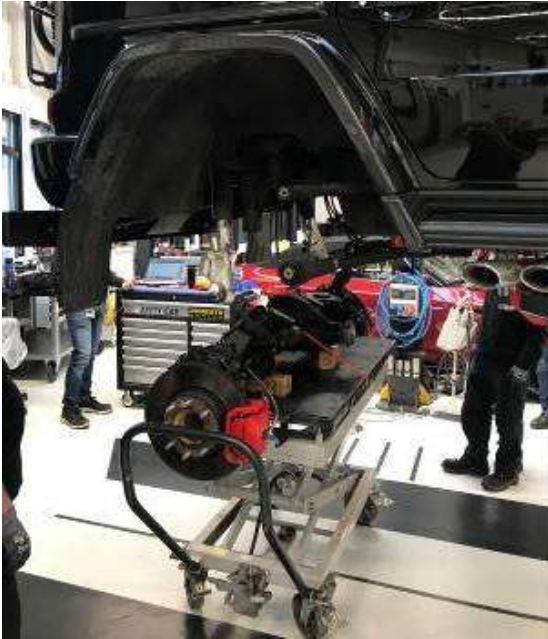
**Figure 24**

22. Fully lower rear axle and remove from underneath vehicle (**Figure 24**).

- i** For basic data, see **AR35.10-P-0010XG**
- i** Pay attention to surrounding component parts when lowering and lifting the rear axle.
- i** Unthread lower trailing arms while lowering.
- i** Helper required.

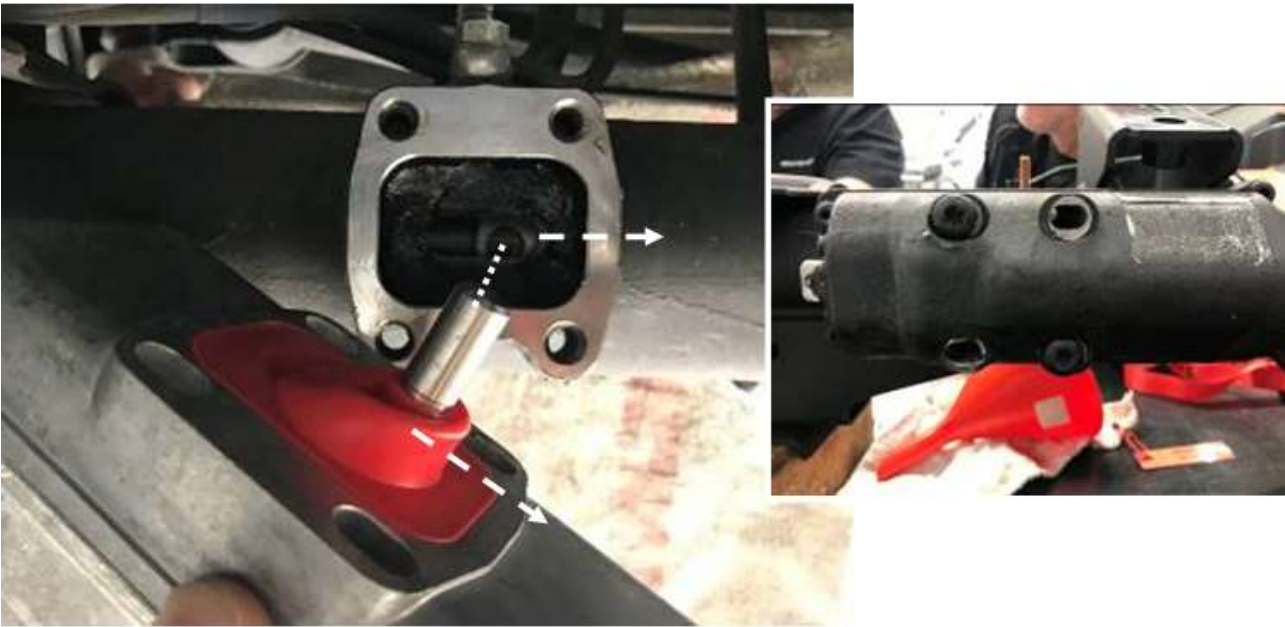
Figure 25

25. Remove rear axle actuator (**Figure 25**).

- i** For basic data, see **AR35.40-P-0001XGA**.
- i** Rear axle actuator is in **lock engaged position**.
- i** **Installation:** The slide in the axle tube for actuating the lock must be slid in the direction of the axle centerpiece. One of the wheel flanges must be turned at the same time.
- Nm** Locking Actuator screw to axle tube **Stage 1: 10 Nm**  
**Stage 2: 20 Nm**  
**Stage 3: 60°**

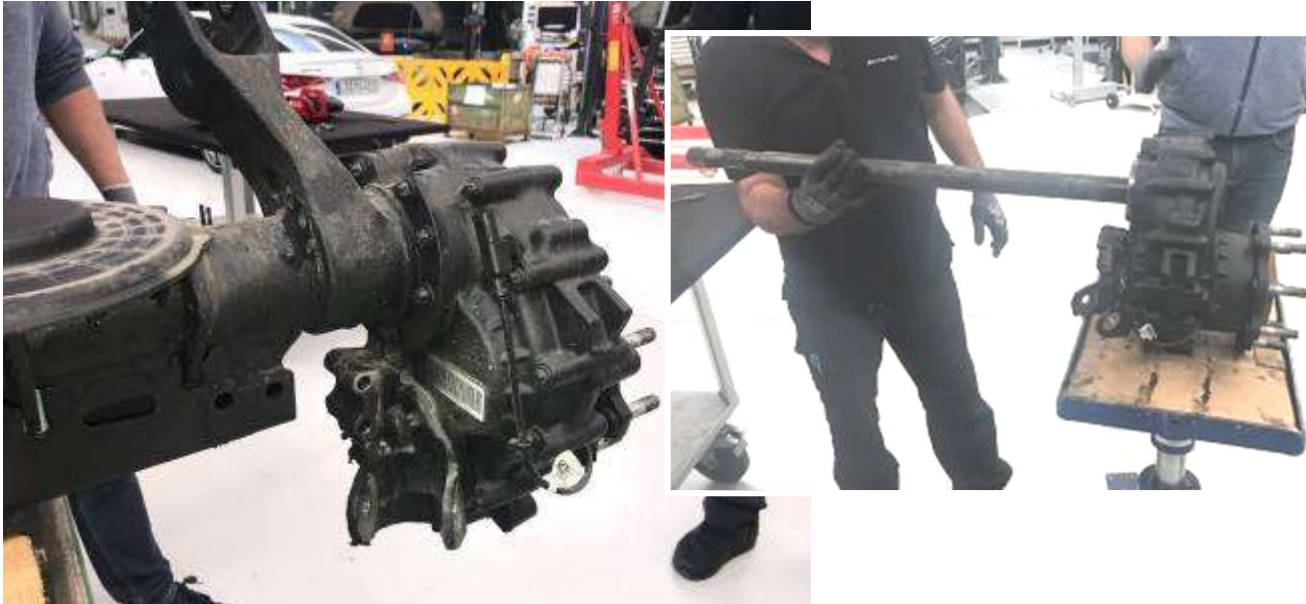
Figure 27

27. Remove left and right hub reduction gears (**Figure 27**).

**Nm** Hub reduction gear screw to axle tube: **Stage 1: 40 Nm**  
**Stage 2: 45°**

**i** **Installation:** Carefully slide hub reduction gear with axle shaft into rear axle differential while turning at the same time so that the gearing engages.

**i** **Installation:** Exercise particular caution when inserting the right (passenger side) portal axle to ensure the slide for the lock actuation is not damaged.

**i** **Installation:** To install the right-side portal axle, **position the lock actuator temporarily** so that the lock tube has better guidance into the new axle centerpiece.

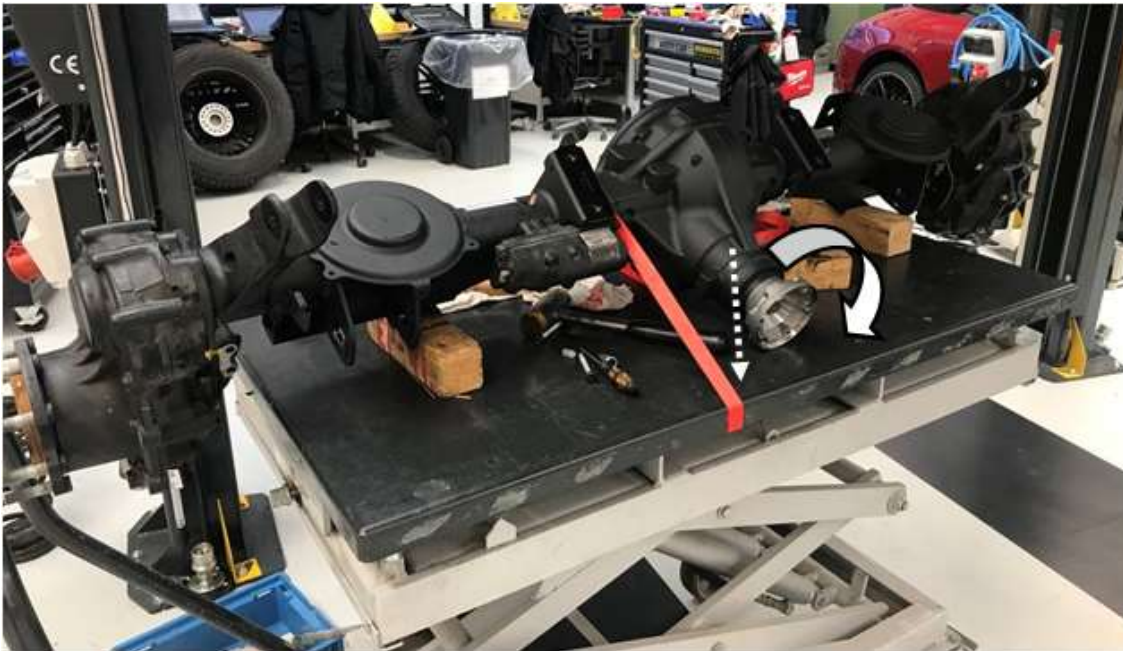
**Figure 33**

32. Fill rear axle centerpiece with 1.5 liters of oil and rotate the differential drive pinion multiple times for **at least 30 seconds** with the drive pinion tilted downward by **at least 5–10°** (**Figure 33**).

**i** **Attention, very important:** This ensures the bearing of the drive pinion is sufficiently lubricated prior to initial use.

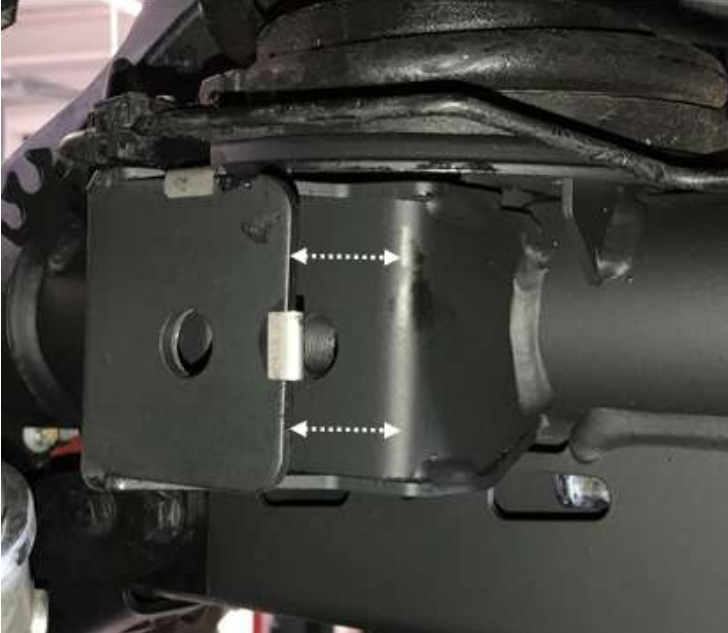
Figure 34

33. Install adjusting plate (if necessary) for transverse control arm on new axle bridge (**Figure 34, 35**).

**i** The left bearing of the transverse control arm must be installed with suction and with almost zero clearance, into the retaining tab of the axle bridge.

**i** The fit for the transverse control arm can be adjusted as required, either **without** an adjusting plate, **with a 0.5 mm** adjusting plate, or **with a 0.8 mm** adjusting plate.

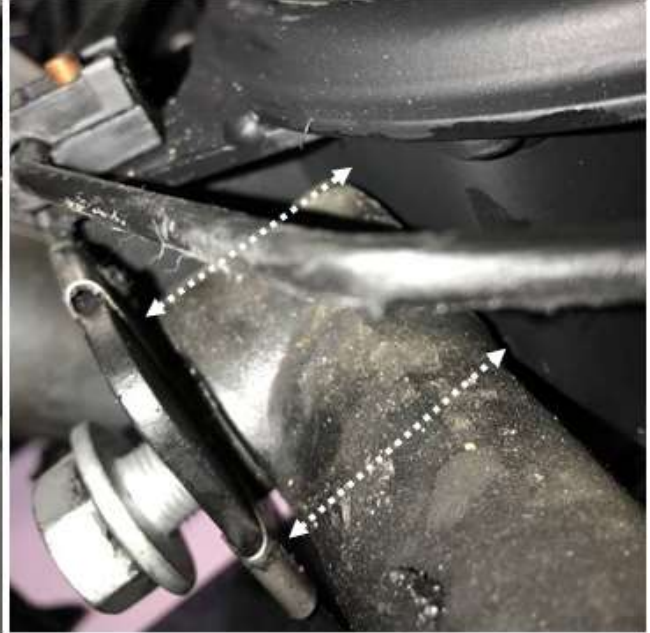
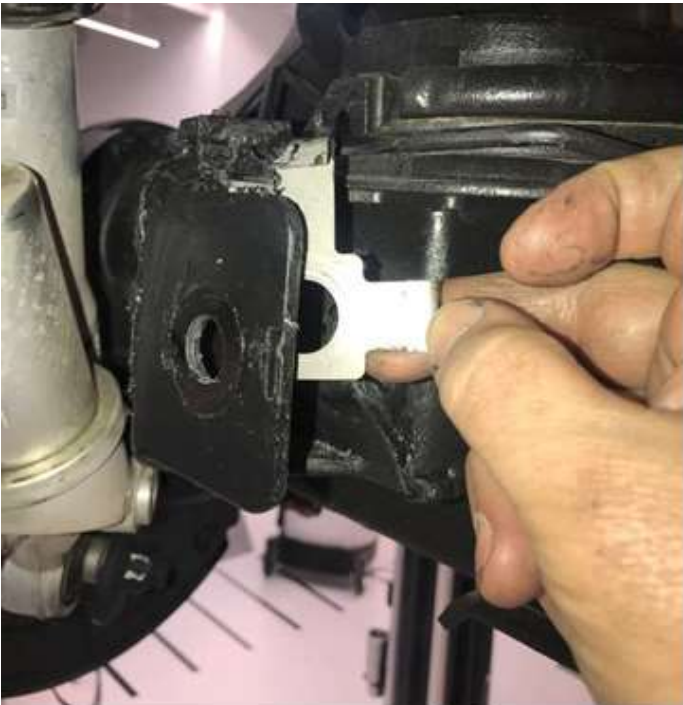
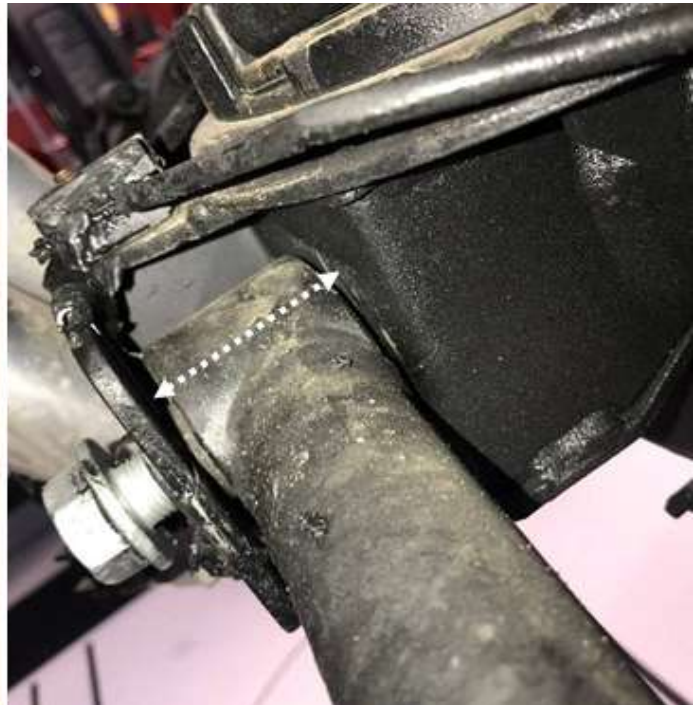
Figure 35

**i** A maximum of one adjusting plate may be installed.

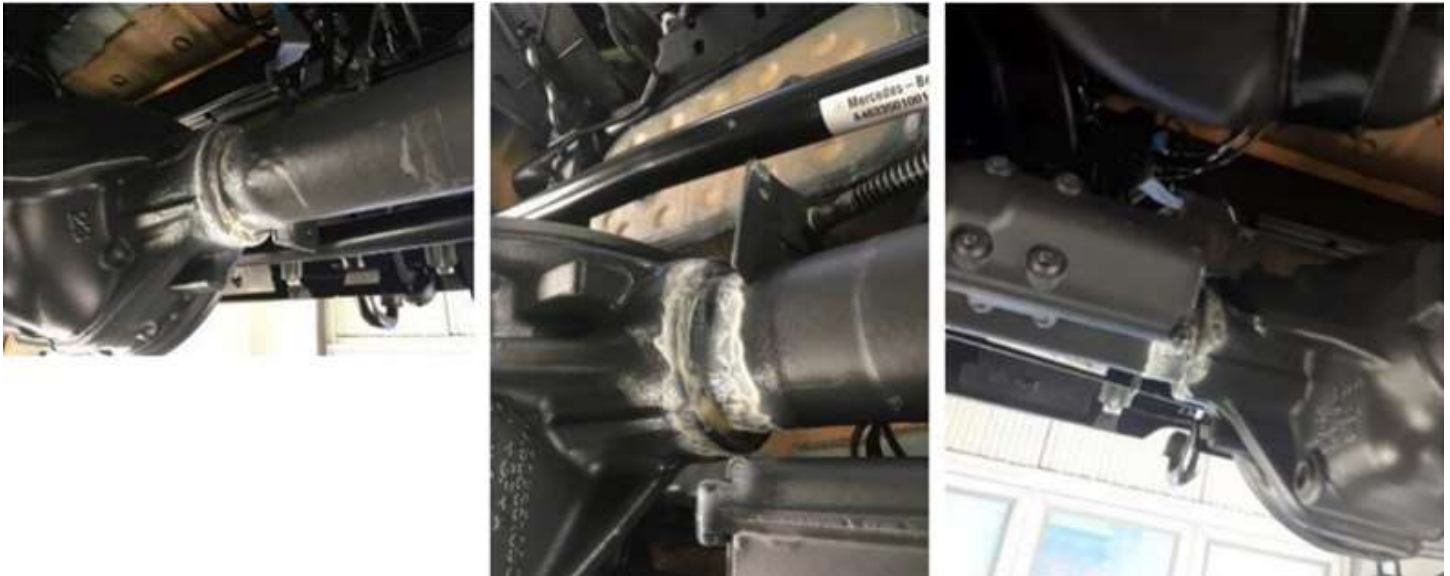
**Figure 36**

39. Apply wax **A 000 986 32 01 09** to rear axle in area between axle tube and differential (**Figure 36**).

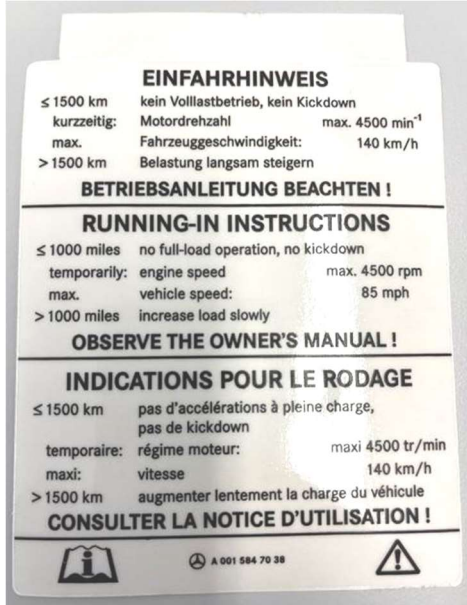
**Figure 37**

42. Install adhesive label for running-in (break-in period) instructions (**Figure 37**) in top left-hand corner on inside of windshield.

- i** Install adhesive label for running-in (break-in period) instructions (**Page 20, Figure 37**) in top left-hand corner on inside of windshield.
- i** Print out information about running-in (break-in period) instructions (**Page 23**) and provide to customer.  
**NOTE:** Running-in instructions are the maximum guidelines for the rear axle operation break-in period.
