TO: Mercedes-Benz Dealer Principals, General Managers, Sales Managers, Service Managers, Parts Managers	FROM: Gregory Gunther, Senior Manager, Vehicle Compliance and Analysis, Engineering Services
RE: Recall Campaign - Launch Notification Replace Rear Axle Differential Housing – Wave 3 MY22-23 AMG G63 4x4 squared (463 platform)	DATE: July 26, 2024

Campaign No. 2024050005, June 2024

SUBJECT: **Model G-Class (463 platform)**
Model Year 2022 – 2023

Replace Rear Axle Differential Housing – Wave 3

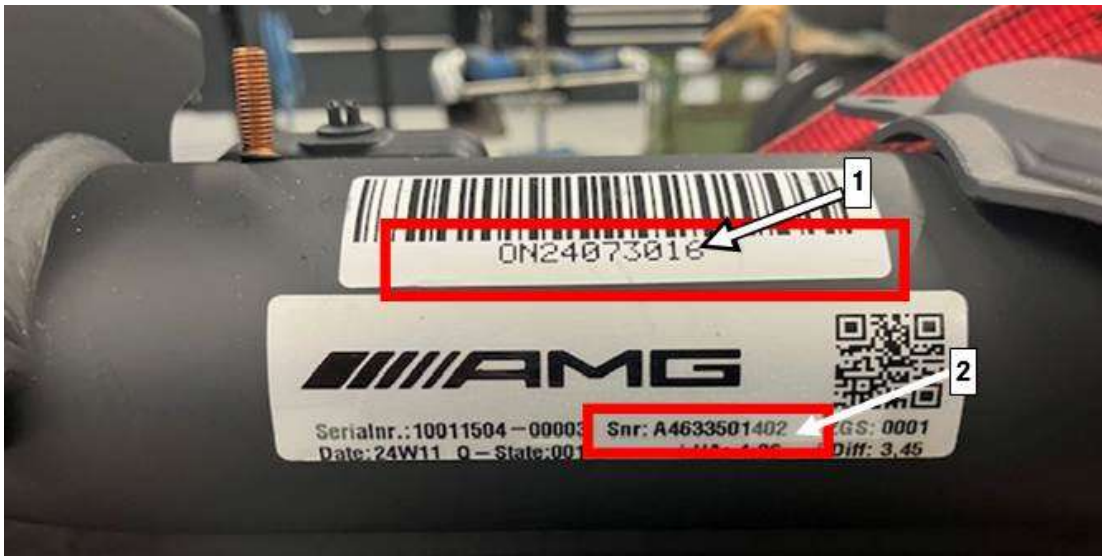
Figure 1

i Serial number (**Figure 1, 1**) and item number (**Figure 1, 2**).

i The new serial number (**Figure 1, 1**) and item number (**Figure 1, 2**) are documented in the VeDoc system in the tab “**VPD & SerienNr. (VPD & Serial no.) (Figure 2, 3)**” – “**Seriennummern (Serial numbers) (Figure 2, 4)**” – “**Hinterachse 1 Fremdhersteller -VPD-Ident (Rear axle 1 other manufacturer -VPD identification) (Figure 2, 5)**”.

i After the **rear axle centerpiece** has been replaced, the new **serial number** and **item number** must be documented in **VeDoc**. This can be done by opening a “**Vehicle Data/VeDoc**” XSF ticket and providing a picture of the new serial number and item number.

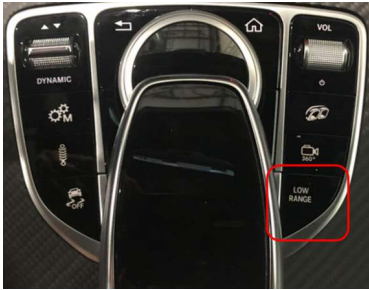
Figure 3

- i** **The rear axle must be removed with the lock actuator set to lock position.**
 - i** **To do this:** Start the engine – Release the parking brake – Engage Neutral position (N) – Engage Low Range (**Figure 3**) – Engage Drive position (D) – Engage Center Differential Lock (**Figure 4, 1**) – While wheels are rotating slowly, Engage Rear Axle Differential Lock (**Figure 4, 2**) – Ensure red confirmation light is illuminated for Center and Rear Differential Lock (**Figure 4**) – Switch 'OFF' Ignition – Disconnect electrical plug on Lock Actuator of rear axle and leave disconnected (**Figure 5**).

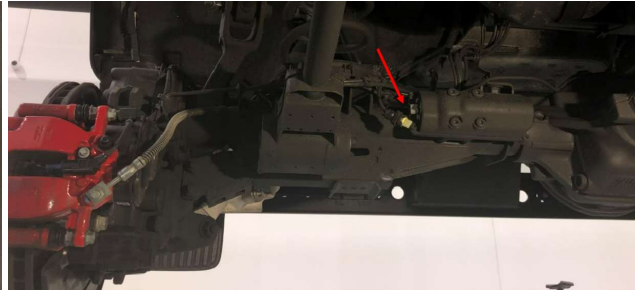
Figure 5

2. When the vehicle wheels are **lifted** off the ground, engage the rear axle differential lock actuator and then disconnect the electrical plug on the rear axle lock actuator while the lock is engaged.

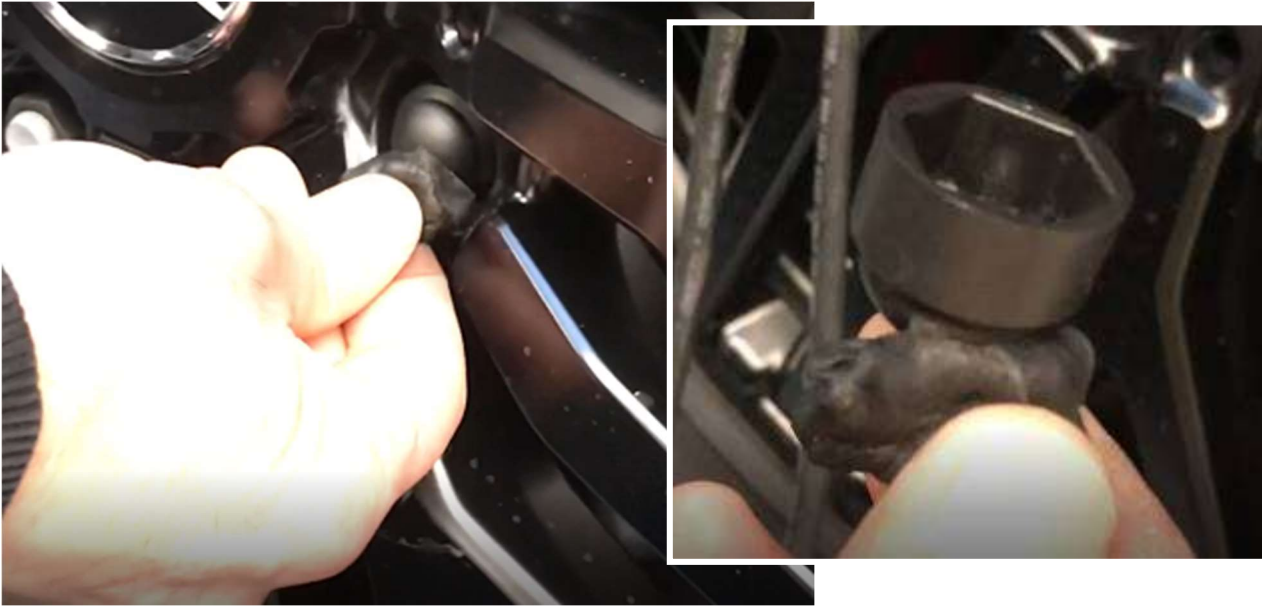
Figure 7

5. Remove cover caps of wheel nuts on all four wheels (**Figure 7**).

i To do this, clean cover caps then press Butyl Tape firmly against the cover cap and pull off the cap.

i Damaged cover caps must be replaced.

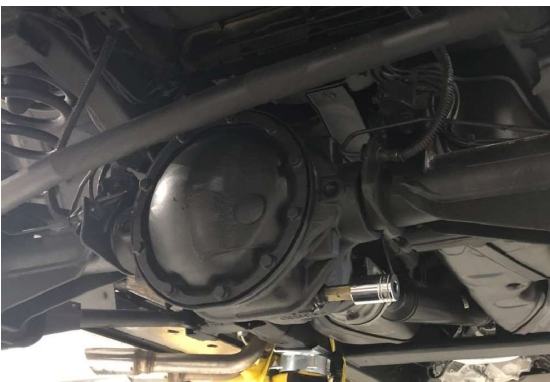
Figure 8

7. Drain rear axle oil (**Figure 8**).

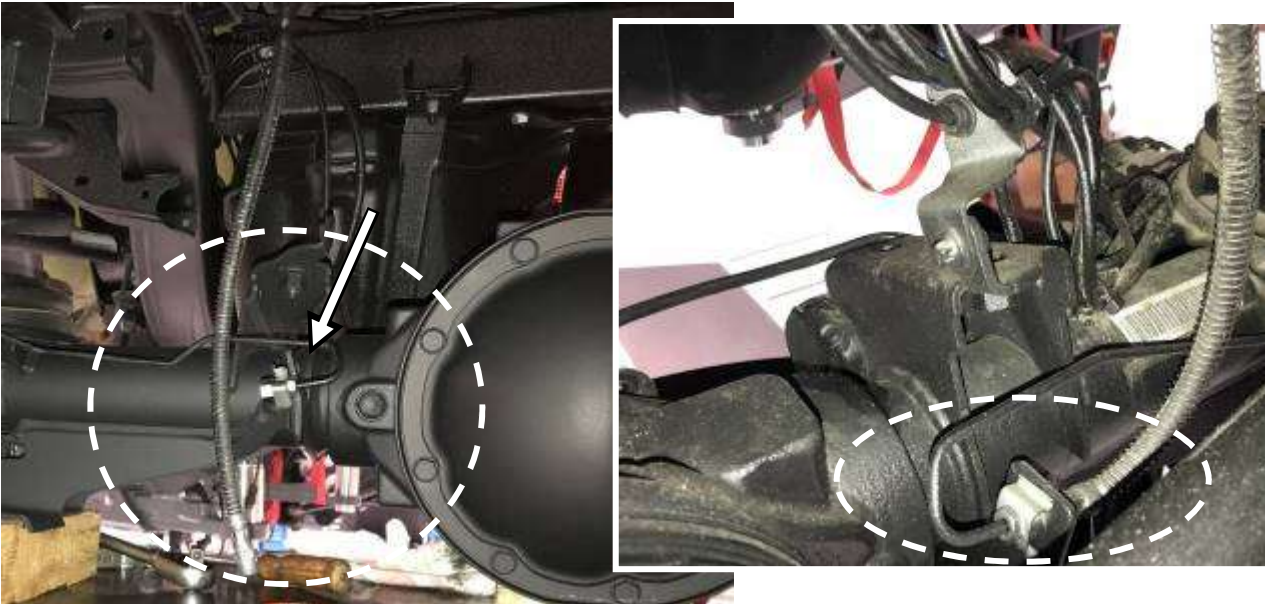
Figure 13

12. Unscrew brake hoses from brake lines on inside of axle (**Figure 13**) and seal open brake lines with suitable stop plugs (e.g. W129 589 00 91 10).

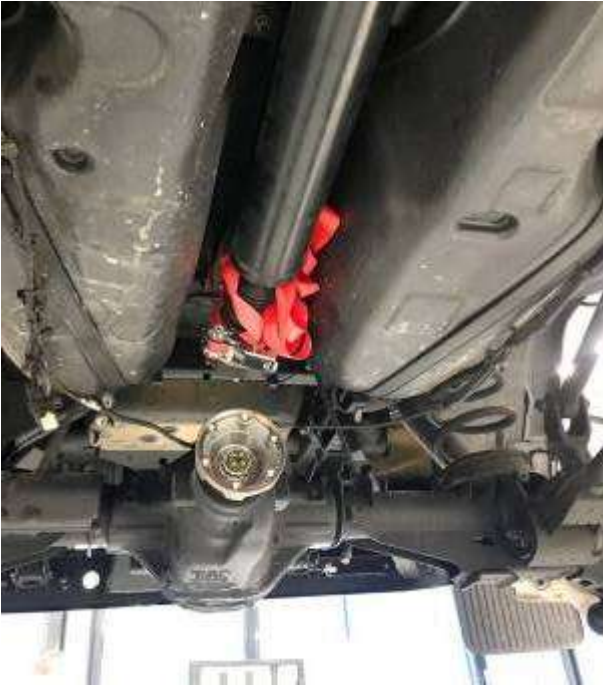
Figure 14

13. Unscrew propeller shaft at rear axle differential, and secure from falling by tying to the top (**Figure 14**).

Nm Propeller shaft screws at rear axle differential: **Stage 1: 40 Nm**
Stage 2: 90°

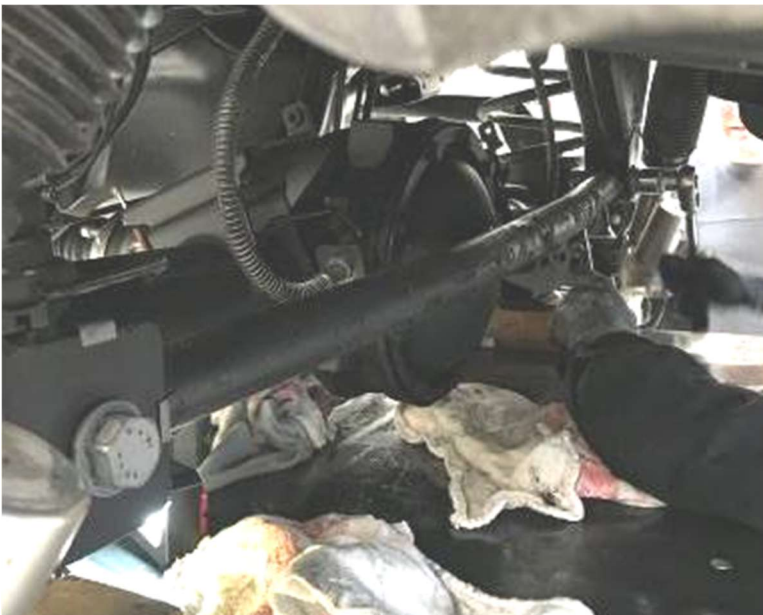
Figure 17

16. Remove transverse control arm of rear axle (Figure 17).
 - i** For basic data, see **AR35.20-P-0140XG**.
 - Nm** Transverse control arm screw to rear axle: **Stage 1: 150 Nm**
Stage 2: 90°
 - Nm** Transverse control arm screw to frame: **Stage 1: 150 Nm**
Stage 2: 90°
 - i** During installation, the transverse control arm at the rear axle **must be fit into the bearing using a shim**.
 - i** The previously installed original adjusting plate shim can be reused.

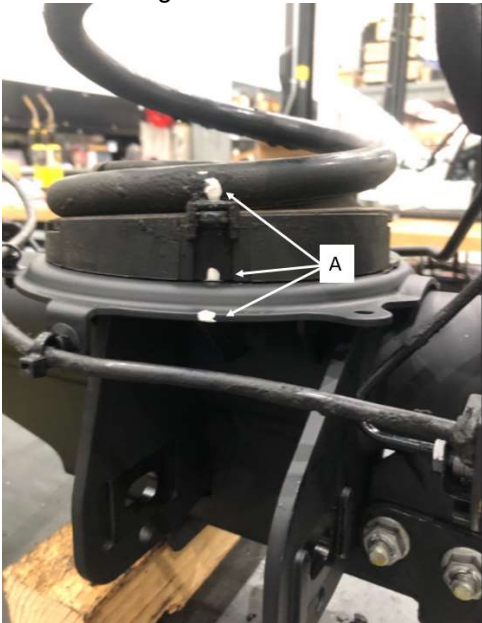
Figure 23

21. Mark the springs, as well as the upper and lower spring retainer, then remove the springs completely (**Figure 23, A**).

i **Installation:** Align installation position (**Figure 23, A**).

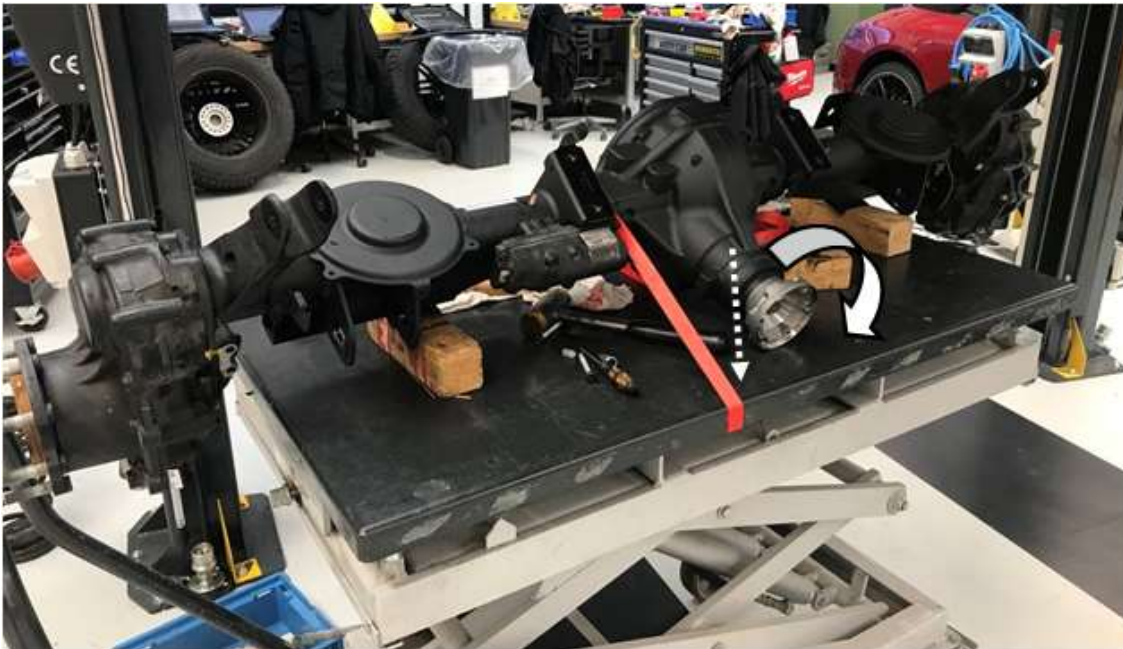
Figure 33

32. Fill rear axle centerpiece with 1.5 liters of oil and rotate the differential drive pinion multiple times for **at least 30 seconds** with the drive pinion tilted downward by **at least 5–10°** (**Figure 33**).

i **Attention, very important:** This ensures the bearing of the drive pinion is sufficiently lubricated prior to initial use.

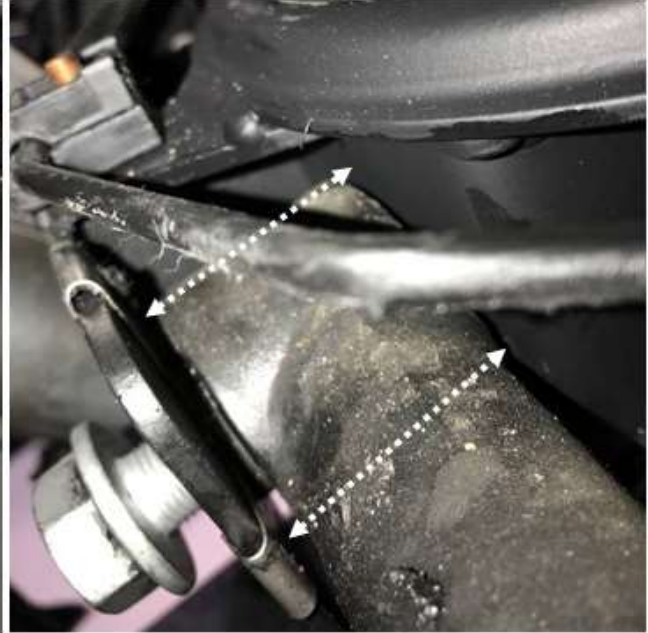
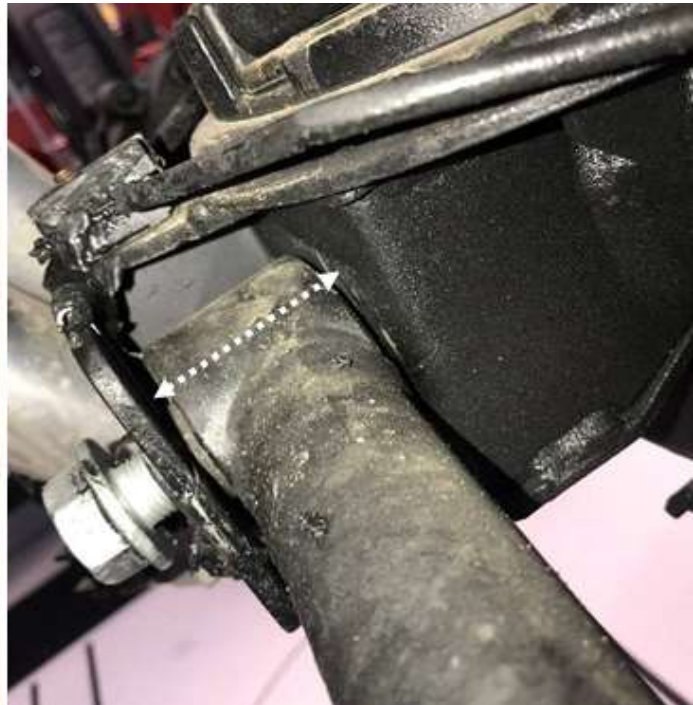
Figure 35

33. Install adjusting plate (if necessary) for transverse control arm on new axle bridge (**Figure 34, 35**).

i The fit for the transverse control arm can be adjusted as required, either **without** an adjusting plate, **with a 0.5 mm** adjusting plate, or **with a 0.8 mm** adjusting plate.

i A maximum of one adjusting plate may be installed.

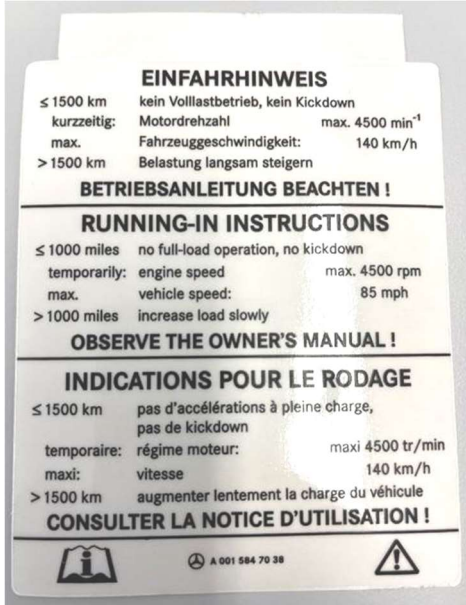
Figure 37

42. Install adhesive label for running-in (break-in period) instructions (**Figure 37**) in top left-hand corner on inside of windshield.

- i** Install adhesive label for running-in (break-in period) instructions (**Page 20, Figure 37**) in top left-hand corner on inside of windshield.
 - i** Print out information about running-in (break-in period) instructions (**Page 23**) and provide to customer.
- NOTE:** Running-in instructions are the maximum guidelines for the rear axle operation break-in period.
