Recall Campaign Bulletin

Campaign No. 2024010011, July 2024

SUBJECT: **Various Models**
Model Year 2021-2024

Replace Fuel Pump Delivery Module – Wave 4

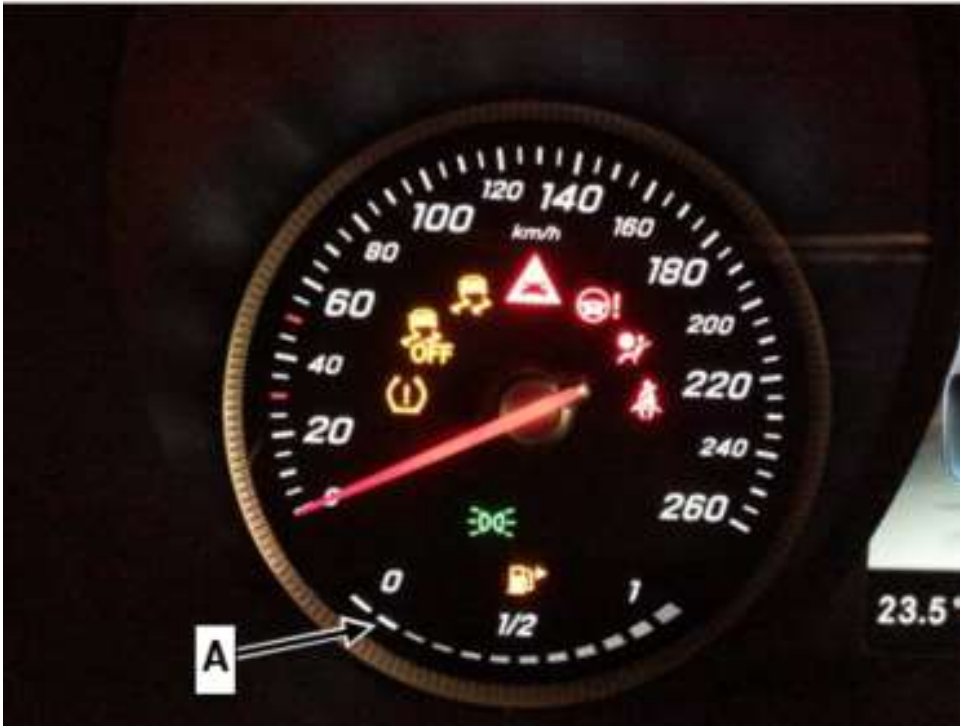
Figure 1 (shown on model 205)

- i** The fuel tank may only be filled up to a **maximum of 20%**.
- i** This corresponds to two lines (A) on the fuel display (**Figure 1**).

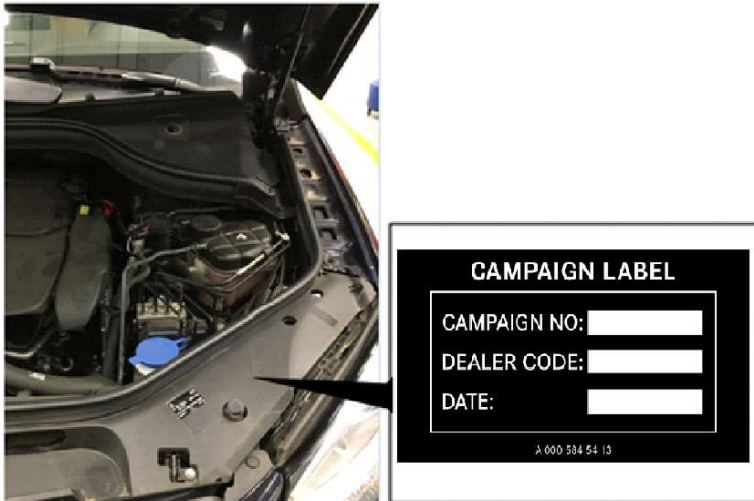
Figure 1

Apply Proof of Correction Label (A 000 584 54 13) to area identified in **Figure 1**. Fill in the blank areas of the label. The “**Campaign No.**” for the California Proof of Correction is unique and must be entered as such (23V880), your “**Dealer Code**”, and the “**Date**” of the repair, using a black permanent marker.

i Note: Clean bonding surface prior to affixing label.
