TO: Mercedes-Benz Dealer Principals, General Managers, Sales Managers, Service Managers, Parts Managers	FROM: Gregory Gunther, Senior Manager, Vehicle Compliance and Analysis, Engineering Services
RE: <b>Recall Campaign Launch Notification</b> <b>Replace Fuel Pump Delivery Module – Wave 4</b> <b>MY21-24 C-Class, E-Class, S-Class, SL, GT, GLC, GLE, GLS and G-Class (205/206, 213/238, 223, 232, 290, 253/254, 167 and 463 platforms)</b>	DATE: August 6, 2024

Campaign No. 2024010011, July 2024

Revision C: 09/03/2024

## **Replace Fuel Pump Delivery Module – Wave 4**

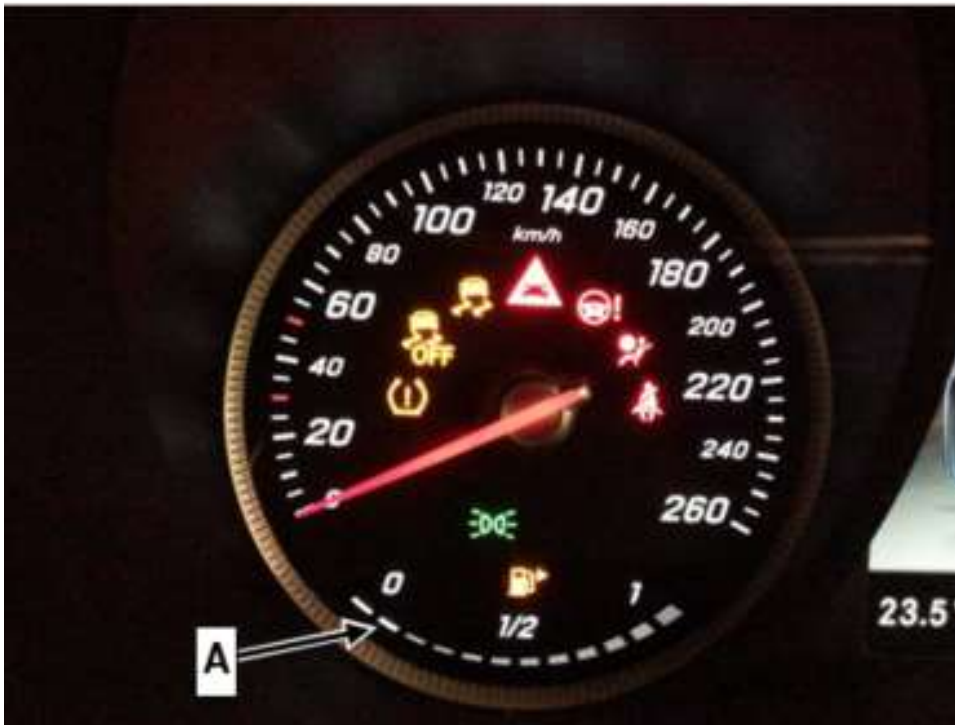
Figure 1 (shown on model 205)

- i** The fuel tank may only be filled up to a **maximum of 20%**.
- i** This corresponds to two lines (A) on the fuel display (**Figure 1**).

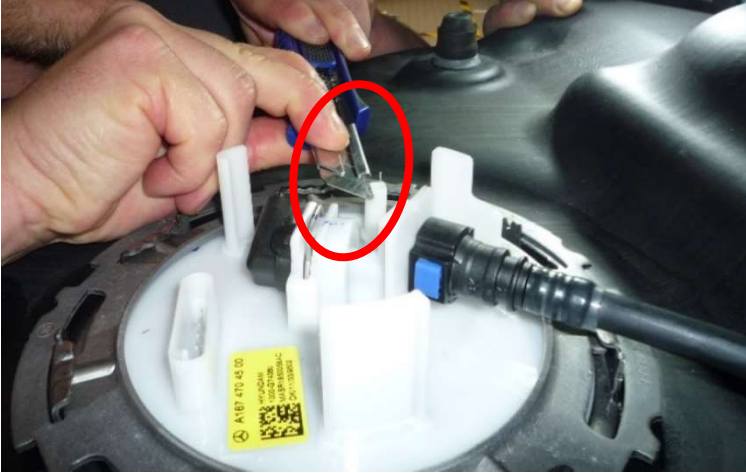
**Figure 3**

**i** For **all** vehicles with code 228 stationary heater, the connection for the fuel supply system must be cut off before installing the fuel pump (**Figure 3**).

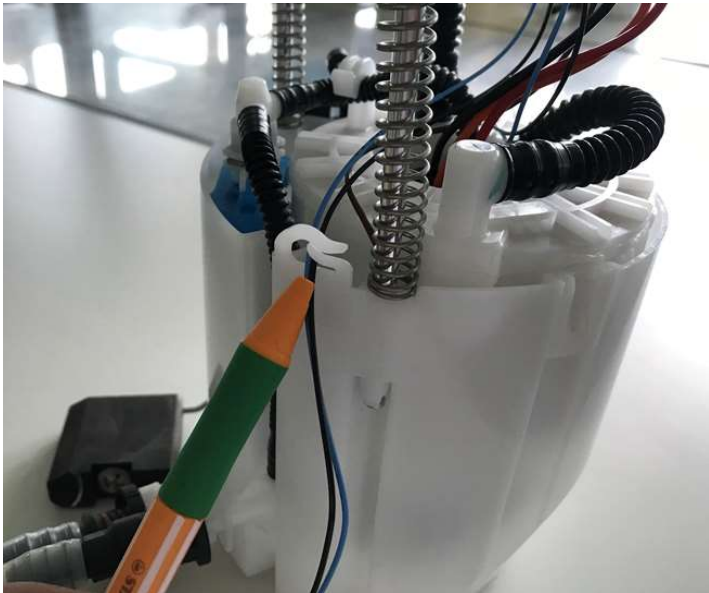
**i** Delivery modules that are delivered **without float-and-lever sensor** must be modified. (**Figure 4-7**)

**Figure 4** (remove electric lines from routing clip)

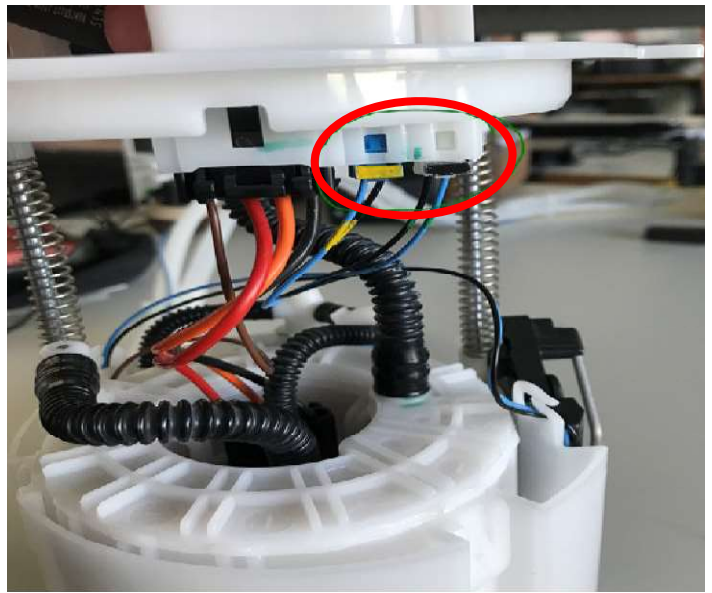
**Figure 5** (release corresponding connector and disconnect the contacts)
