Vehicle Compliance & Analysis

Recall Campaign Bulletin

Campaign No. 2024010011, April 2024

Replace Fuel Pump Delivery Module - Wave 3

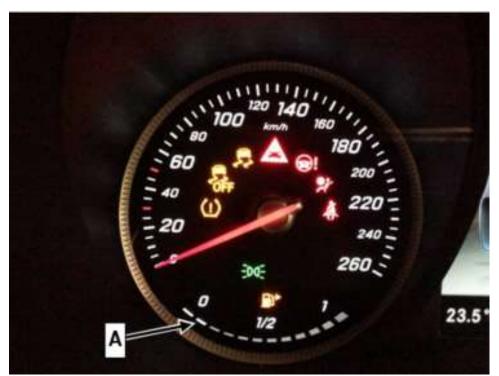
Figure 1 (shown on model 205)

- 1 The fuel tank may only be filled up to a *maximum of 20%*.
- This corresponds to two lines (A) on the fuel display (Figure 1).

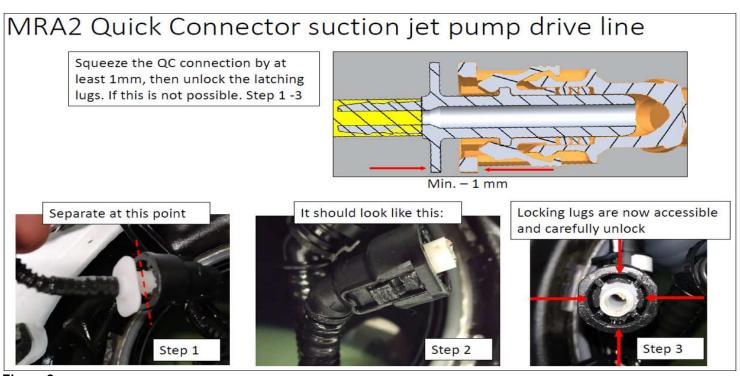
Figure 2

- i For basic data, see AR47.20-P-5710*
 - * Select WIS document according to the vehicle model.
- It *must be* ensured that the fuel lines are sealed with the stop plugs specified in WIS: **WS00.00-P-0255Z.**The fuel lines **must not run empty**!
- i Quick test **does not** need to be performed.
- Only model 206, 232: Note on disassembly of suction jet pump drive line quick connector.

The procedure steps 1-3 should only be performed when the quick disconnect is not working (Figure 2).

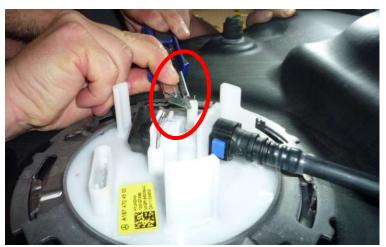
Figure 3

i For *all* vehicles with code 228 stationary heater, the connection for the fuel supply system must be cut off before installing the fuel pump (**Figure 3**).

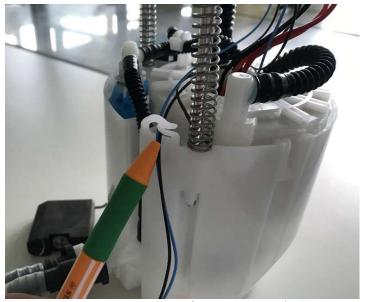
Delivery modules that are delivered without float-and-lever sensor must be modified. (Figure 4-7)

Figure 4 (remove electric lines from routing clip)

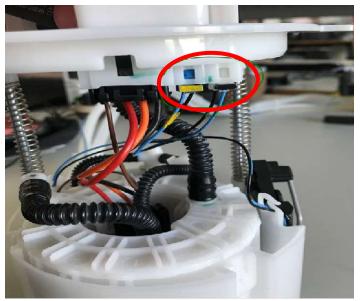
Figure 5 (release corresponding connector and disconnect the contacts)

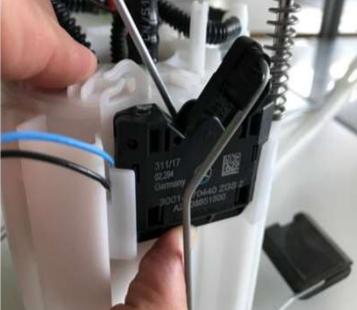
Figure 7 (using a screwdriver, carefully push float-and-lever sensor housing away from module housing and at the same time push float-and-lever sensor housing upwards.)

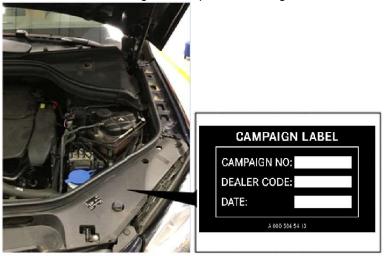
Figure 1

Apply Proof of Correction Label (A 000 584 54 13) to area identified in Figure 1. Fill in the blank areas of the label. The "Campaign No." for the California Proof of Correction is unique and must be entered as such (23V880), your "Dealer Code", and the "Date" of the repair, using a black permanent marker.

1 Note: Clean bonding surface prior to affixing label.
