TO: Mercedes-Benz Dealer Principals, General Managers, Sales Managers, Service Managers, Parts Managers	FROM: Anthony Washington, Senior Manager, Regulations and Certifications
Re: Launch Recall Campaign Notification Model: Metris (447) Model Years: 2022-2023 Replace Fuel Delivery Module	DATE: April, 2024

IMPORTANT RECALL CAMPAIGN INFORMATION

Campaign No. :	Campaign Desc. :	Replace Fuel Delivery Module(dealer inventory only)
2024040005	VS2KRAPUM2	
<p>This is to notify you of a Recall Campaign Launch to replace the fuel delivery module on approximately 80 MY 2022-2023 Mercedes-Benz Metris vans. The recall campaign will be visible on the www.safercar.gov website and may generate questions from customers. All affected VINs will be flagged "OPEN" in VMI and cannot be sold until the recall has been remedied.</p>		
Background		
Issue	<p>Mercedes-Benz AG, the manufacturer of Metris vans, has determined that on certain Metris (447 platform) vehicles, the fuel pump impeller might not meet specifications in regards to material characteristics. As a consequence, the impeller might deform and come into contact with the fuel pump housing, leading to a mechanical resistance. In some instances,

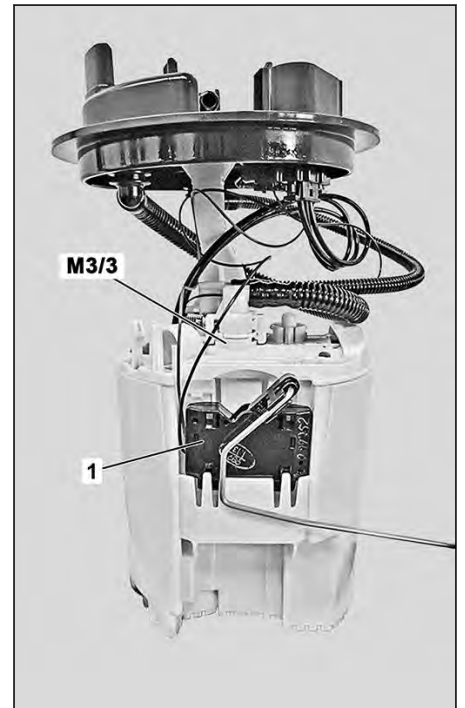
S47.20-A027-03

- 1 *Fuel tank fill level sensor*
- M3/3 *Fuel pump with fuel feed module*

Remove		
4	Remove fuel pump with fuel delivery module (M3/3).	<p>

Modify		
5	Transfer fuel tank fill level sensor (1) of removed fuel pump with fuel delivery module (M3/3) to new fuel pump with fuel delivery module (M3/3).	Only if new fuel pump with fuel delivery module (M3/3) was delivered without fuel tank fill level sensor (1).	AR47.50-S-0111E

Install		
6	Install new fuel pump with fuel delivery module (M3/3).		AR47.20-S-7000E

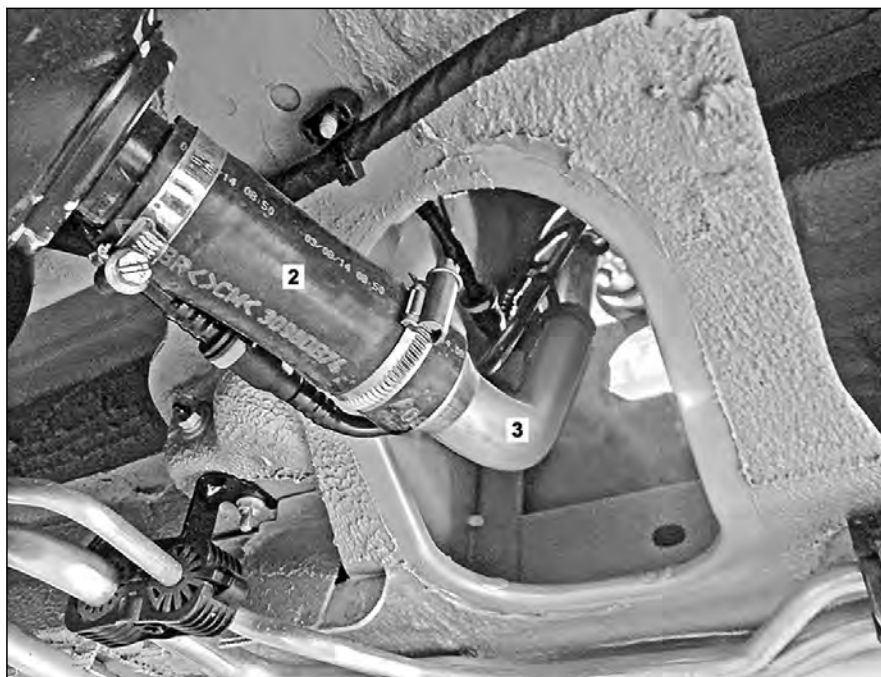
S47.20-A028-06

- 2 Fuel hose
- 3 Filler neck

Contrary to the statement in the reference document on removal of the fuel tank, the fuel hose (2) does not need to be removed.</p> <p>The filler neck (3) is only detached from the body and remains on the fuel tank.</p> <p>
