IMPORTANT SAFETY RECALL

[NHTSA Recall No. 23E-021](#)

Ducati Motorcycle: Ducati Performance Accessory part no. 96781971AA for DesertX MY23

Dealer Bulletin: SRV-RCL-23-001

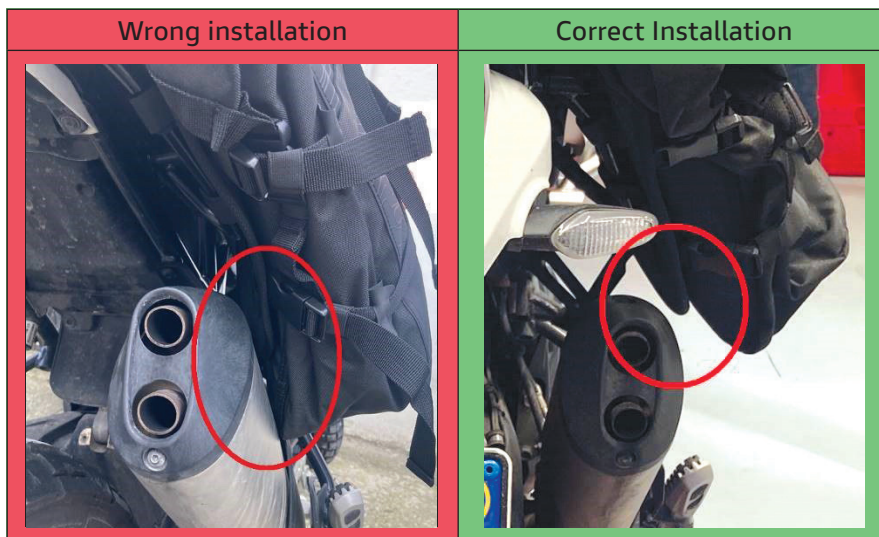
Ducati records indicate that you may have purchased a Soft Side Bag Kit. When installed on a motorcycle, the right pannier could come into contact with the exhaust and may melt or burn, increasing the risk of a fire which can result in a crash or injury. Dealers will provide and install a new right side bag frame, free of charge. Owners who have purchased a Soft Side Bag Kit, will receive a new right side bag frame and instructions on how to affix the bag to the motorcycle.

The assembly instructions have therefore been improved in order to avoid this potential problem (instructions are attached and can also be found in the dedicated area of the ducati.com website in the DesertX model accessories section).

In order to make assembly even stronger, a new right-side pannier support subframe will be made available and will be supplied to you free of charge in approximately 90 days (you will receive another letter notifying you of the availability so that you can schedule a visit to our workshop).

Please note that it is important to mount the panniers correctly in order to avoid contact with the exhaust. The new right-side pannier support subframe is an additional element that further increases the reliability of the assembly.

We therefore invite you to check the assembly of the kit on your motorbike and to check it periodically during use, as well as every time you use the side panniers. Depending on the load, the retainers must be tightened regardless of the presence of the new right side pannier support subframe.

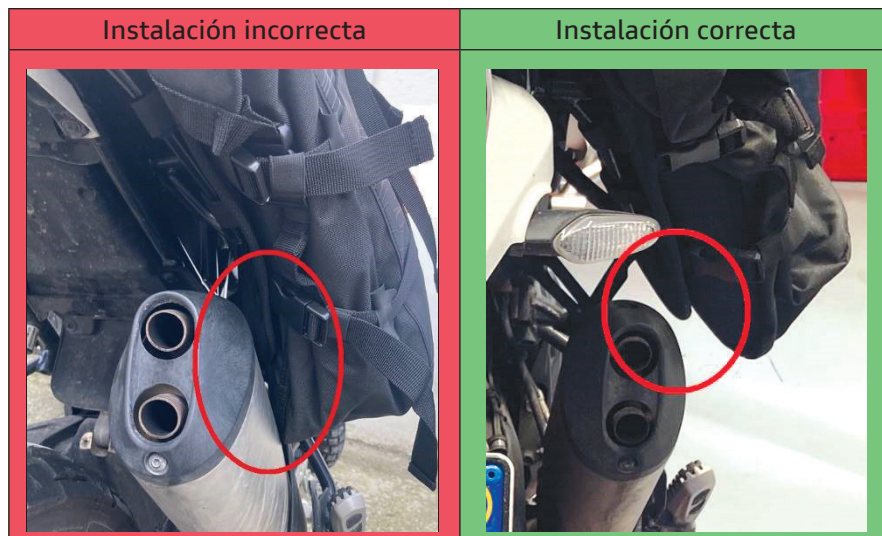
Los registros de Ducati indican que es posible que haya adquirido un Kit de bolsas laterales suaves. Cuando se instala en una motocicleta, la alforja derecha podría tener contacto con el tubo de escape y derretirse o quemarse, aumentando el riesgo de incendio que puede provocar un accidente o lesiones. Los concesionarios suministrarán e instalarán gratis un nuevo bastidor de alforja derecha. Los propietarios que hayan adquirido un kit de bolsa lateral suave, recibirán un nuevo bastidor de bolsa lateral derecha e instrucciones sobre cómo fijar la bolsa a la motocicleta.

Por lo tanto, se han mejorado las instrucciones de instalación para evitar este posible problema (se adjuntan las instrucciones y también puede encontrarlas en el área específica del sitio web ducati.com en la sección de accesorios del modelo DesertX).

Para que el montaje sea aún más resistente, se pondrá a su disposición un nuevo bastidor secundario de soporte de la bolsa derecha, que se le suministrará gratuitamente en un plazo aproximado de 90 días (recibirá otra carta notificándole la disponibilidad para que pueda programar una visita a nuestro taller).

Tenga en cuenta que es importante montar correctamente las bolsas para evitar el contacto con el escape. El nuevo bastidor secundario de soporte de la bolsa derecha es un elemento adicional que aumenta aún más la confiabilidad del conjunto.

Por ello, lo invitamos a revisar el montaje del kit en su moto y a revisarlo periódicamente durante su uso, así como cada vez que use las bolsas laterales. Dependiendo de la carga, los retenedores se deben apretar independientemente de la presencia del nuevo bastidor secundario de soporte de la bolsa lateral derecha.
