IMPORTANT SAFETY RECALL

NHTSA Recall Number: 23V525

Altec Identifier: CSN-3103

Samlex Inverter Circuit Breaker

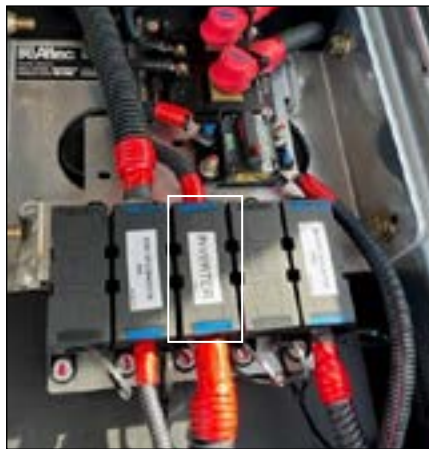
Figure 1 — Inverter Fuse Installed on Tailshelf Auxiliary Battery

1. Position the unit on a level surface, apply the parking brake, and turn off the engine. Remove the key from the ignition, and secure it following your employer's vehicle lockout/tagout procedure. Chock the wheels.
2. Locate the remote inverter upfitter switch, if equipped. Make sure the switch is in the Off position. The switch may be located in the cab or near the inverter.
3. Refer to the electrical schematic in the unit's Maintenance and Parts Manual, or Altec Connect, to locate the 12VDC circuit breaker or 12VDC fuse from the battery source supplying the inverter 12VDC input. The circuit breaker or fuse may be located near the main or auxiliary chassis battery (refer to Figures 1 and 2). Remove and retain the 12VDC circuit breaker or 12VDC fuse.

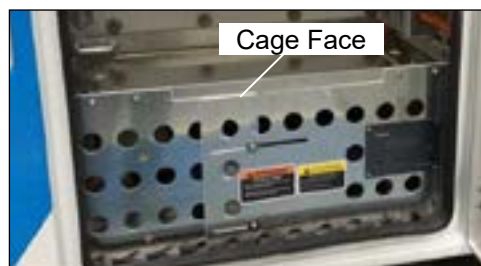
Figure 3 — Inverter

4. Locate the Samlex inverter. The inverter may be located in the cab of the vehicle or in one of the vehicle compartments. Empty the inverter compartment to allow for easy access to the inverter, if necessary.
5. Remove and retain the inverter cage face, controller module, and all hardware (refer to Figure 3). Make sure to unplug the modular plug from the controller module before removal, if equipped.

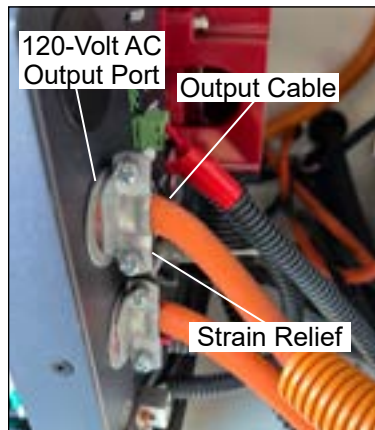
Figure 4 — Single 120-Volt AC Output Port and Cable

6. Locate the 120-volt AC output cable(s) installed in the back of the inverter. The unit may be equipped with 1 or 2 output cables (refer to Figures 4 and 5). Remove the entire inverter cage to access the cable(s), if necessary.

10. Review the inspection results.
 - If the unit is equipped with 1 orange output cable and a single output connection:
 - Order 991662439 x 1
 - If the unit is equipped with 1 orange output cable and dual output connections:
 - Order 991662439 x 1 and 991692741 x 1
 - If the unit is equipped with 2 orange output cables and a single output connection:
 - Order 991662439 x 2
 - If the unit is equipped with 2 orange output cables and dual output connections:
 - Order 991662439 x 2 and 991692741 x 2
 - If the unit is equipped with 1 gray output cable and a single output connection:
 - Order 991662439 x 1 and 991692754 x 1

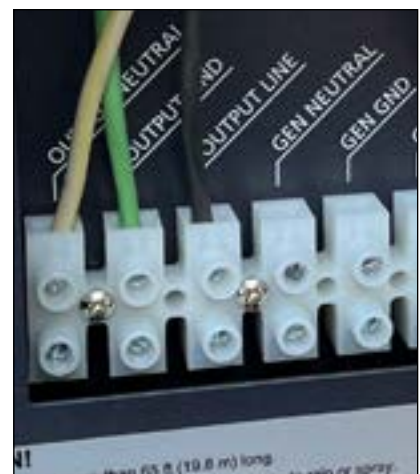
Figure 7 — 120-Volt Single Connection AC Output Wiring

7. Record the color and number of output cables in Figure 6.
8. Remove the inverter front access panel and locate the 120-volt AC output wiring. The unit may be equipped with single or double inverter connections (refer to Figures 7 and 8). Retain the cover and the hardware.

9. Record the number of output connections in Figure 6.
