## IMPORTANT SAFETY RECALL

**NHTSA Recall Number:** 23V702

**Altec Identifier:** MAB-3120

## Rotation Gearbox Brake Flange Composition

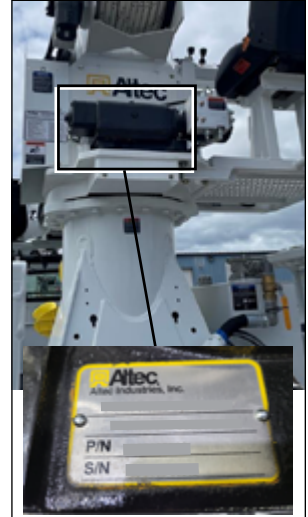
*Figure 1 —  
Rotation Gearbox*

1. Position the unit on a level surface, apply the parking brake, and turn off the engine. Remove the key from the ignition, and secure it following your employer’s vehicle lockout/tagout procedure. Chock the wheels.
2. Go to the rear of the turntable to access the rotation gearbox (refer to Figure 1).
3. Find the rotation gearbox serial number (S/N) and compare it to Figure 2.
  - If your serial number does not match a serial number in Figure 2, proceed to step 4.
  - If the serial number matches a serial number in Figure 2, proceed to step 5.

4. No repair is required. Perform steps a through d below.
  - a. Put the unit back into service.
  - b. Complete the Inspection Sheet at the end of this notice and return it to Altec, or use the [QR code](#) below to submit the inspection results.
  - c. If the inspection was performed by Altec, mark this notice as complete on the Service Request.
  - d. Do not complete the remaining step in this notice.
5. Take the unit out of service. Do not return the unit to service until a repair has been made. Do not complete the Inspection Sheet at the end of this notice.
  - a. Order and install the Rotation Gearbox Replacement kit, part number 991683364, or contact Altec to schedule the installation of this kit.
  - b. Use the QR code to submit your inspection results.
