# **IMPORTANT SAFETY RECALL**

**Pratt Intermodal Chassis Recall 2023 -00001**

## **Pratt Intermodal Chassis Model GN30402-EC-6P Owner/Purchaser Letter NHTSA Recall ID 23V-767**

### **Structural issue when carrying 20 ft containers.**

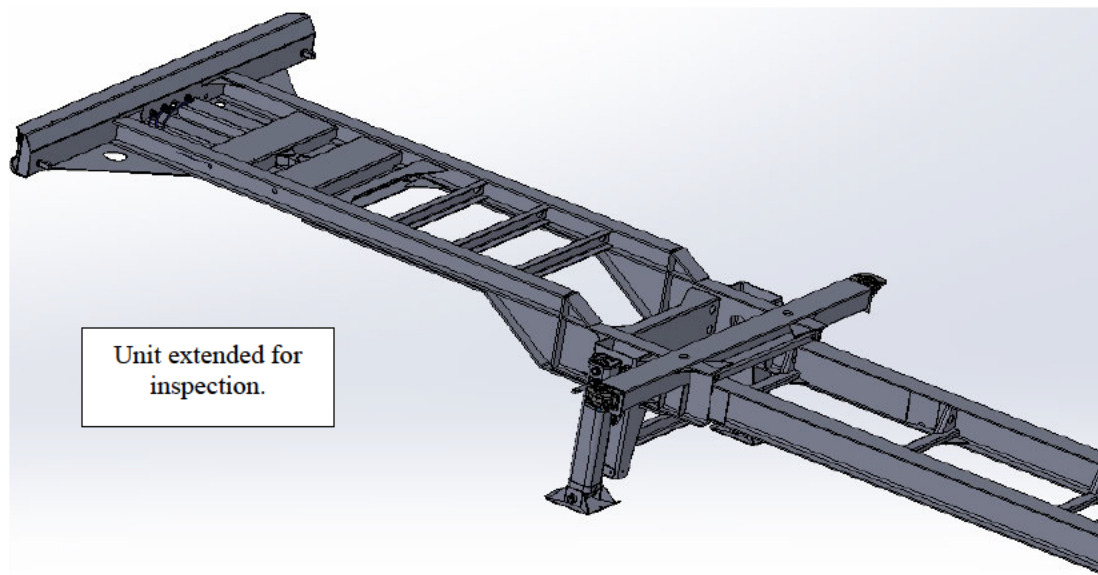
**Step 1:** Extend the chassis to the 40 FT position or at least far enough to expose the area shown below and highlighted in Diagram 1 and 2.

- If this area has little or slight deformation but does not show signs of fatigue cracking, then proceed to Step 2 for repair procedure.
- If fatigue cracks or significant deformation exist, do not use the chassis and contact PIC via email at [warranty@prattchassis.com](mailto:warranty@prattchassis.com) for arrangements to have the chassis returned to the factory for complete frame replacement remedy at PIC's expense.

2. If cracks exist in the area shown in diagram 2 then the unit may NOT be used and must NOT remain on the road. Please contact PIC via email at [warranty@prattchassis.com](mailto:warranty@prattchassis.com) for arrangements to have the chassis returned to the factory for complete frame replacement remedy at PIC's expense.

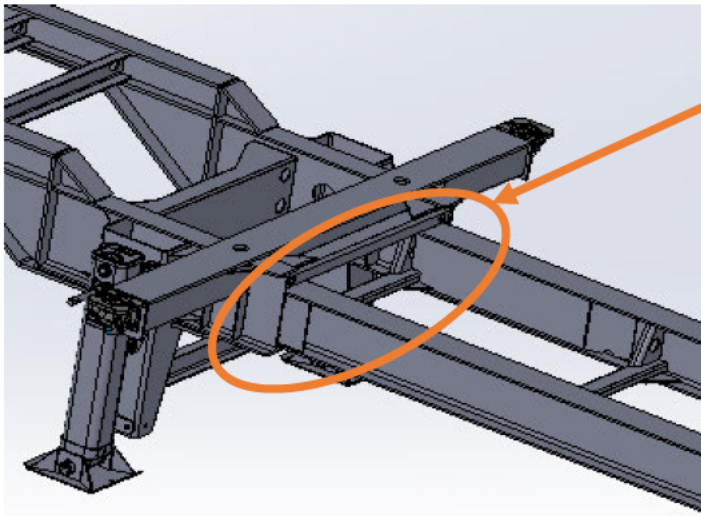
Diagram 2

Area of concern:

- Potential deformation
  - Mid beam will be bent upward as shown in picture 1.
- Potential crack of beam

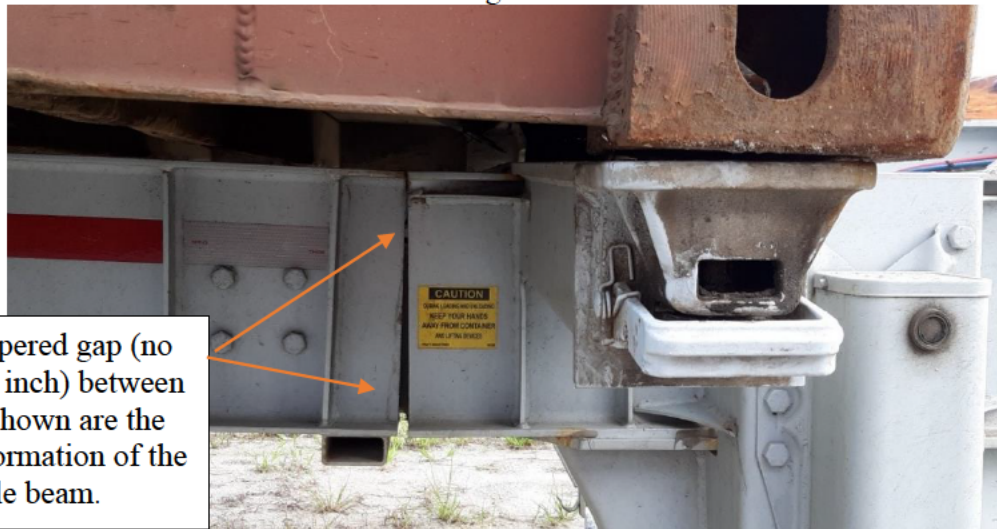
Picture 1

Minimal tapered gap (no more than 1 inch) between beams as shown are the signs of deformation of the middle beam.

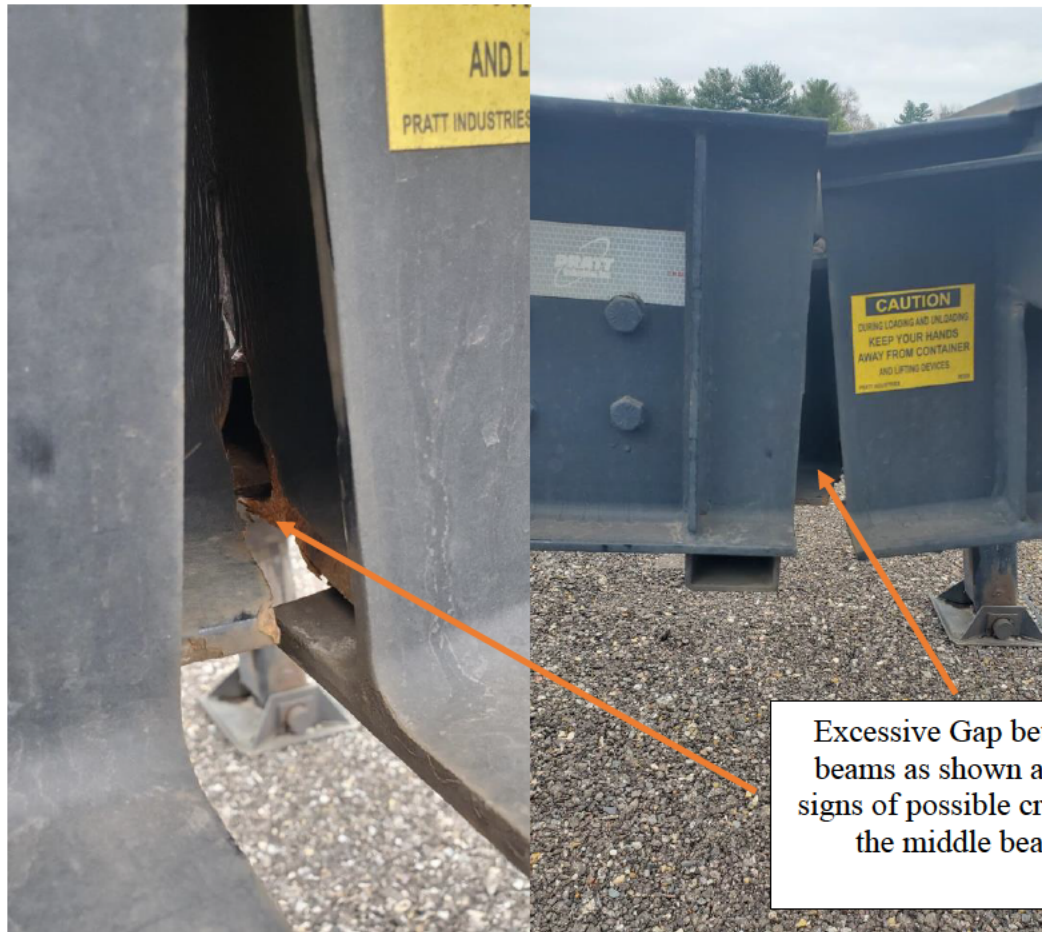
Picture 2

Excessive Gap between beams as shown are the signs of possible cracks in the middle beam.

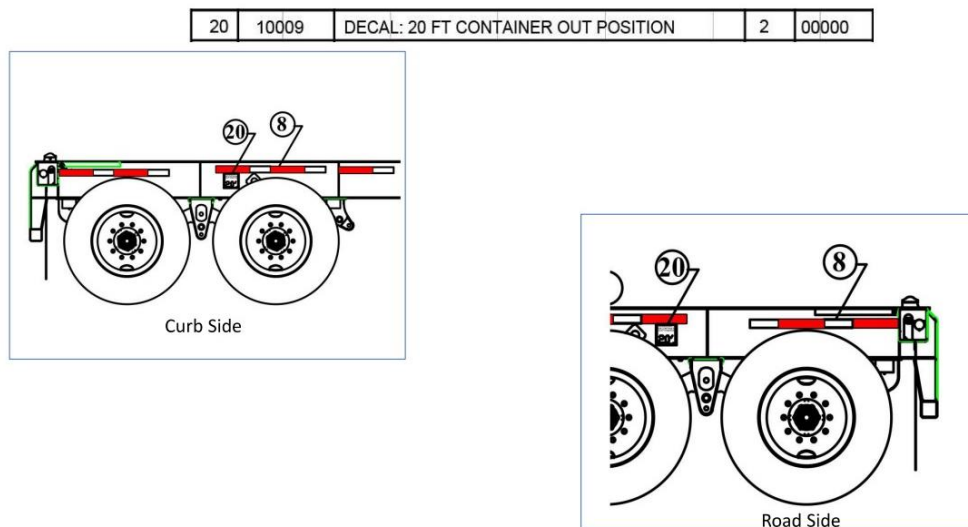
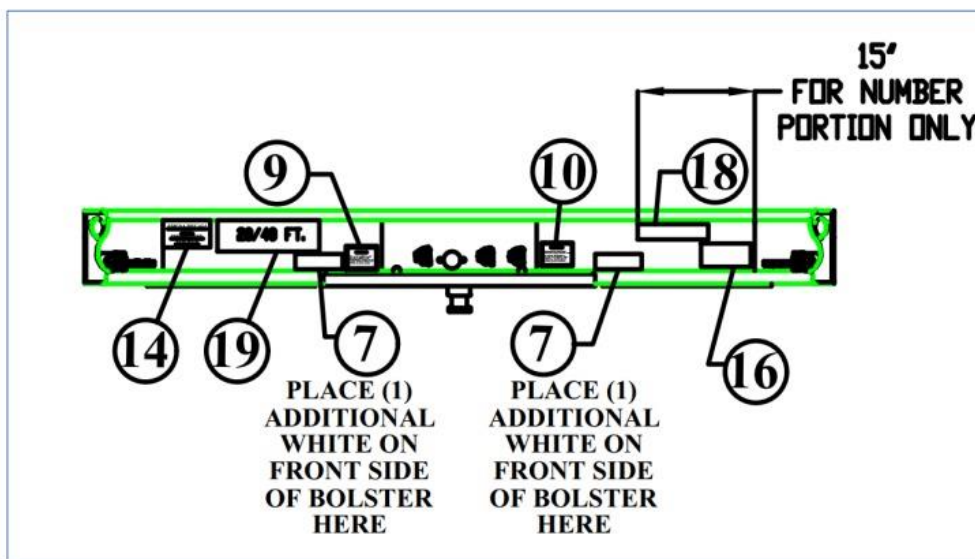
19	10050	20/40 FT. DECAL	1	00000
----	-------	-----------------	---	-------

Step 6: Remove any decals identifying the ability of the trailer to carry a 20 ft container, and any other decals that may have been added after delivery referring to carrying a 20 ft container. Items 19 and 20 in Diagram 6
