IMPORTANT SAFETY RECALL

Pratt Intermodal Chassis Recall 2023 -00001

Pratt Intermodal Chassis Model GN30402-EC-6P Owner/Purchaser Letter NHTSA Recall ID 23V-767

Structural issue when carrying 20 ft containers.

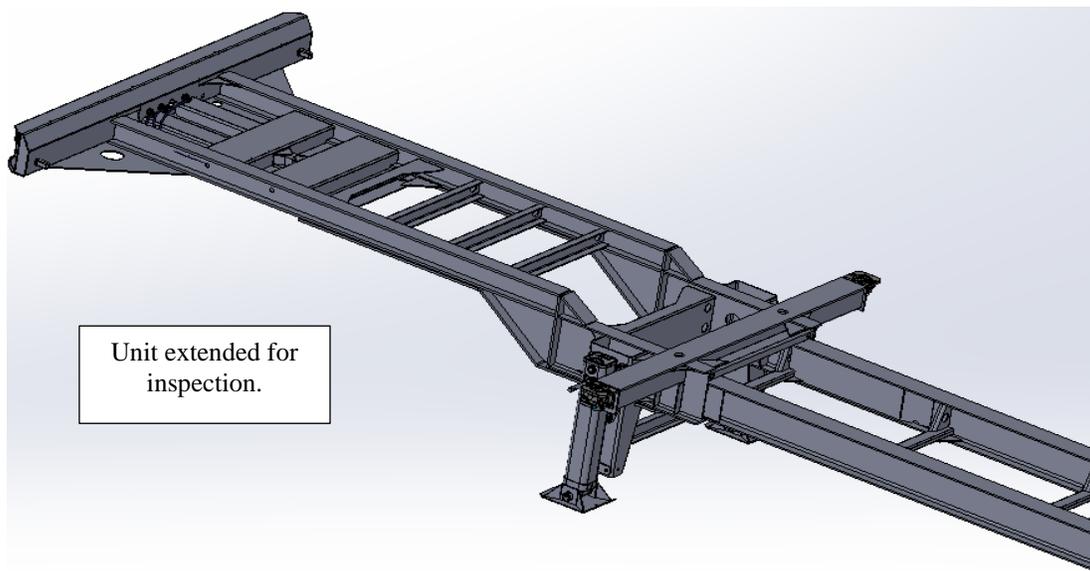
Step 1: Extend the chassis to the 40 FT position or at least far enough to expose the area shown below and highlighted in Diagram 1 and 2.

- If this area has little or slight deformation but does not show signs of fatigue cracking, then proceed to Step 2 for repair procedure.
- If fatigue cracks or significant deformation exist, do not use the chassis and contact PIC via email at warranty@prattchassis.com for arrangements to have the chassis returned to the factory for complete frame replacement remedy at PIC's expense.

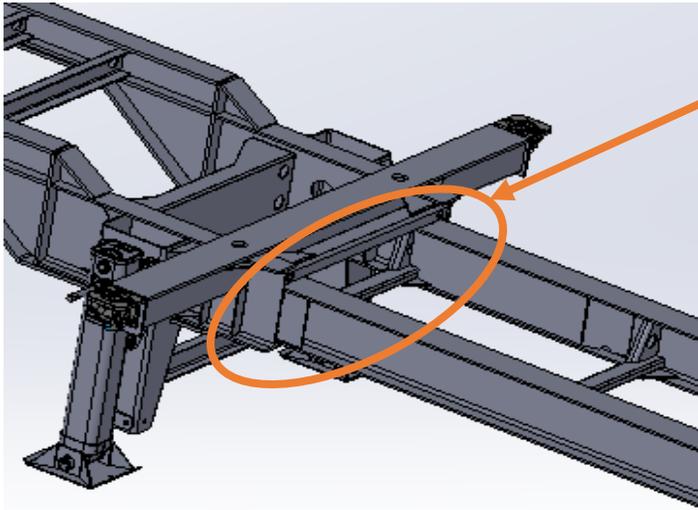
Diagram 2

Area of concern:

- Potential deformation
 - Mid beam will be bent upward as shown in picture 1.
- Potential crack of beam

2. If cracks exist in the area shown in diagram 2 then the unit may NOT be used and must NOT remain on the road. Please contact PIC via email at warranty@prattchassis.com for arrangements to have the chassis returned to the factory for complete frame replacement remedy at PIC's expense.

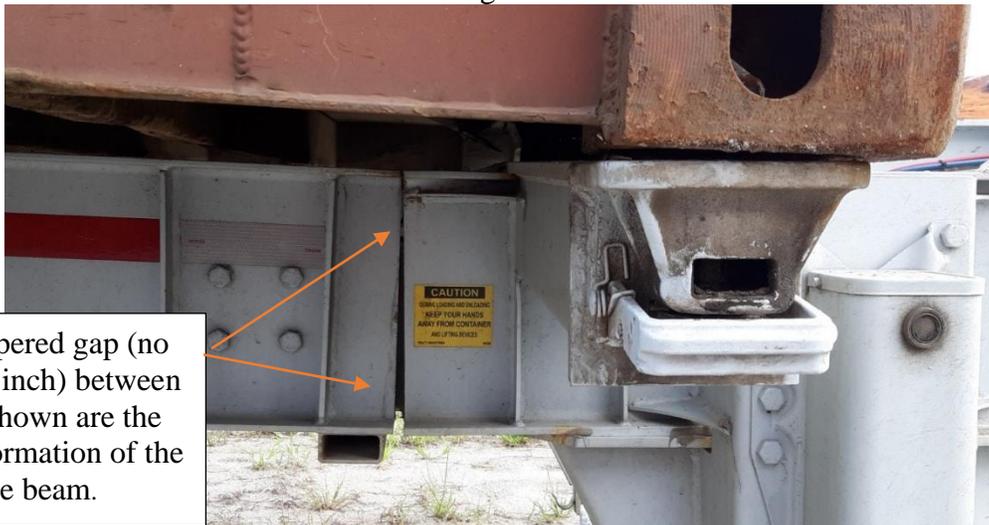
Picture 1

Minimal tapered gap (no more than 1 inch) between beams as shown are the signs of deformation of the middle beam.

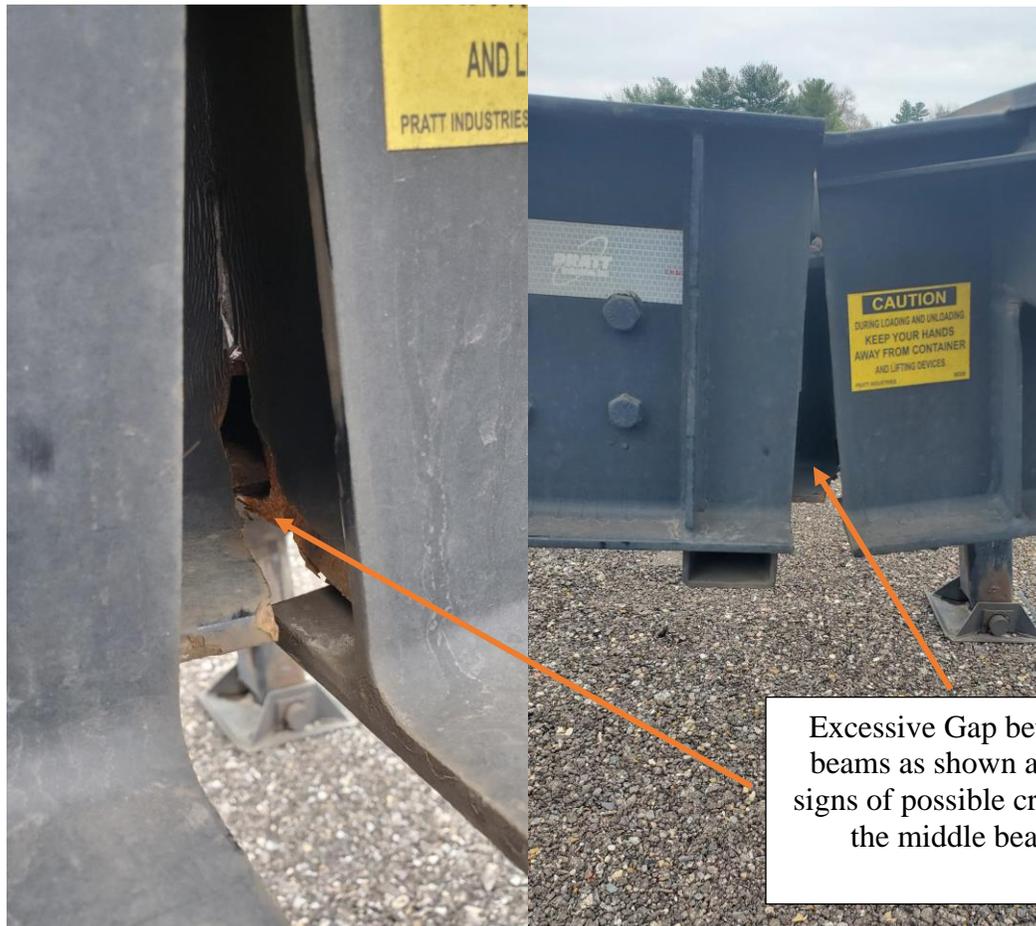
Picture 2

Excessive Gap between beams as shown are the signs of possible cracks in the middle beam.

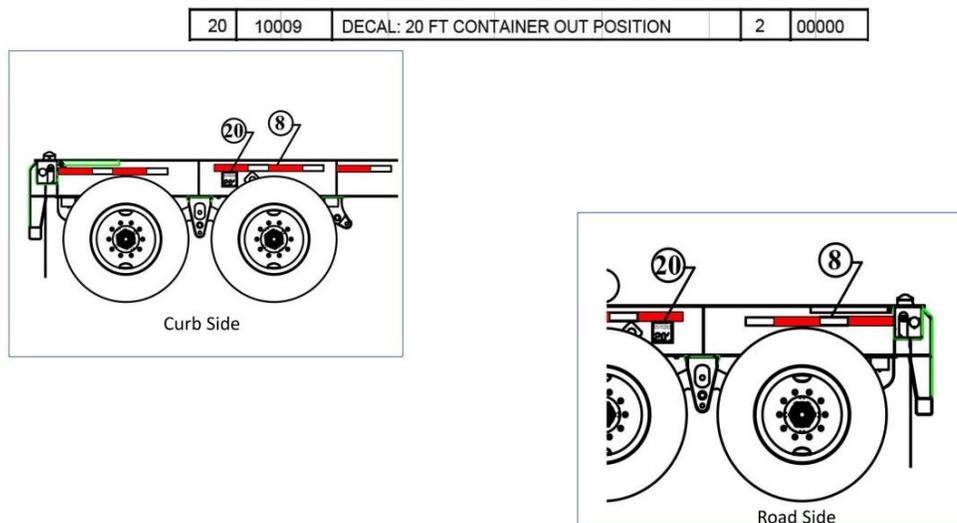
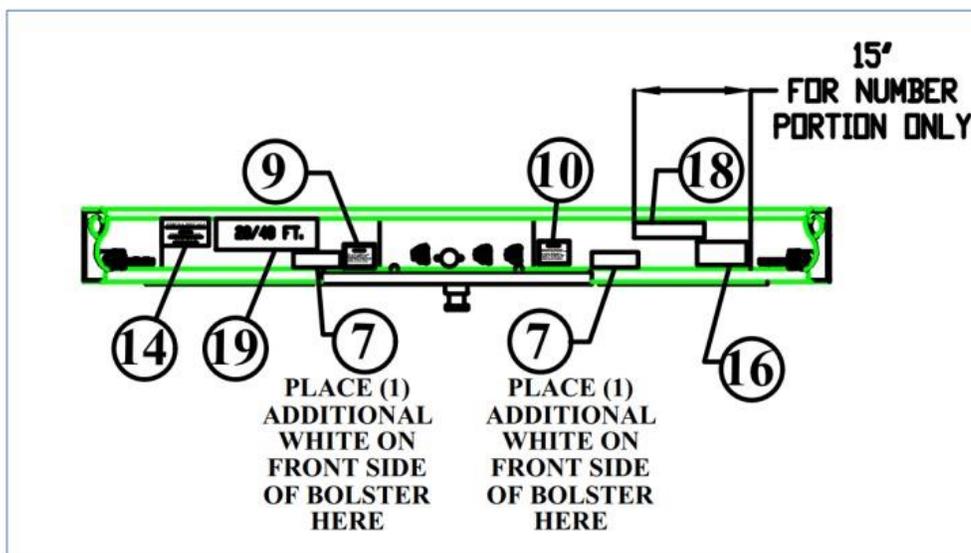
19	10050	20/40 FT. DECAL	1	00000
----	-------	-----------------	---	-------

Step 6: Remove any decals identifying the ability of the trailer to carry a 20 ft container, and any other decals that may have been added after delivery referring to carrying a 20 ft container. Items 19 and 20 in Diagram 6
