Equipment Safety Recall 29A

NHTSA 23E-023

Frame Stud

This recall applies only to the above short wheelbase frames (Body Style: JL72) intended for use on 2018-2023 (JL) Jeep Wrangler vehicles.

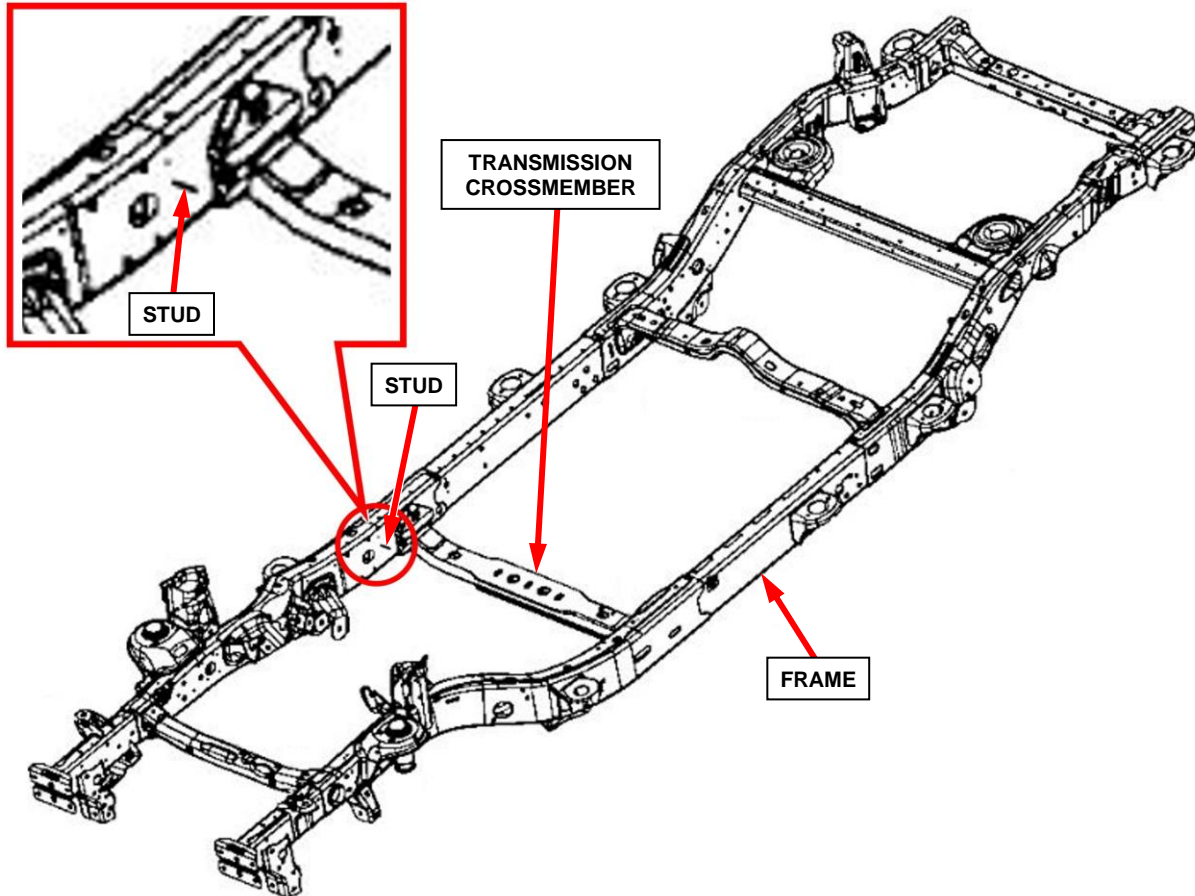
Figure 1 – Frame Stud Location – Inspect for Frame Stud

Visually look for a stud on the frame in the location shown in (Figure 1).

- **Frame Stud Located:** Proceed to **Section D. Frame Stud Removal** for stud removal procedure and perform only **Steps 1 - 3** then claim the “Off Vehicle” stud removal LOP.
- **Frame Stud Does NOT Exist:** No further action required. Claim the “Off Vehicle” stud inspection LOP.

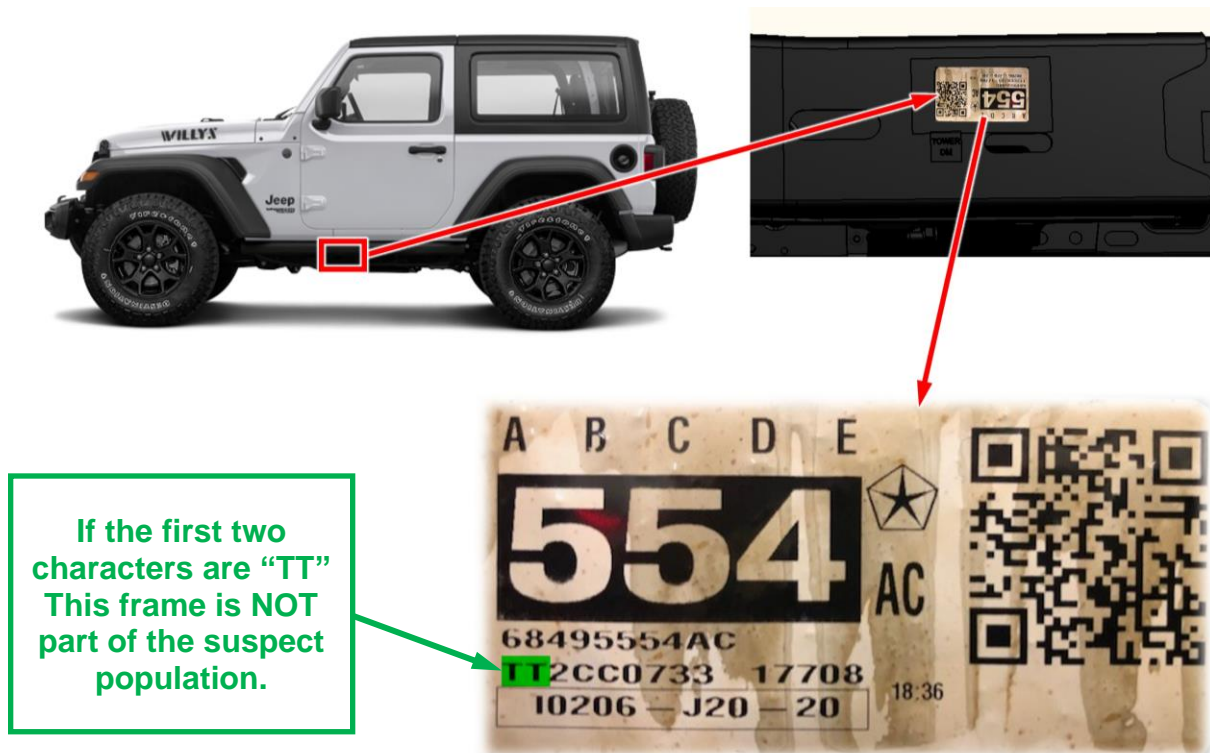
Figure 2 – Front Reinforcement Crossmember

1. Look for a label on the driver side frame rail just rearward of the door hinges.
2. If the label looks like (Figure 2) and is readable not missing or covered over by an aftermarket coating material, then read the label as instructed in (Figure 2).
3. If the label does NOT look like (Figure 2) or is unreadable, missing, or covered over by an aftermarket coating material, then proceed to **Section C. Frame Stud Inspection.**

4. What were the first two characters on the label as instructed in (Figure 2).
 - First two characters were “TT” – No further action required. Claim the appropriate inspection LOP and return vehicle to customer.
 - First two characters were some other combination of characters - Proceed to **Section C. Frame Stud Inspection.**

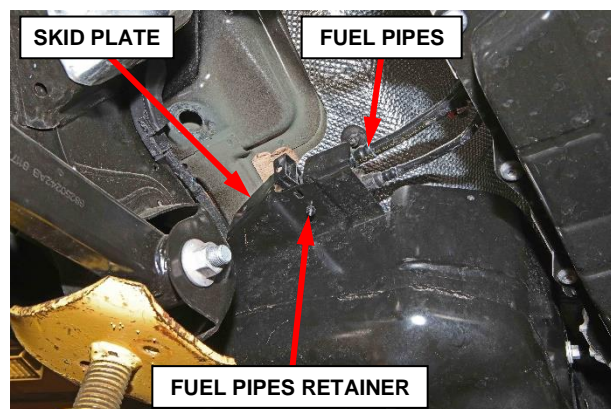
Figure 4 – Fuel Pipes Retainer

3. Release the fuel pipe retainer from the fuel tank front skid plate (Figure 4).

7. Install the fuel pipe retainer to the fuel tank front skid plate (Figure 4).

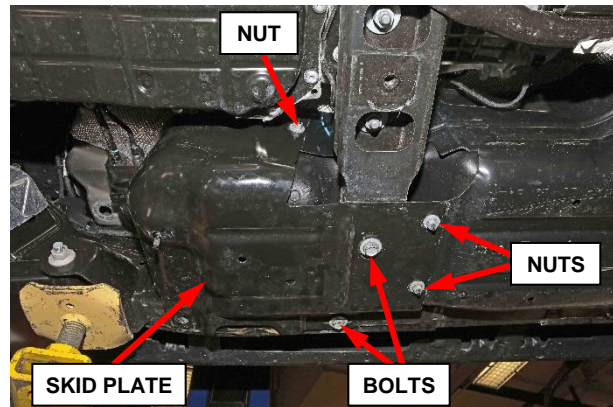
Figure 5 – Fuel Tank Front Skid Plate

4. Remove the fasteners, two bolts and three nuts securing the fuel tank front skid plate then remove the skid plate from the vehicle (Figure 5).

NOTE: Nut locations on skid plate are slotted so nuts do not need to be fully removed.

6. Position the fuel tank front skid plate to the vehicle then install and tighten the fasteners, two bolts and three nuts (Figure 5).
 - Bolts: 75 N·m (55 ft. lbs.)
 - Nuts: 20 N·m (15 ft. lbs.)

4. Position the fuel tank front skid plate to the vehicle then install and tighten the fasteners, two bolts and three nuts (Figure 5).
 - Bolts: 75 N·m (55 ft. lbs.)
 - Nuts: 20 N·m (15 ft. lbs.)
5. Install the fuel pipe retainer to the fuel tank front skid plate (Figure 4).
6. Position the front reinforcement crossmember to the vehicle then install and tighten the three bolts and one nut (Figure 3).
 - Bolts crossmember to outer frame rails: 95 N·m (70 ft. lbs.)
 - Bolt crossmember center leg to crossmember: 75 N·m (55 ft. lbs.)
 - Nut: 20 N·m (15 ft. lbs.)
7. Lower the vehicle and return to the customer or inventory.
8. Claim the stud removal LOP.

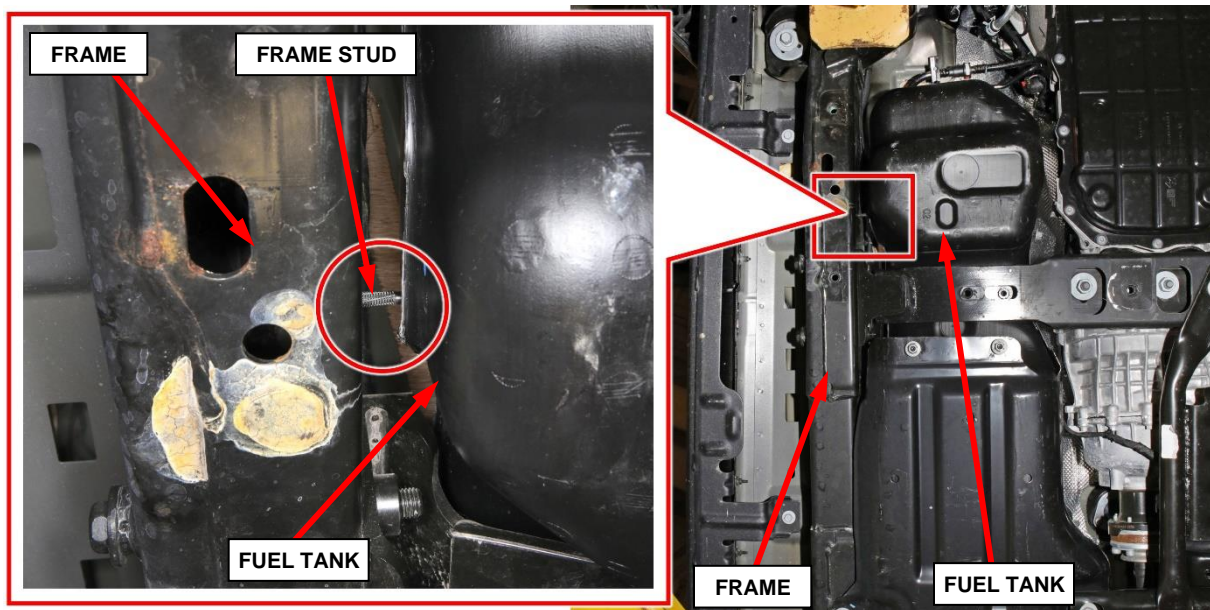
Figure 6 – Frame Stud Location – Inspect for Frame Stud

On about 160 of the above frames may have been built with an unnecessary and unused frame stud. When installed in a vehicle, the frame stud may contact the fuel tank in a crash, which, in certain circumstances, can cause a fuel leak. A fuel leak in the presence of a competent ignition source may result in a fire, increasing the risk of occupant injury and/or injury to persons outside the vehicle.

5. Visually look for a stud on the frame in the location shown in (Figure 6).
 - **Frame Stud Located:** Proceed to **Section D Frame Stud Removal** for stud removal procedure. Do NOT continue with Inspection Procedure.
 - **Frame Stud Does NOT Exist:** Continue with **Inspection Procedure** to reassemble the vehicle. Section D is not required if no stud exists.

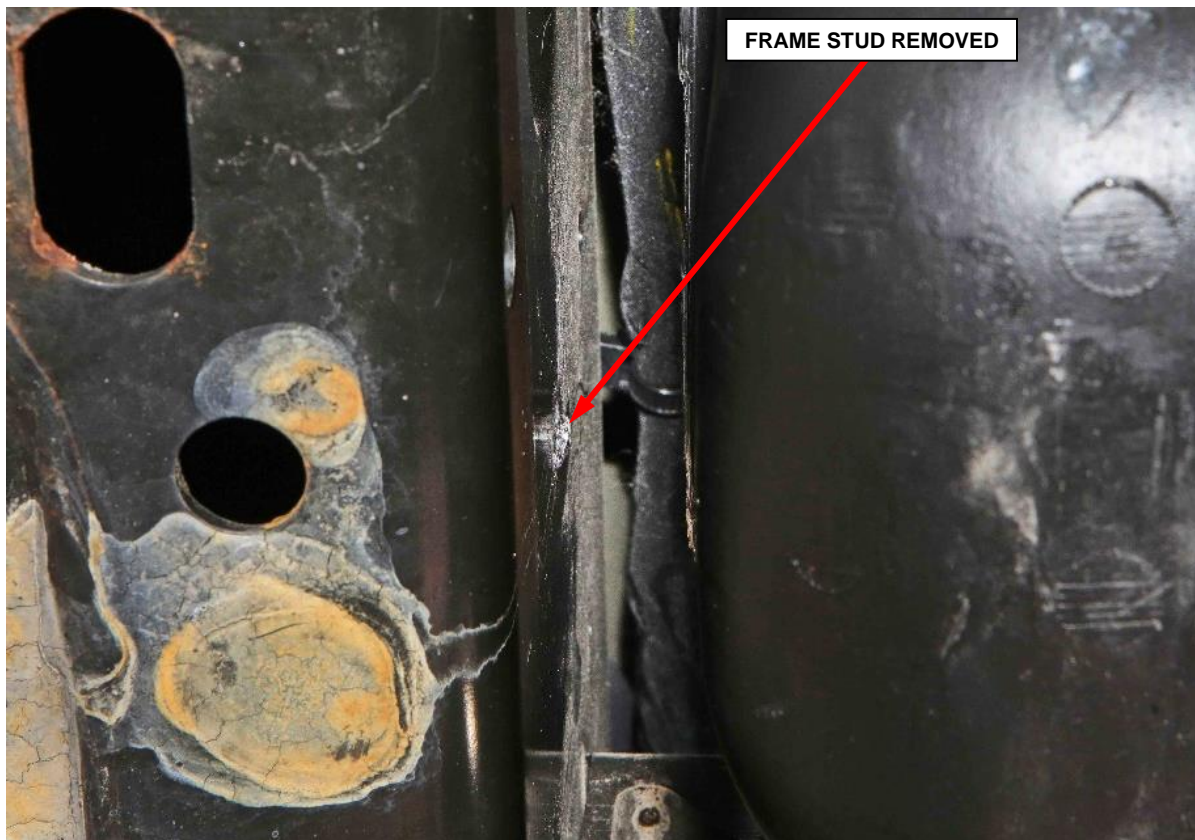
Figure 8 – Frame Stud Removed

2. After removing the frame stud (Figure 8).
