# VOLUNTARY RECALL CAMPAIGN

Classification: BT23-004A	Reference: NTB23-033A	Date: June 7, 2023
------------------------------	--------------------------	-----------------------

## VOLUNTARY SAFETY RECALL CAMPAIGN 2022-2023 PATHFINDER AND 2021-2023 ROGUE; DRIVER'S SEAT RAIL INSPECTION

**CAMPAIGN ID #:** PC966, PC980  
**APPLIED VEHICLES:** 2022-2023 Pathfinder (R53)  
2021-2023 Rogue (T33)

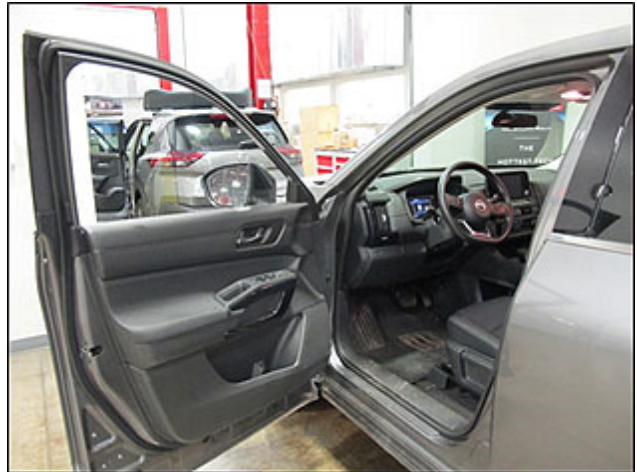
Figure 1

1. Open the driver (LH) front door.

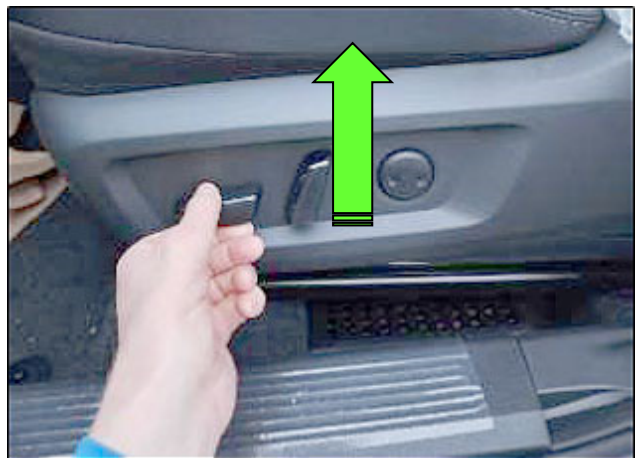
Figure 2

2. Move the driver's seat bottom to the fully UP position (Figure 2).

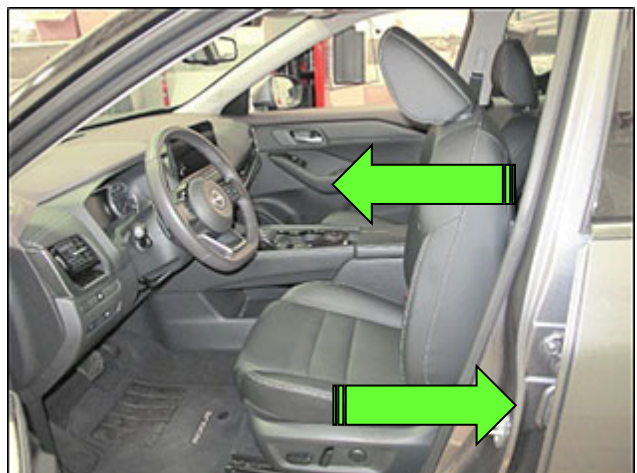
Figure 3

3. Move the driver's seat bottom to the fully REARWARD position and move the seat back fully FORWARD (Figure 3).

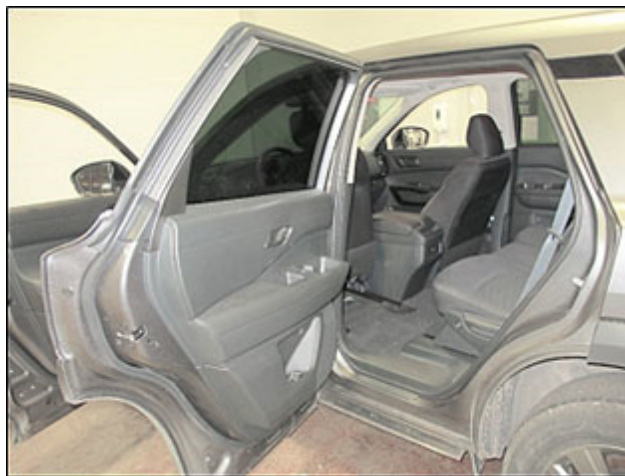
Figure 4

4. Open the driver (LH) rear door.

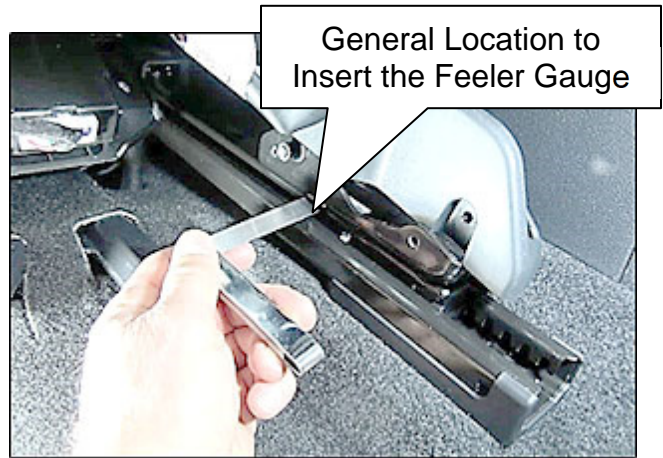
8. Using a 0.55 mm (**0.022 inch**) feeler gauge, attempt to insert the feeler gauge between the Driver's Seat Track Inner and the Seat Slide Inner.
- Verify the 0.55 mm (**0.022 inch**) feeler gauge will not insert at locations A, B or C, between the seat track and seat slide (Figure 10).

- Reference Figure 8 on page 4 for the angle that the photo should be taken and send a photo to: [claims-inspections@nissan-usa.com](mailto:claims-inspections@nissan-usa.com)

10. Take a clear digital picture of the feeler gauge inserted between the seat track and the seat slide, and a clear picture of the VIN on the certification label.
