# SOP09174

## QAAR 10253 Battery Disconnect

### Terminal Post Protection

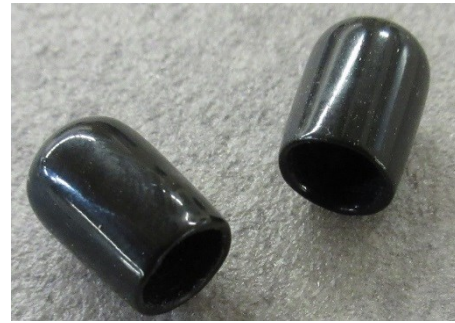
Terminal Post Protective Covers
