RECALL 23V061 / 2023-025 REMEDY INSTRUCTIONS

Make(s): GALLERIA, BEYOND & NOVA
Model(s): MANY, SEE BELOW
Model Year(s): 2022 - 2023

Concern:
The internal aluminum burner tubes connecting the gas valves to the cook top burners can fracture from excessive vibration or shock experienced in recreational vehicles.

521337/521340 SDS2 FIELD RECALL KIT INSTRUCTION SHEET FOR STOCK NUMBERS 3031AST AND 3032AST

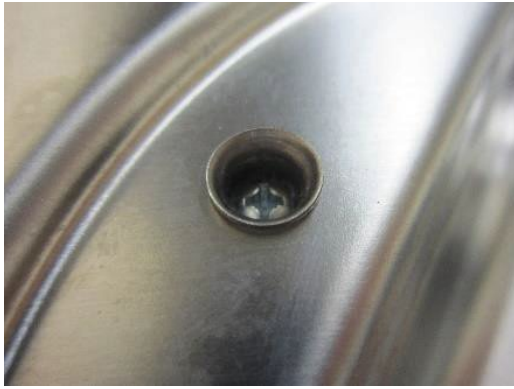
3. Using a #2 Phillips screwdriver, loosen the screws under each bumper. This will retract the clamping mechanism that attaches the cooktop to the countertop.

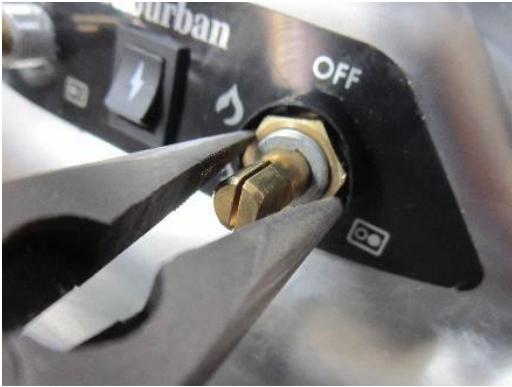
17. Using needle nose pliers, remove top nut securing the left valve to the main top. Your cooktop may have one or two nuts securing each gas valve.

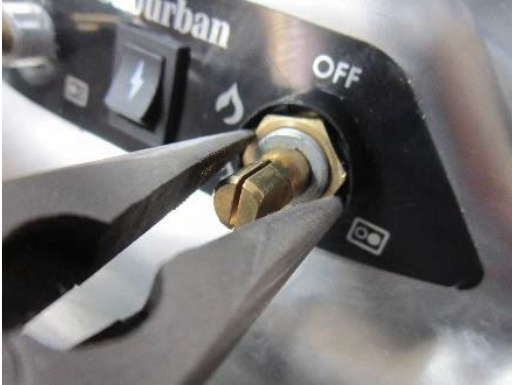
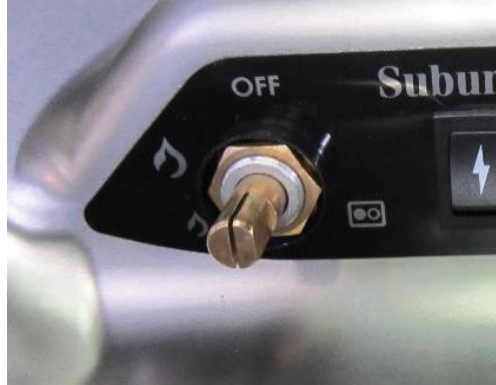
20. Install top nut and torque to 20 in-lb.

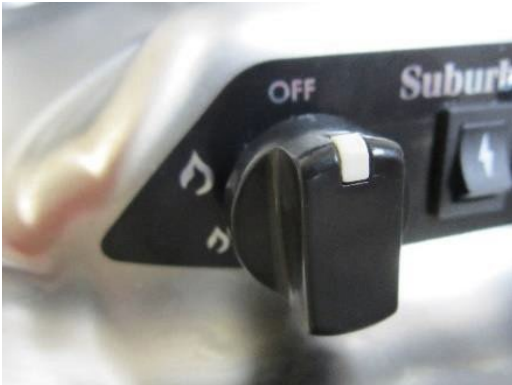
21. Reinstall control knob.
