Compliance Recall

Code: 50G5

Subject	Safety Certification Label																			
Release Date	April 14, 2023																			
Affected Vehicles

Subject: Compliance Recall 50G5 – Safety Certification Label

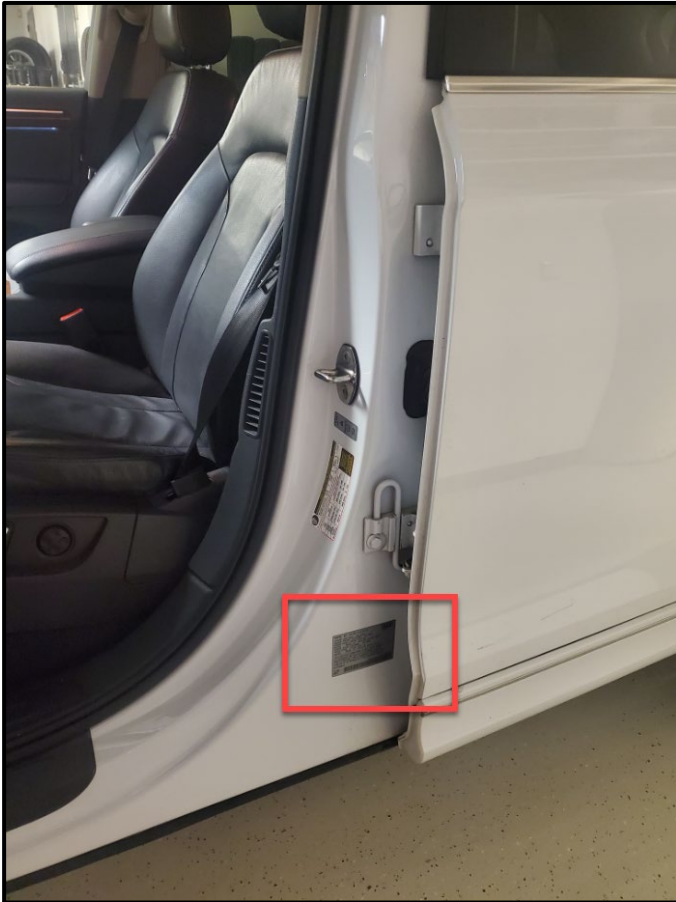
Section B – Repair Procedure

- Open the driver front door.
- Locate the “Safety Certification” label on the lower part of the B-pillar.
- Clean the surface of the existing label.
- **Only the REAR GAWR information is being updated.**
- Peel the replacement label overlay off the backing paper.
- Apply the label overlay so only the affected data is covered. Do not cover any additional data on the existing label.
- Canadian vehicles: The overlay includes one for each language (English + French).

- Ensure minimal air bubbles are created when installing the new label overlay.

- The surface of the existing label must be clean, dry, and free from oil residue prior to applying the replacement label overlay.
- Handle the replacement label overlay carefully. Do not touch the adhesive backing.
