# **BRAKE PEDAL**

## **ASSEMBLY INSPECTION**

(9/15/2022)

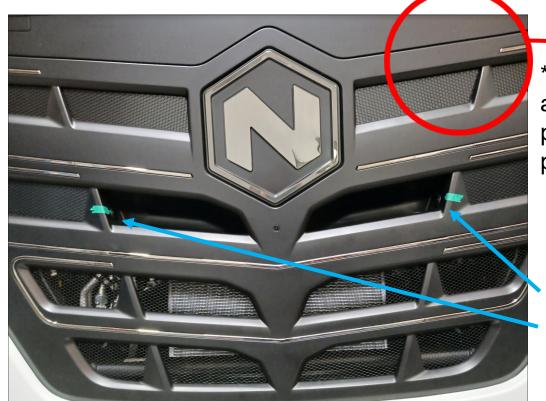
\*Approximate area of supplier production date plate under Hood

\*Hood is opened by pressing two buttons simultaneously

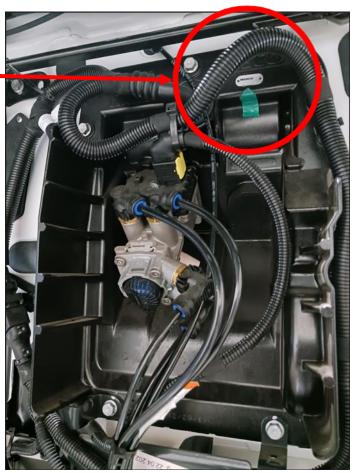
## Step 2: Verify if vehicle is within suspect range

1. Engine side – nameplate with production date

0522 CW – calendar week of production YY – year of production

Suspected parts for inspection **BEFORE CWYY 1522**

\***NOTE**: Further inspection not required if date of production is CW15 of 2022 or later

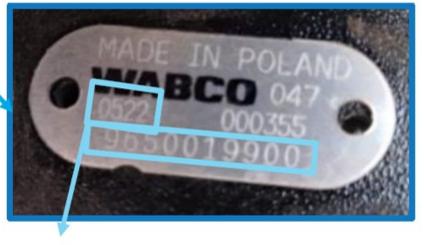
**9650019900 –** ZF Part Number 5802814623 – IVECO PN 00612809 – NIKOLA PN

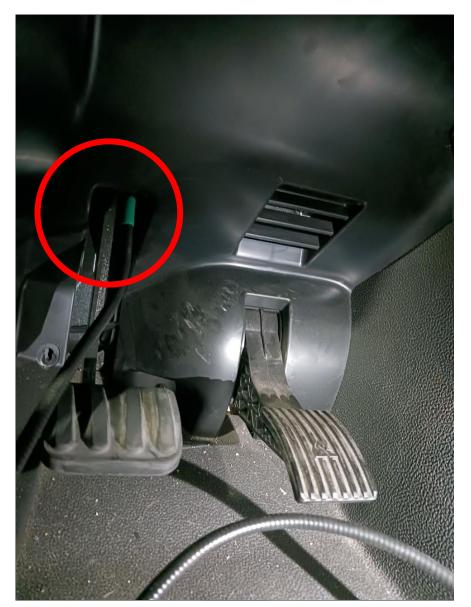
- A) Locate Brake Pedal Assembly on driver`s side
- B) Turn on borescope and insert camera approximately 6-7 inches inside the opening of the Brake Pedal Assembly, following the RIGHT side of the pedal

NOTE: Camera should glide against pedal and may need to be manipulated in order to locate suspect screw (see slide 5 if using side view borescope)

\*It is recommended to mark the borescope to assist in inserting the appropriate length

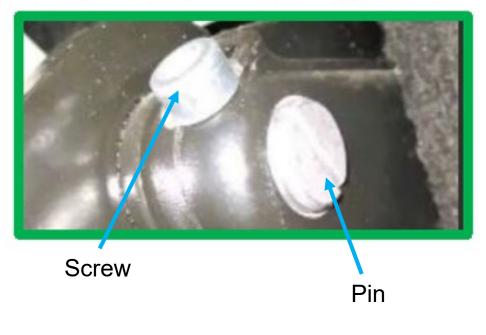
#### BAD PART – screw not tightened

#### BAD PART - missing screw
